The Mechanical Contact Behaviour and Tribology of Polymer Gears

A thesis submitted in partial fulfilment of the requirements
for the degree of
Doctor of Philosophy in Engineering

University of Warwick, School of Engineering

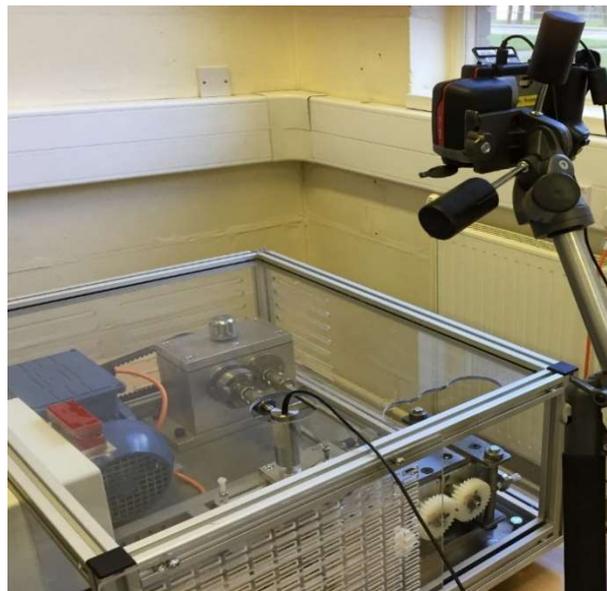
At test rig I, where gears run in dry condition, the camera was fixed above both gears (Figure 3.14). The gear teeth flank temperature was measured for both the driver and driving gears simultaneously. After setting up the camera and connecting it to the computer, some of the preliminary parameters were entered in the ‘FLIR Research IR’ software as in Table 3.1. Temperatures were recorded in milliseconds and plotted against gear running cycles.

Figure 3.14 Thermal imaging camera location

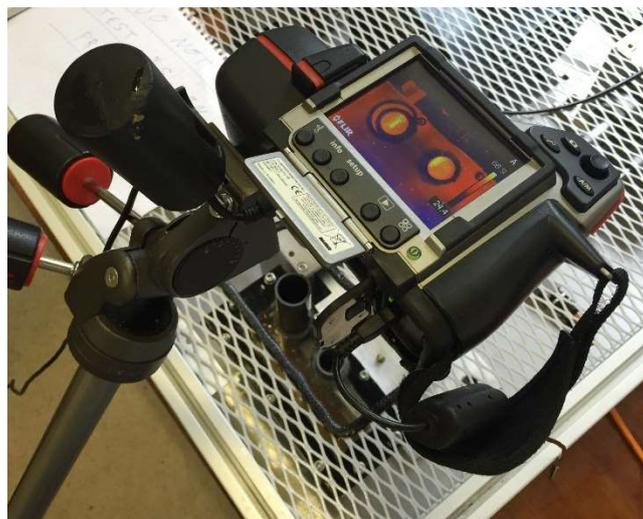
Figure 3.16 Thermal imaging camera position at test rig II

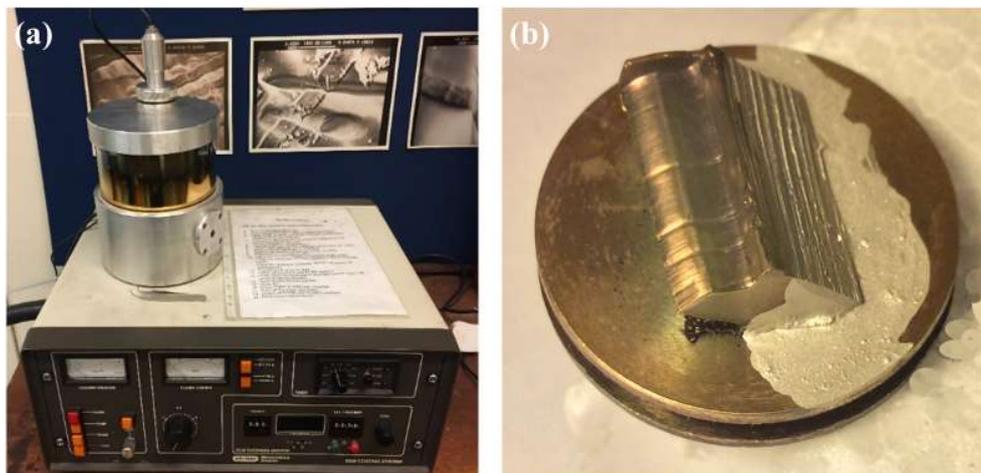
specimen holder using a special brush, to act as an electric field connector (Figure 3.25 (b)). The prepared specimen was placed in the SEM chamber, which was then evacuated less than 5×10^{-5} mbar. At this vacuum pressure, the accelerating voltage can be applied and image appears on the screen. The accelerating voltage was set to the range of 5 to 12 kV to avoid the heating and melting of the gear tooth surface, because of the hardness properties of polymer materials.

Figure 3.25 (a) BIO-RAD SEM Coating System and (b) gear tooth prepared for SEM

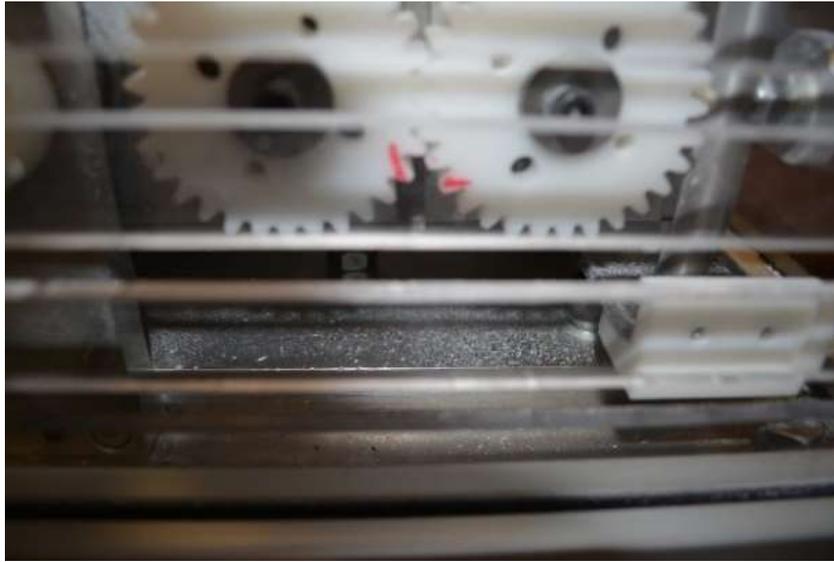
Monitoring the acetal gears test over the running time revealed that wear debris was falling from them in very small amounts during both the running in and steady stages of wear (Figure 5.2). Similar behaviour was observed with injection moulded acetal gears in previous work [75]. Some gear teeth and samples of the debris collected were investigated under the SEM, and pictures taken. Figure 5.3 shows the after-test machine cut acetal gear pair.

Figure 5.2 Debris falling from machine cut acetal gear test under 7 Nm load and at 1000 RPM
