Seismic Strengthening of Low Strength Concrete Columns using High Ductile Metal Strap Confinement: A Case Study of Kindergarten School in Northern Thailand[†]

Abstract

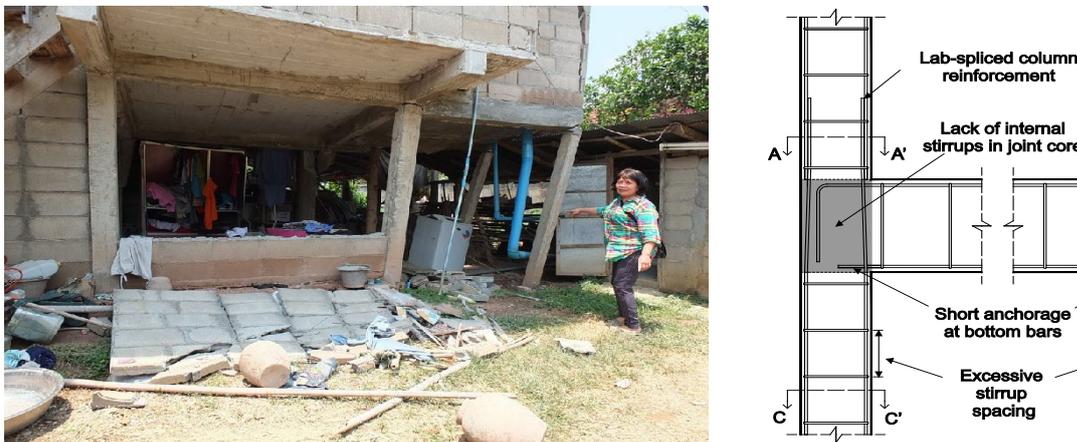
Figure 1 (a) Building partial collapse during the 2014 Mae Lao earthquake (Chaing Rai, Thailand) due to failure of exterior beam-column joints, and (b) typical substandard detailing of beam-column joints in Thailand (adapted from Imjai *et al.* [6]).

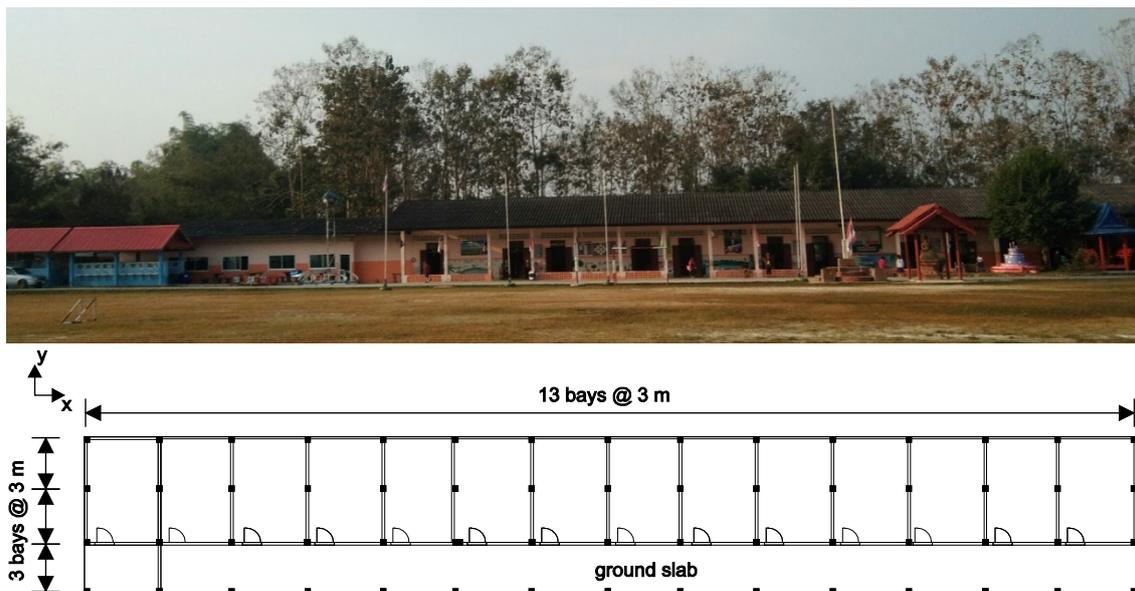
The investigated RC building is the public primary school (Sanchangtai School) located in Northern Thailand (Ampor Pan, Chiang Rai province). The one-story RC building has 7 teaching rooms (13 bays in X and 3 bays in Y directions having a typical span of 3 m - see **Figure 2**). The building was built in 1998. The cross-section of columns is 200×200 mm². The columns had a total height of 3 m and were reinforced with main reinforcement of 4-DB 12 (Yield stress = 295 MPa) and RB6@200 mm (Yield stress = 235 MPa) as steel stirrups, having a modulus of elasticity = 200 GPa. The wall is made from concrete blocks. The ground slab is 100 mm thick. Before performing the visual inspection, no drawing/material data were available and the averaged concrete compressive strength was obtained from NDT test as $f'_c = 17.3$ MPa, according to ASTM C805 [7]. With such limited information from the construction drawings, detailed engineering assessment (DEA) was subsequently performed by the design team to re-check structural capacity of the as-built concrete members.

Figure 2 Overview of one-story kindergarten school and column layout.

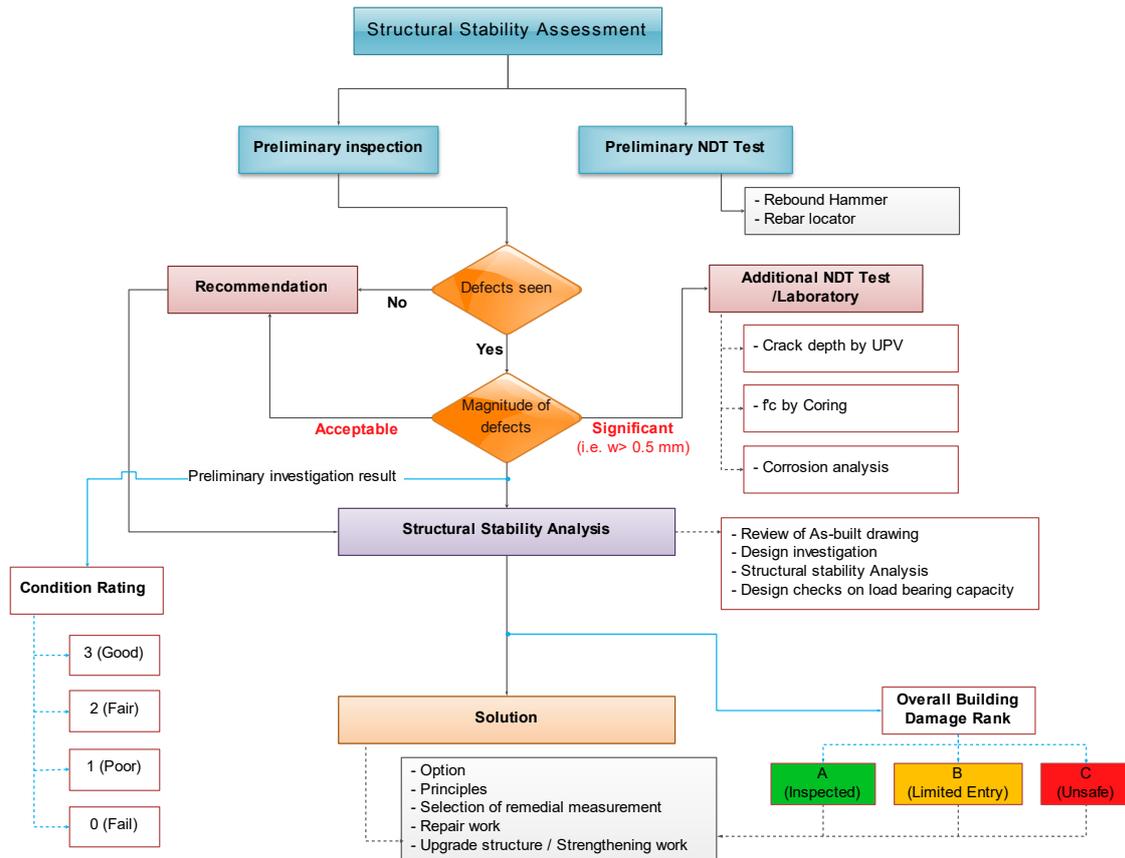
Figure 3 Flow chart from structural condition assessment to solution.

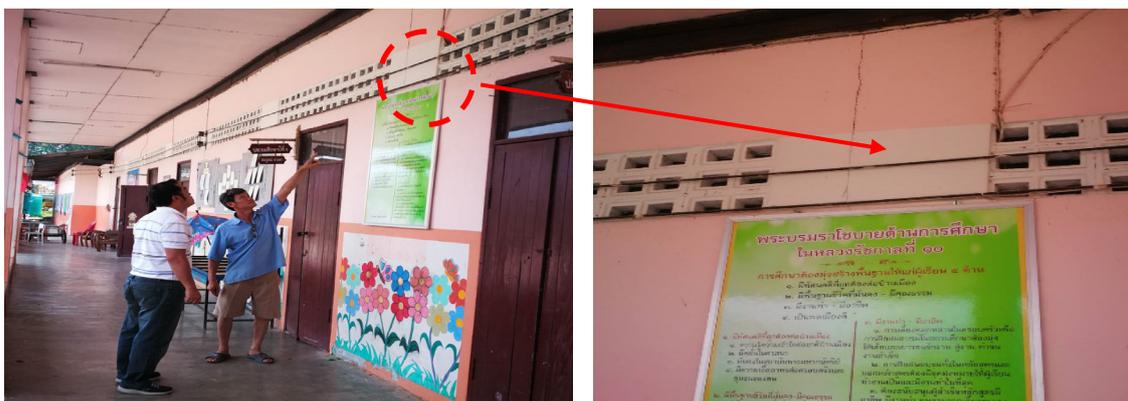
It is, however, noted that a visual inspection (Figures 4 and 5) is essential and during the walk-around there may be an opportunity to obtain samples of defects/loose concrete or cracks from spalled area that may be easily detached. At this stage, opportunities to view all the structure may be limited, for example, high parts of the structure or hidden areas behind false ceilings.

Figure 4 Visual inspection of damaged building performed during phase 1 (photo no. F-01).

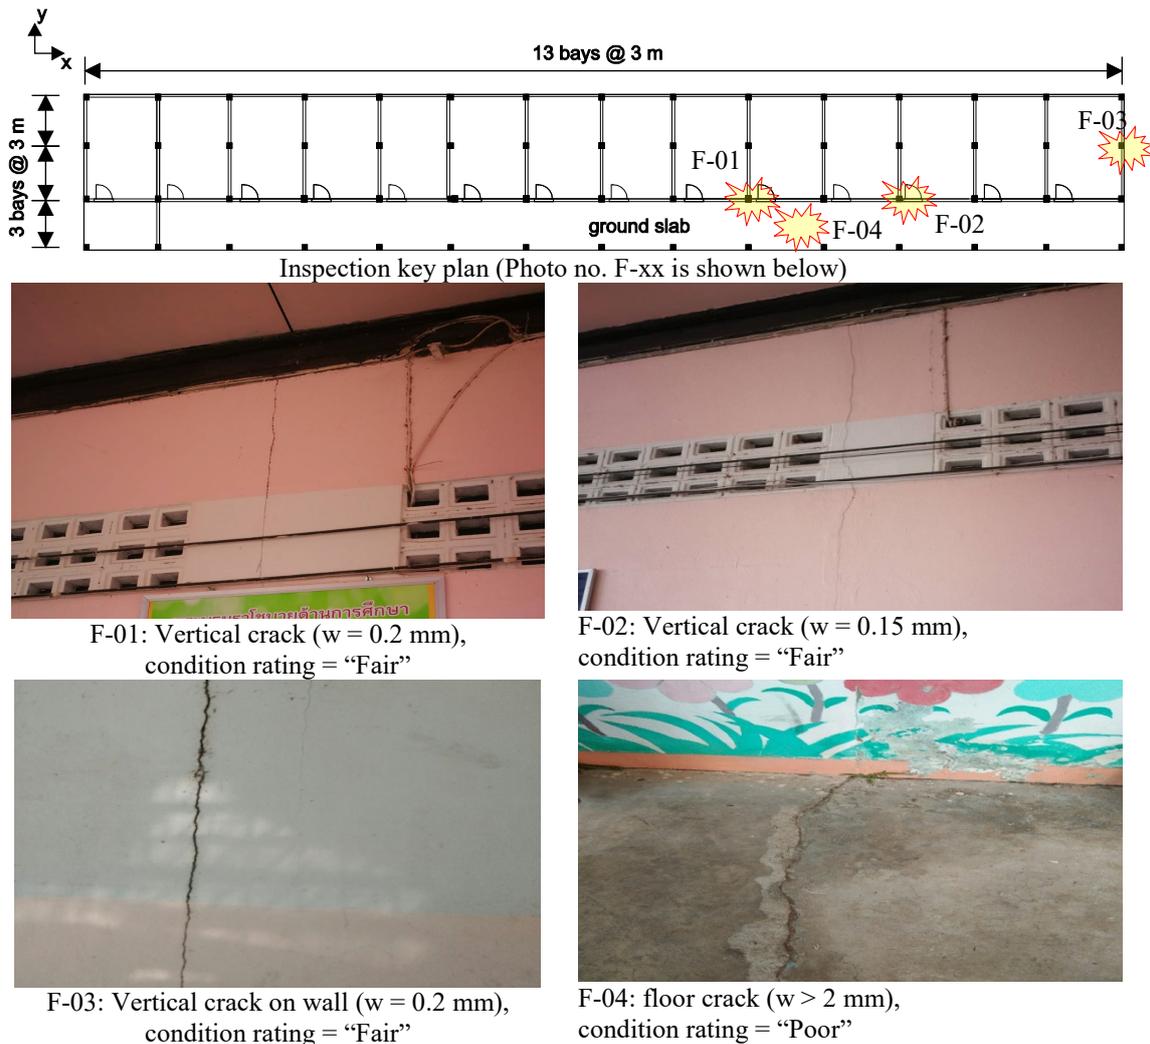
Figure 5 Photos from visual inspection (adapted from the field inspection report by Imjai *et al.* [6]).

During the visual inspection, a structural condition rating (i.e. **Table 1**) was given to the inspected structural components such as column, beam, and slab of the building. This rating condition was given according to the damages observed during the field inspection survey only. Damages such as concrete spalls, cracks, bulging are classified according to the degree of damage and rating level ranged from 0 (Fail) to 3 (Good). This condition rating for individual structural components should not be used as a representative damage ranking for the whole building. It is intended to be used as conditional rating for only inspected structural members and thus required action can be specified for those members once the rating condition is given. Crack mapping results from structural engineering assessment performed during Phase 1 were shown in **Figure 5**.

- During the visual inspection, vertical cracks found on the concrete wall with a maximum crack width of 0.2 mm which was rated as “Fair” condition. Thus, this damaged wall required repair work. For ground slab, it was found that a 2 mm crack width occurred at the columns and, thus, was rated as “Poor”, which required urgent repair work.

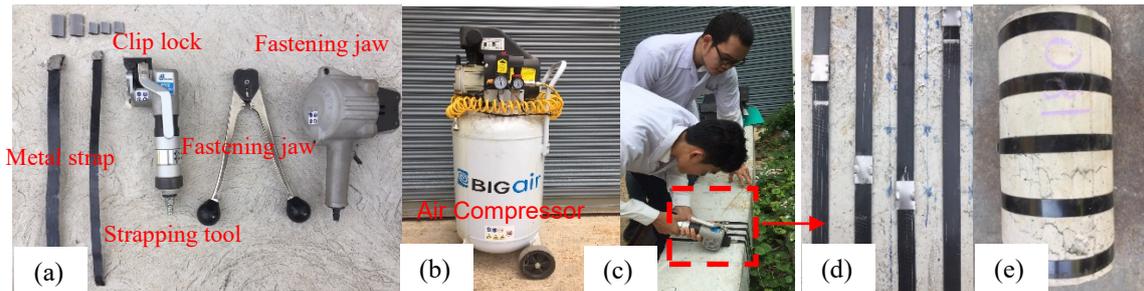
Previous research at the University of Sheffield [12] led to the development of the Post-tensioned Metal Strapping (PTMS) technique. The technique used ductile high-strength steel straps post-tensioned around RC elements using strapping tools as those used in the packaging industry (see **Figure 6a**) Metal straps are commercially available in various thicknesses, widths, and strengths. The ease of handling and strengthening objective determine the strap dimensions. Typical metal strap yield strengths vary between 300 and 1,000 MPa. Two types of tensioning machines exist i) pneumatic, in which the tension force is regulated accurately by applied air/hydraulic pressure (see **Figure 6b**), or ii) manual, in which the tension force is controlled by the operator. A cylindrical specimen confined using an air-powered tensioning machine is shown in **Figure 6c**. This method has demonstrated to be effective in strengthening medium-scale RC members subjected to monotonic loading (see **Figures 6d-6e**) [13-15]. The low cost of the materials and the ease and speed of application make this technique very effective for the repair and strengthening of existing deficient RC buildings. However, corrosion of the mild-steel clip lock becomes an issue when using this technique and becomes one of the main issues when using PTMS for retrofitting concrete buildings in harsh/wet environmental conditions. Moreover, the technique requires pre-tension using pneumatic air pressure and the creep effect on the pre-tensioned straps may be required particular attention for long-term application. Recent extensive research work at Walailak University (WU) by Imjai *et al.* [16-18], performed a series of creep tests on PTMS to verify the effectiveness and applicability of the high ductile Post-tensioned Metal Strapping (PTMS) technique at different scale levels led to the development of a durable Post-tensioned Metal Straps for retrofitting RC beams and columns.

Figure 6 Photos from visual inspection (adapted from Imjai *et al.* [17]).

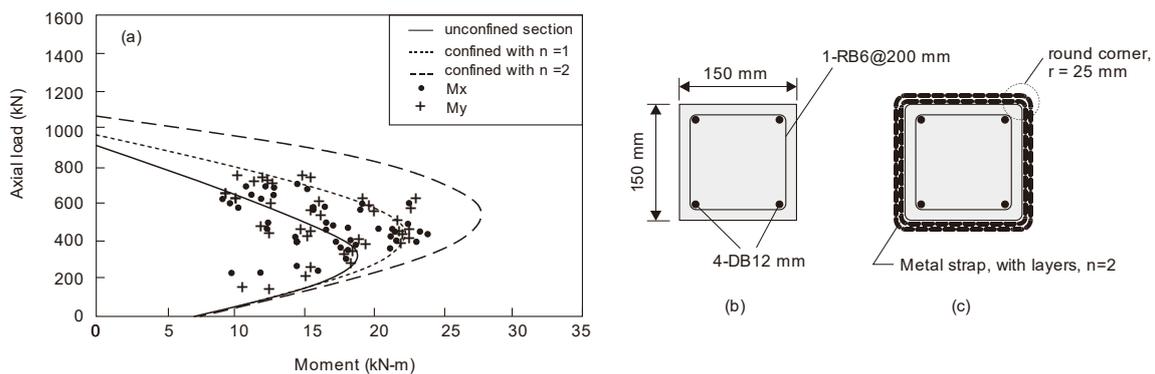
The capacity of confined concrete columns can be calculated by using cracked sectional analysis. Force equilibrium and strain compatibility requirements are used to calculate the ultimate load of unstrengthened and strengthened sections. The RC columns with 3,000 mm height with a 150×150 mm² cross section (**Figure 13a**). Four ϕ 12 mm mild-steel bars were considered as main reinforcement in all of columns. Shear spans were reinforced in shear with 6 mm steel stirrups (2 legs) at a spacing of 120 mm. The calculated interaction diagram of existing RC columns obtained the crack-sectional analysis shown in **Figure 7**, is compared to the confined concrete columns with 2 layers of 0.8×25 mm² metal straps having the yield strength = 800 MPa, ultimate strength = 950 MPa, respectively. The strengthening of the columns resulted in an increase in the axial load carrying capacity by up to 120 %, enabling the column to behave in a more ductile manner.

Figure 7 Seismic strengthening of concrete columns; (a) interaction P-M diagram, (b) unstrengthened section and (c) strengthened section with 2 layers of metal straps.

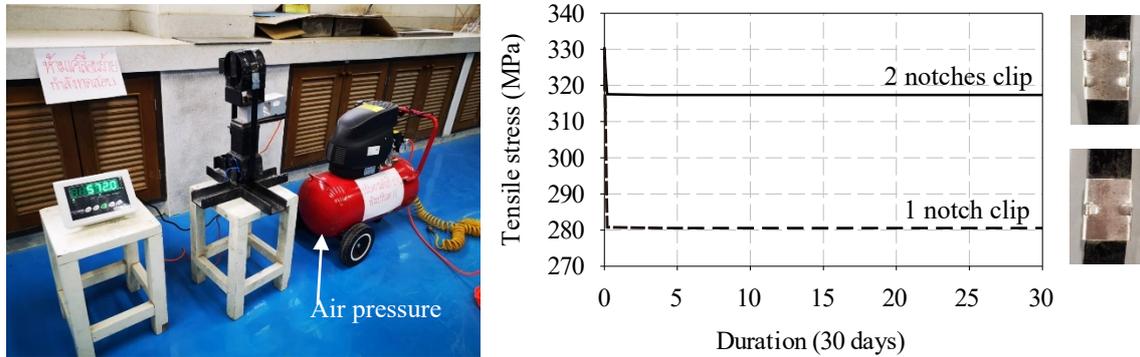
The loss in prestressing force in the strip was measured following the sealing application. This is due to the lifting imposed on the strip during the sealing of the clip by the sealing tool. Stress relaxation due to creep effect was also performed by the authors to investigate this reduction of prestress in 6 coupons (25×0.8 mm² strip) secured with single and double notch clips. The setup shown in **Figure 8a** was used to perform the tests for 1 month, the results of which are plotted in **Figure 8b**. It can be seen that the average prestress loss after sealing at an applied air pressure of 8 bars (116 psi), was approximately equal to 4 %

and 15 % of the initial stress (330 MPa), as measured single notch and double notches sealing applications.

Figure 8 Test setup for creep test (a) and stress relaxation test result over 30 days period (b).

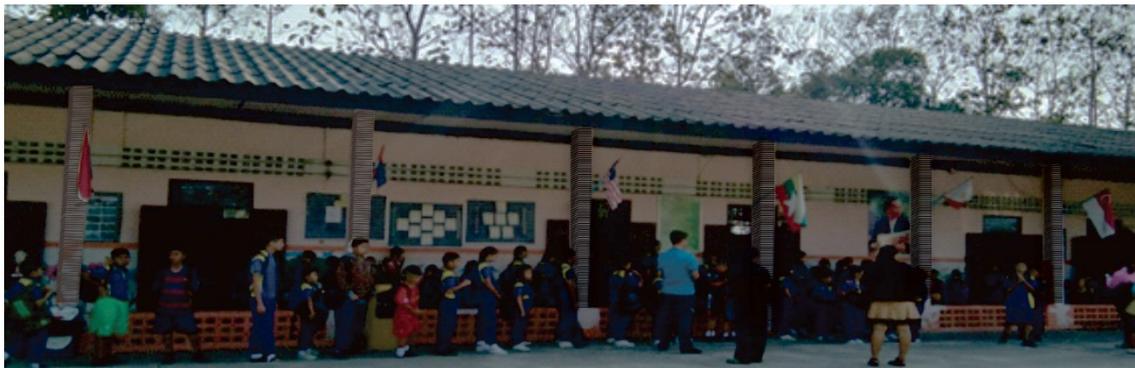
Figure 9 Strengthening of concrete columns after installation of PTMS in the building 1 (front view).

Figures 9 and 10a - 10b show the installation of metal straps on existing RC columns. Following the installation of the straps, two layers of epoxy coating was applied on the PTMS (**Figure 10c**) as a fire protection system similar to the externally bonded CFRP system i.e. [23,24].

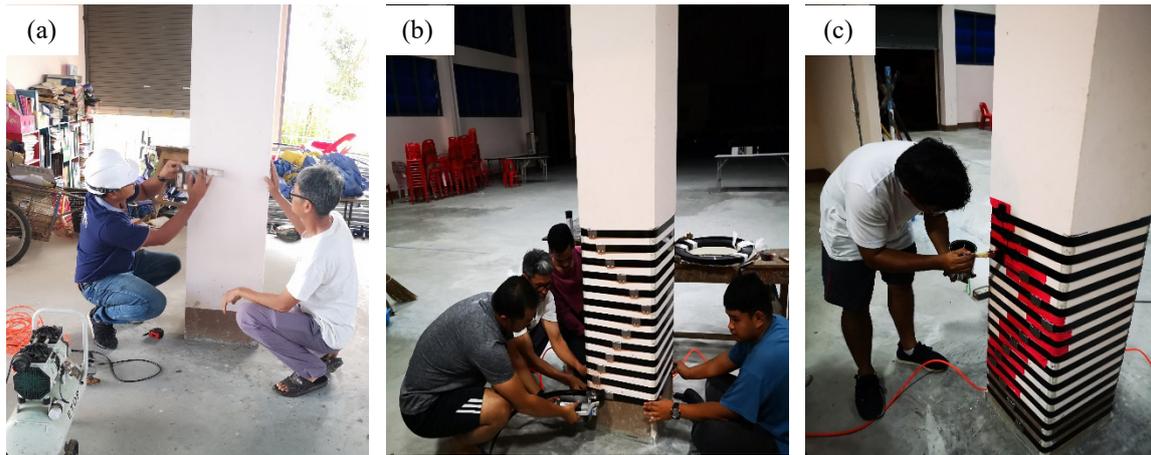
Figure 10 Installation of Post-tension metal straps (PTMS) on a RC column (Gymnasium building).
