The Construction of the Gothic Priory Church of Hexham

JENNIFER S. ALEXANDER

The priory church of Hexham which survives from the late 12th to early 13th century is an ambitious building of some size that derives its architectural design from buildings in the north of England and Scotland. The choir and transepts were planned together but there is evidence in the fabric that a change was introduced during the building of the north transept, and it is suggested that this was due to the replacement of the master mason. The construction sequence can be understood from a detailed examination of the fabric, and from a survey of its masons' marks.

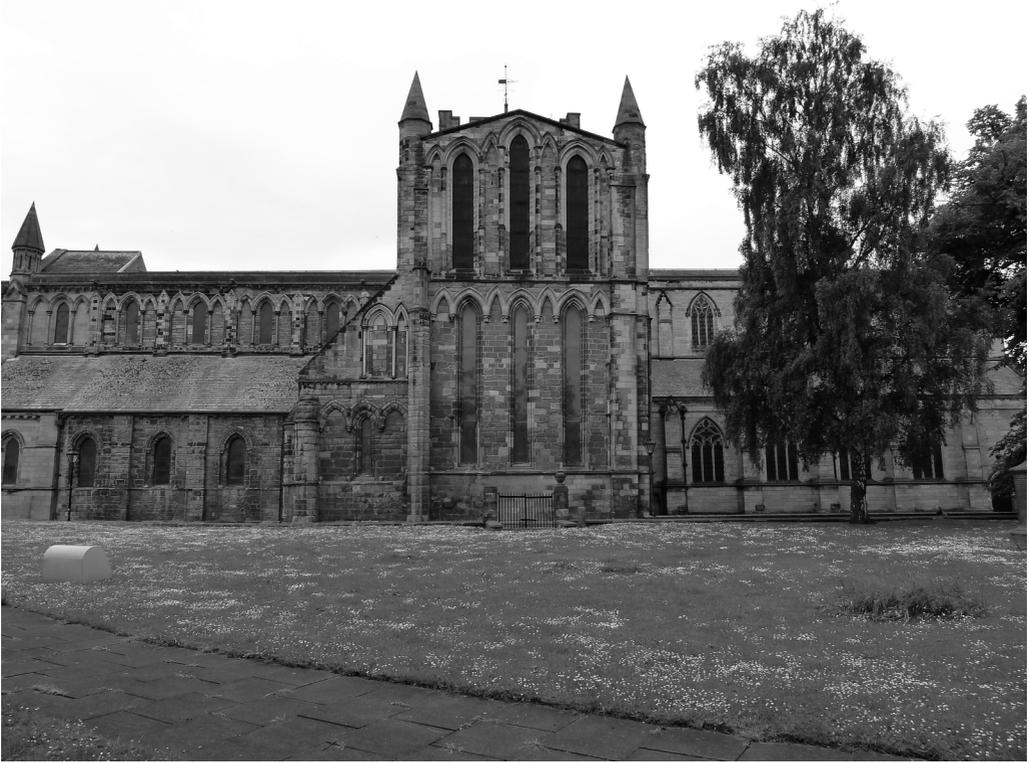
FIG. 1. Hexham priory church exterior from the north

HEXHAM priory was an early foundation, and the first records of building work relate to the period of St Wilfrid in the 7th century, from which the crypt survives.¹ Its position close to the Scottish border has meant that it suffered raids both to its outlying properties and to its urban site, with consequent periods of financial hardship and of repair, or reconstruction, of its church and claustral buildings. The documentary history was transcribed by James Raine in the 1860s and needs only brief mention here.² The most significant event in its early history was its refoundation *c.* 1113 as an Augustinian house, by which time Hexham had been removed from Durham and placed in the see of York. This does not seem to have been the stimulus for an immediate reconstruction of the church and we hear only that the claustral buildings were rebuilt in stone by Asketill, the first prior, who died in 1130. Instead, surviving Anglo-Saxon work, of unspecified date, seems to have been refurbished in the late 11th century.³ There may have been a partial rebuilding of the choir in connection with the translation of the relics of Hexham's saints to a site close to the high altar in 1155, from which the apse has been found, but it was swept away in a complete reconstruction of the choir and transepts in the late 12th and early 13th century (Fig. 1).⁴

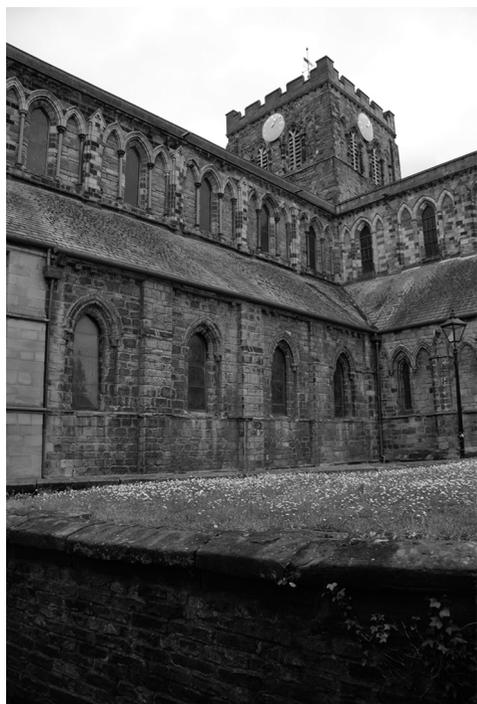
FIG. 2. Choir exterior from north-east

finished with moulded arches on chalice or waterleaf capitals and monolithic shafts, place the start of work in the last two decades of the 12th century (Figs 2, 3).

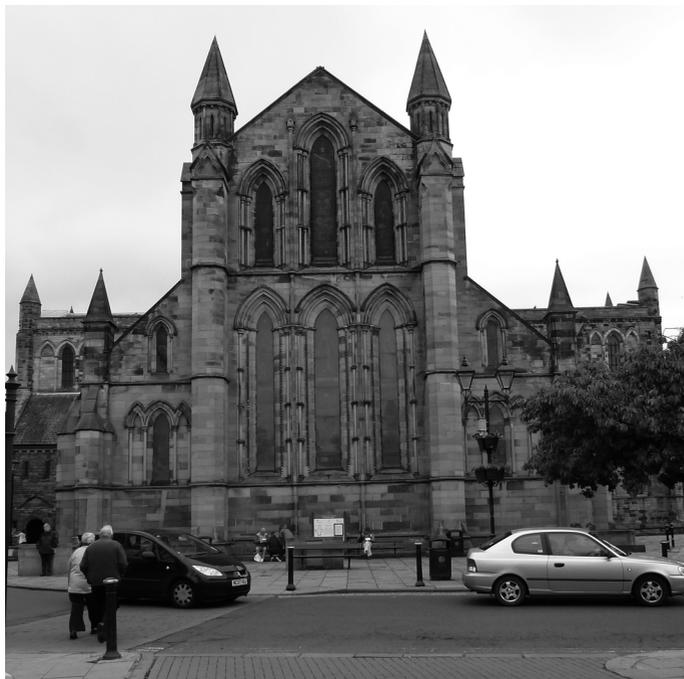
FIG. 4. Choir exterior east wall

Hexham's stylistic affinities are with buildings in the north of England and Scotland, as will be discussed below, but it departs from these prototypes in the plan of its east end, as it had neither a projecting unaisled presbytery, nor an eastern aisle. Hexham's flat east wall with its two levels of tall lancet windows is the result of an 1860 remodelling by the Newcastle architect, John Dobson, as the replacement for a high gable and the late medieval row of chapels aligned across the east end of the building, which had become derelict (Figs 4, 6).¹⁰

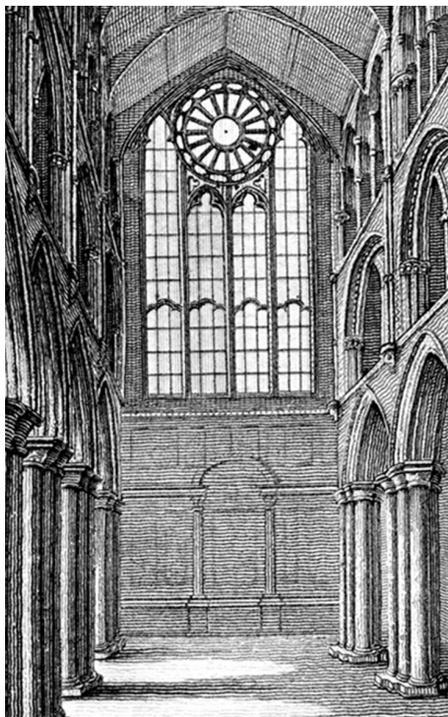
FIG. 5. Detail of a drawing by W. Brown, published in 1809, showing the east window flanked by tracery from an earlier east window

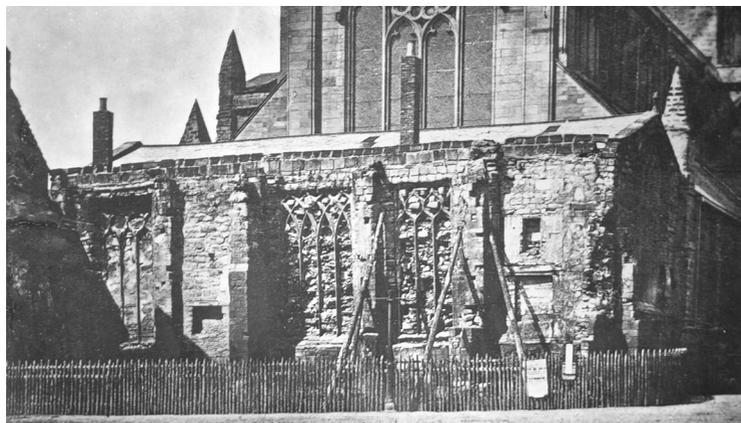
FIG. 6. Photograph taken in *c.* 1858 before the removal of the 14th-century chapels built against the east end of Hexham

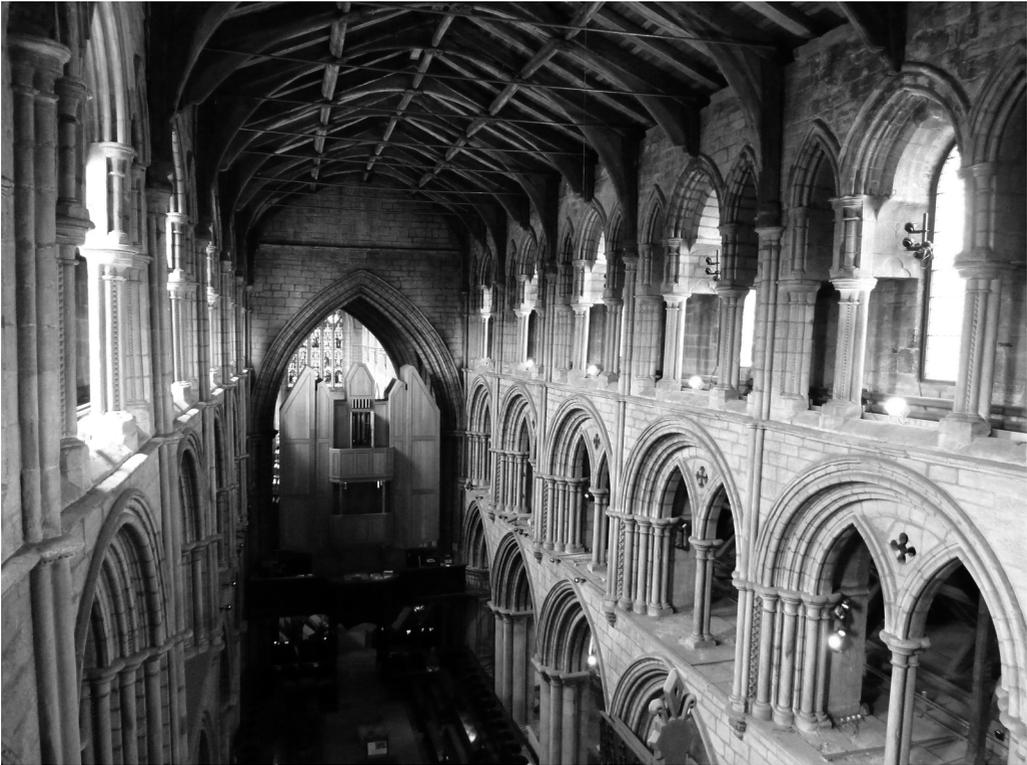
FIG. 7. Choir interior from the south-east

between the shafts of the lay-brothers' door at Jervaulx, on the processional cloister door at Whitby, and in the clerestory at Tynemouth. The roof shafts are grouped monoliths at triforium level but change to coursed ones in the clerestory where they separate the bays of a tall two-storeyed triple arcade of two blind arches flanking a window, with a wall passage (Fig. 7).

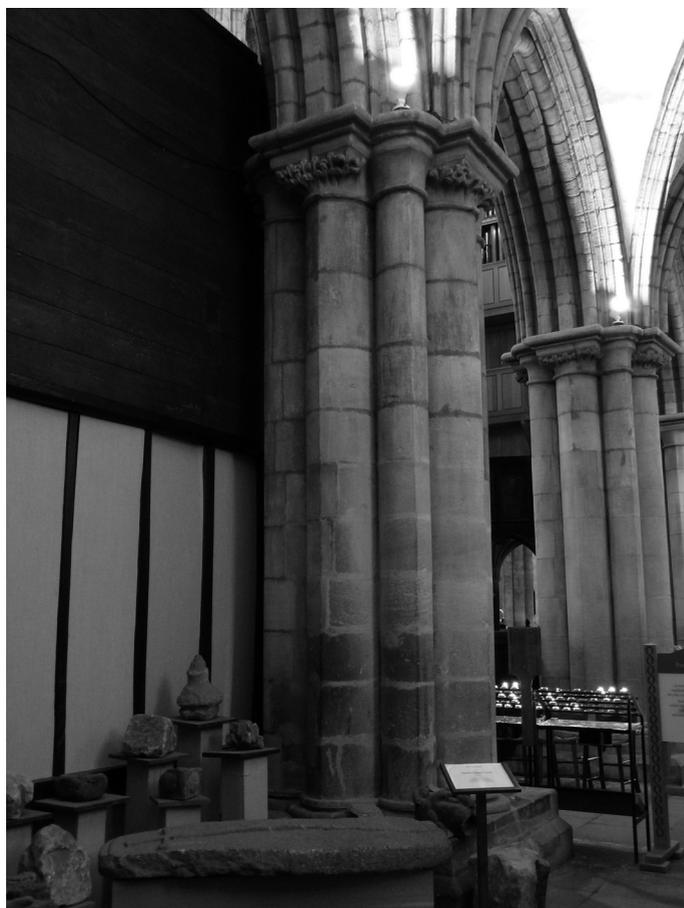
FIG. 8. Choir north arcade piers from the aisle

differ between the two sides (Fig. 8). Stepped bases above square plinths are described as unique to Hexham, but only one pair of pier bases has this design and the rest are square.²⁰ Construction of the arcade was from east to west, with a pause while the Romanesque east end was removed and the last two bays were then built.²¹ The coursing in the spandrels between the arcade arches on the south is mostly regular until the fourth bay from the east where it changes, and the last two bays have been built from west to east (Fig. 9).²² Masons' marks suggest that all the piers belong to the same phase, with the marks repeated along, and across, the arcades, but in no particular pattern. There are no marks on the western responds.²³

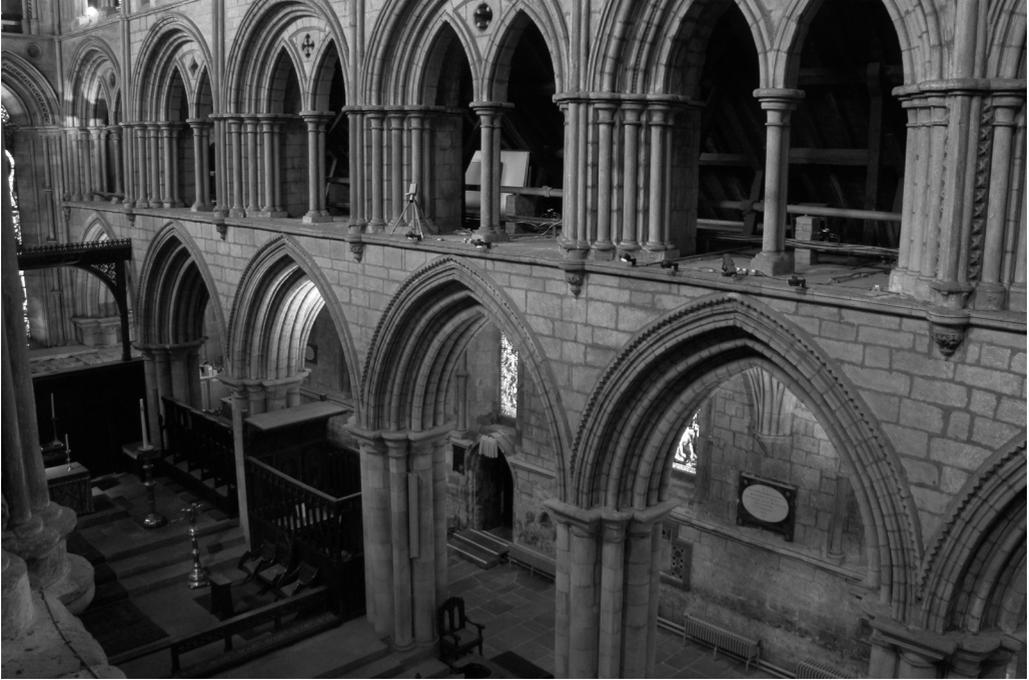
FIG. 9. Choir south arcade from the north-west, with the building break above the fourth arch from the left

The triforium followed with masons from the piers joined by others for its construction. A building break evident in bay four on the south, in line with that of the arcade beneath, has the same masons' marks on either side of the break suggesting that it was not of long duration. There is no corresponding break on the north. The west bay on the south and all the north bays have an order of dogtooth flanking slender shafts between the bays and both sides have narrow bands of nailhead in each arcade arch. Dogtooth is used in a similar way in a number of other northern abbeys,

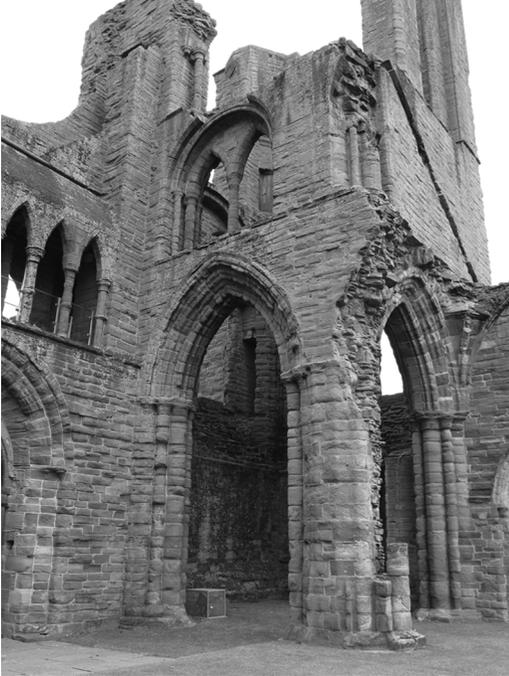
FIG. 11. Arbroath abbey church, nave,
north-west bay
Photo by Richard Fawcett

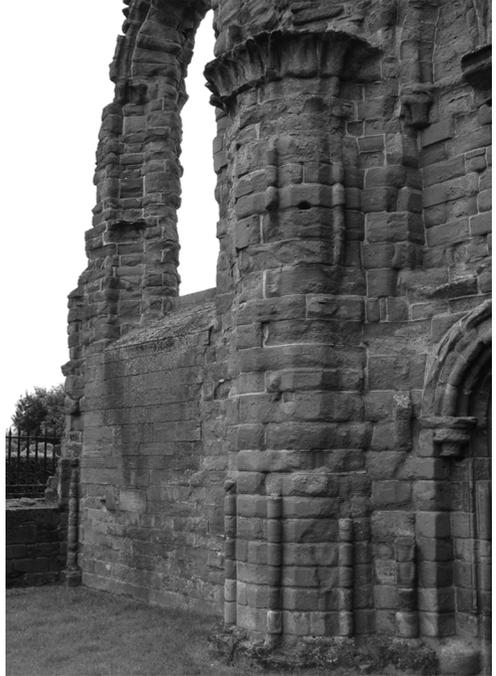
FIG. 12. Arbroath, south transept respond
Photo by Richard Fawcett

One feature clearly adopted by Hexham from Arbroath (and St Andrews) is the type of respond used at the crossing.²⁶ At both Scottish sites a type of pier based on half an octagon with slender coursed shafts sunk, rather than inset, into the angles is used as a transept respond (Fig. 12). Hexham takes the idea further to create a new version in which the bases and separate capitals are removed, leaving the shafts to rise directly out of the pier base and to be subsumed into the pier core below the level of the single, large, moulded capital (Fig. 13). It is used opposite two different designs of arcade pier, in choir and transept, and makes no visual connection with either, or with the shafts of the eastern crossing pier to which it is attached, or with any of the four different arch mouldings which it supports.

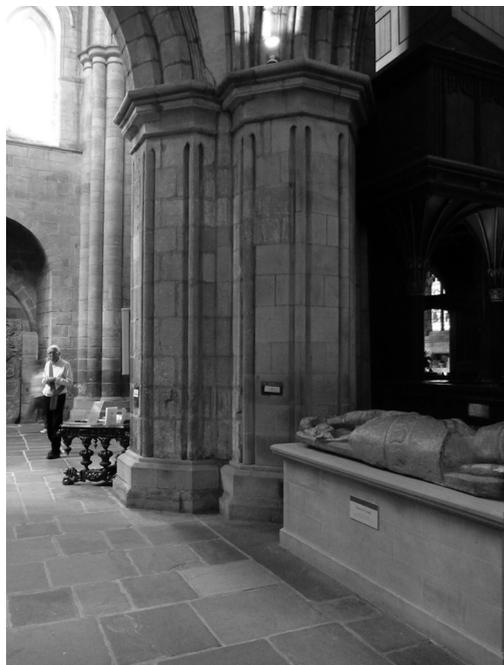
FIG. 13. Hexham south choir aisle respond

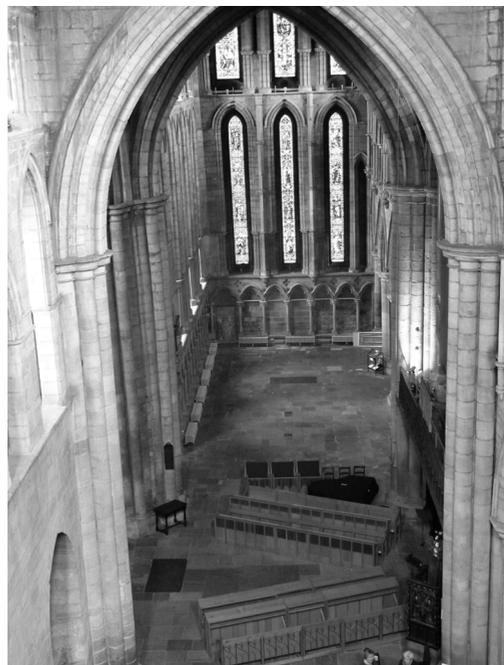
FIG. 14. Hexham crossing piers from the south

round abaci to the east and lobed ones to the west, were not all built at the same time (Fig. 14). Neither of the eastern piers is coursed in with the masonry of the adjacent transept walls, the north-west pier is only in bond until a few courses above the arch into the nave aisle, whereas the south-west pier is fully coursed into the corner of the nave and south transept for its entire height. Masons' marks are shared between the two eastern piers and the east arch, but only one of these marks appears on the lower courses of the north-west pier and the south-west pier has no marks. The sequence of construction is that the eastern crossing arch and its piers were built with the end of the choir, including the western faces of the piers and the transept responds, plus the first few courses of the mouldings of the main north and south arches and the toothings of the corner above. The transept east walls were built up against the standing piers, with the result that there are butt-joints between the arcade spandrels and the piers and disturbed areas of masonry in the upper levels (Fig. 15).²⁷ The western piers were then raised, with the corner of the south transept, and the crossing arches completed to a simpler design that replaced the roll mouldings of the outer orders with chamfers.

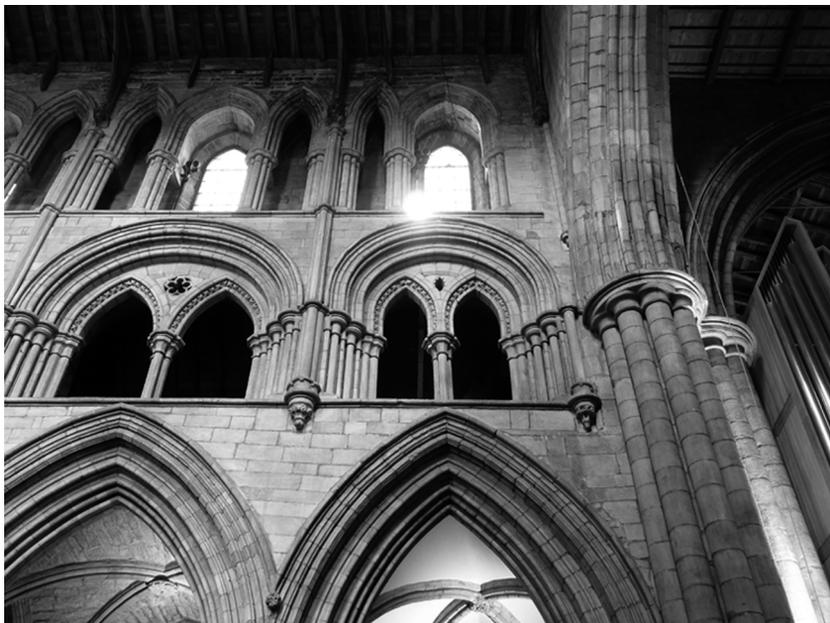
FIG. 15. North transept, east wall, bay next to the crossing

the triforium had been set at the higher level.³⁴ Once the arch was built the string-course at the base of the triforium had to rise to clear it and the detached shafts of one side of the triforium arch were shortened (Fig. 23). The clerestory, to the same design as those of the south transept, was then built between the two fixed points of the crossing pier and corner of the north elevation (Fig. 15).

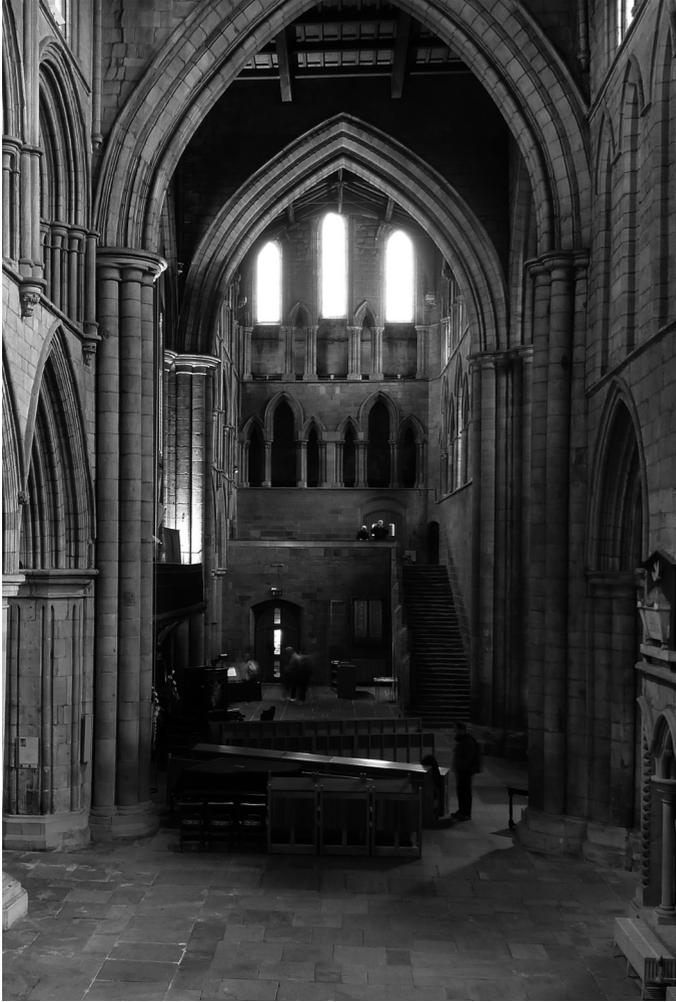
FIG. 17. South transept from the north

line up with centres of the arches on the other (Fig. 17). Its debt to Coldingham's east wall is evident in the relationship between the arches framing the passage and those set at a higher level that frame the windows of the clerestory (compare Fig. 10). The two upper storeys derive their levels from the east wall, and a subtle adjustment was made to the length of the corner shafts in the clerestory to effect the transition to a different proportion scheme on the south wall (Fig. 18). It was repeated in reverse for the west clerestory.

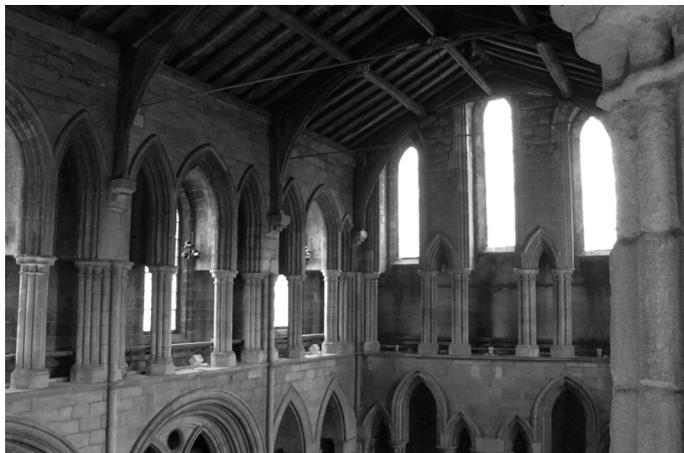
FIG. 18. South transept east and south clerestories, with the stepping up of the capital height in the south-east corner

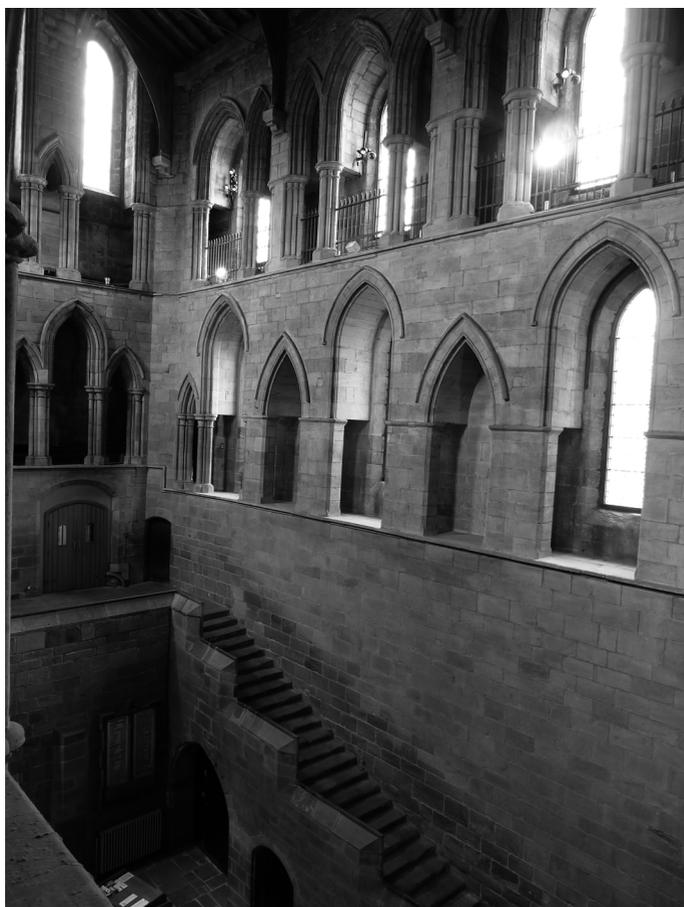
FIG. 19. South transept west wall from the north-east

The west wall presents a marked contrast with a conspicuous lack of alignment between the two upper levels (Fig. 19). The triforium string-course drops down in the corner to allow the west windows to be longer, and the arcade design of the south wall continues for part of the first bay, but then changes to a plainer form without shafts, deep mouldings, or vertical divisions into bays. At no point are the clerestory windows in line with any of the triforium openings, as is apparent on the exterior where the two levels of windows are clearly out of alignment (Fig. 20).

It seems probable that the design is the work of a second master mason, who was recruited after the east side of the north transept had been constructed, since the second phase brings in a new sense of lightness and a much greater voiding of the wall made possible by abandoning the fourth storey. The increase in the height of the triforium, so that it starts above the wall arcade, results in it having a *remois* passage rather than a triforium one, and, while Lincoln's west transept has a passage at a similar height, it is at the base of a lower arcade since its elevation has three levels of windows above the dado (Fig. 25). The contrast between the triforium designs for the west walls of the two arms of the transept, the mass and solidity of the south side and the transparency of the north, and the alignments of their relative levels, strongly suggest that they are the work of two different master masons (compare Figs 19 and 26).

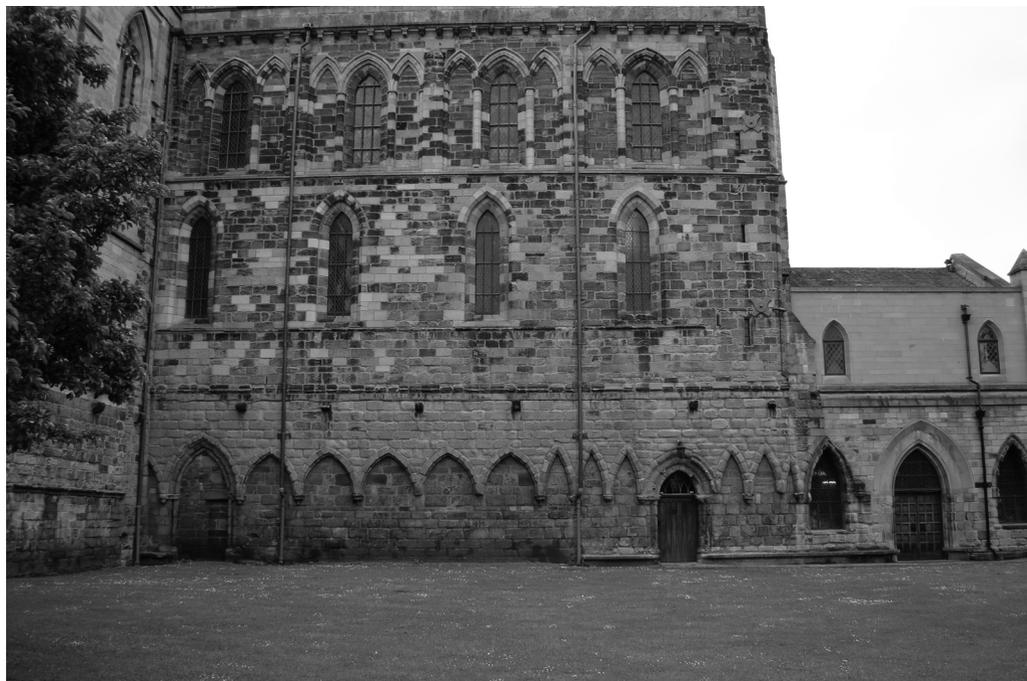
FIG. 20. Exterior west wall of the south transept from the cloister site

It seems to have been the siting of the most northerly window very close to the end of the triforium, to provide light for the crossing area, that has resulted in the misalignment. The clerestory window could not be sited above it since the tower stair, that rises from the clerestory passage, is positioned in the corner and the security of the tower would have been compromised by having another void there.³⁰

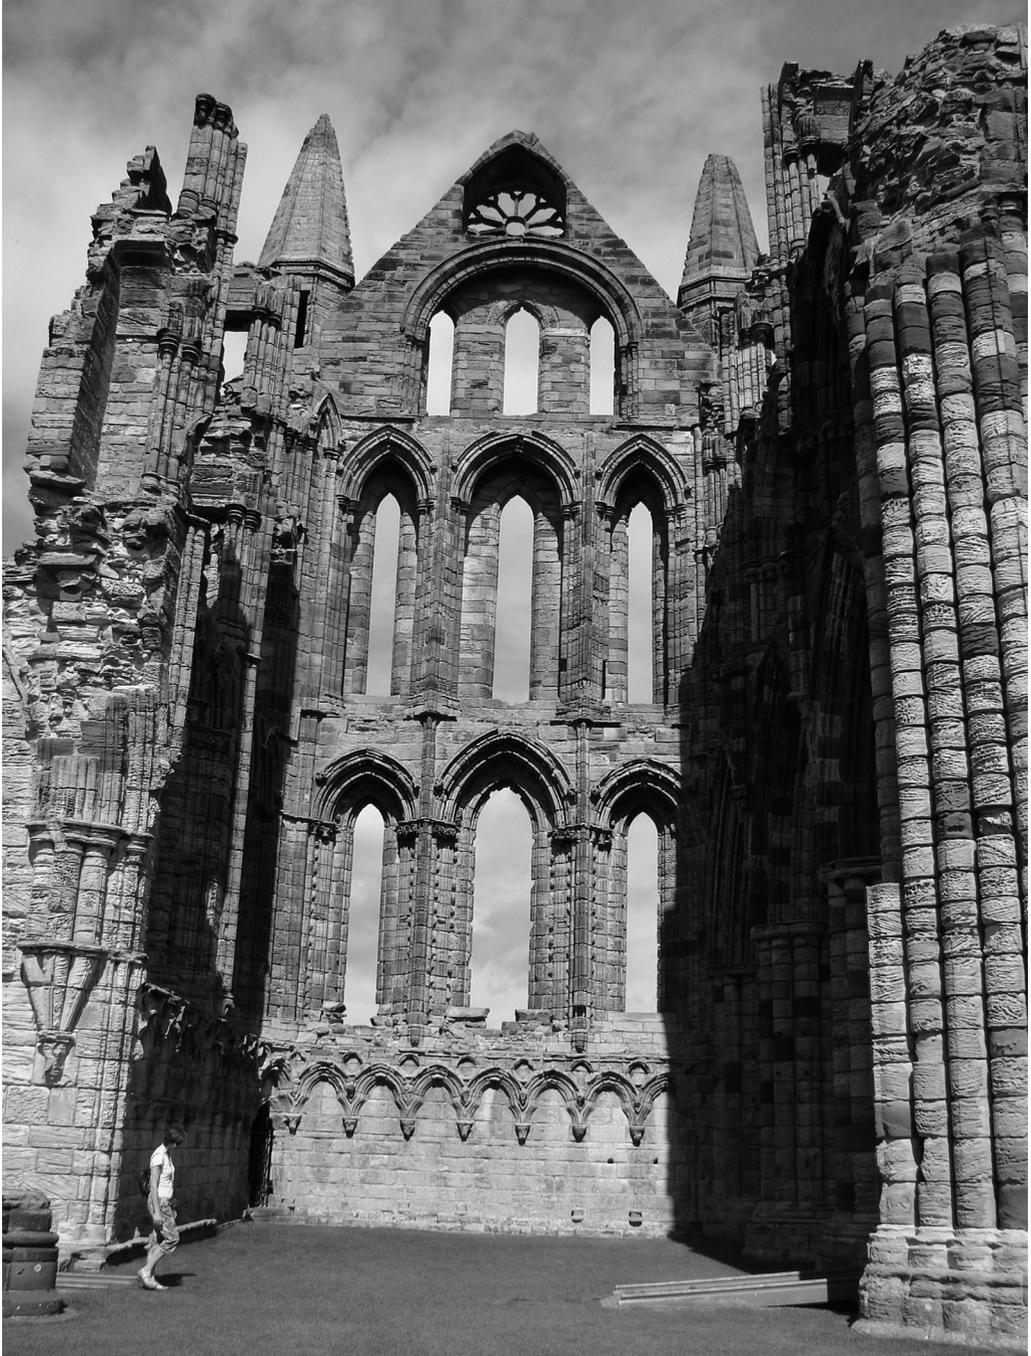
FIG. 21. Whitby abbey, north transept

The north facade uses the classic early Gothic design of two levels of tall lancets seen, for example, at York, Whitby, or Lichfield in the first half of the 13th century (Fig. 1). Whitby's north transept (Fig. 21), with its eastern aisle and similar design of wall arcade, bears some resemblance to Hexham's, but the tall vertical shafts that link the two levels at Whitby end abruptly at the string-course when used at Hexham because the upper windows are not aligned with the lower ones there (Fig. 22).³² Hexham's south transept scheme of continuing the triforium and clerestory at about the same level across all three walls, which Whitby shares, is not followed for the north transept, and only the north and west walls maintain the same levels for the upper storeys. The east elevation has little in common with them. In part this is due to a change in design for the north wall, but it is clear that the original design only included a continuation of the level of the clerestory, and not the triforium.

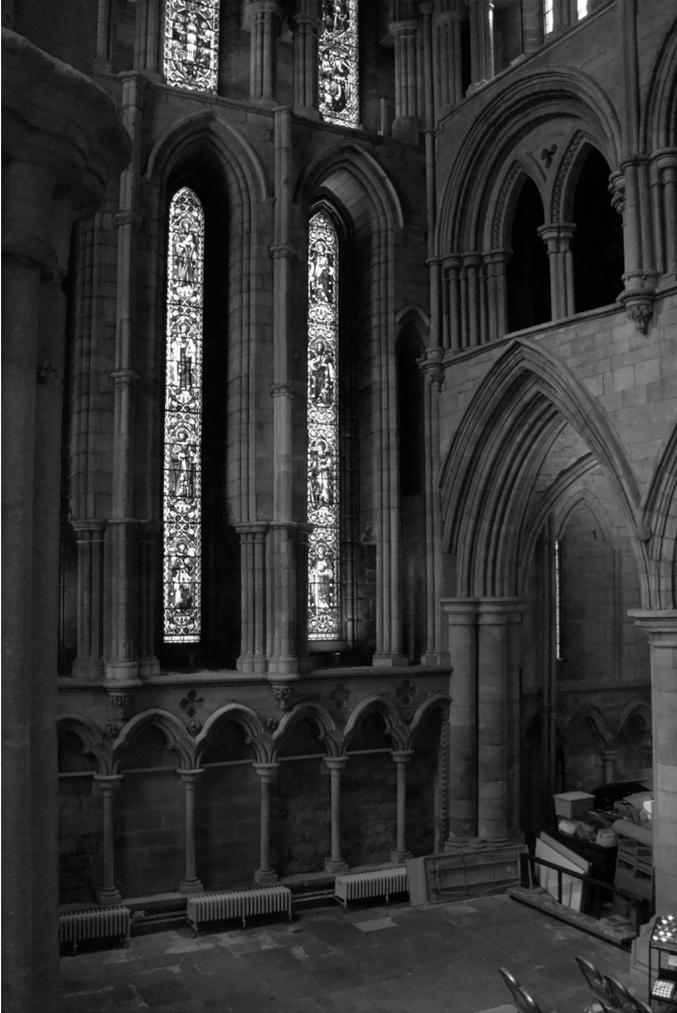
FIG. 22. Hexham, north transept north and east walls

The design of the north wall was changed at that stage, and the low blind arch on the extreme end of the lower lancets modified (Fig. 22). The arch is of a simpler design than those of the second scheme and consisted of a group of slender shafts rising from an octagonal base above the dado with capitals supporting the arch head, of which one remains. The new design took the stilted arches on shafts of the east clerestory windows and elongated the mouldings further to frame the lancet windows. On the exterior there are the remains of the framing for the first scheme, which would have

The north clerestory was intended to be at the same height as the eastern one, but the new design required slightly longer windows and so an extra sub-base was installed in the north-east corner, the string-course was stepped down and all the arches of the second phase were sprung from a lower point.³⁶ It seems likely that the stones for all the northern shafts had already been cut since their length and design remain the same as those of the east clerestory and the bases are the same octagonal shape (Fig. 22).

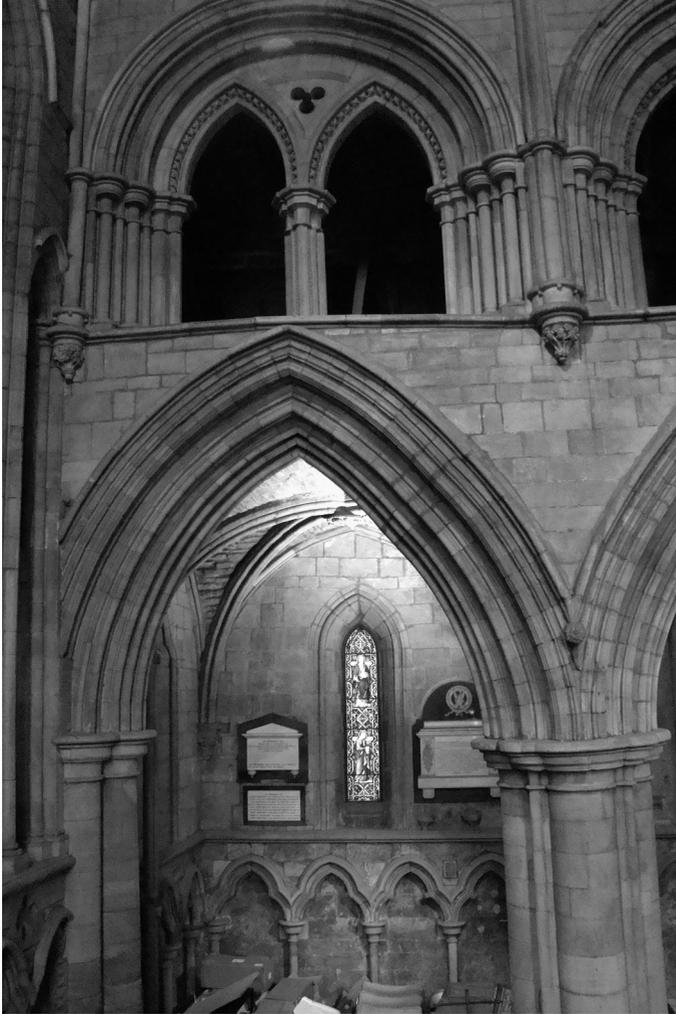
FIG. 23. Hexham north transept north-east bay with distortion to the right side of the arch and raised string-course

34. A lack of suitable foundations caused the pier to sink towards the north and twist its side of the arch, presumably as the weight of the arch settled on it, and some voussoirs slipped. The arch did not fail, however, and the coursing of the spandrel blocks reveals little distortion, although problems are visible in the aisle vault, and the stair behind the respond has been filled in. The arch is asymmetric, as is the arch at the other end of the arcade which was built with the crossing pier to which it is attached, although that one is lower, which suggests that their geometry had been calculated before that of the main arcade arches.

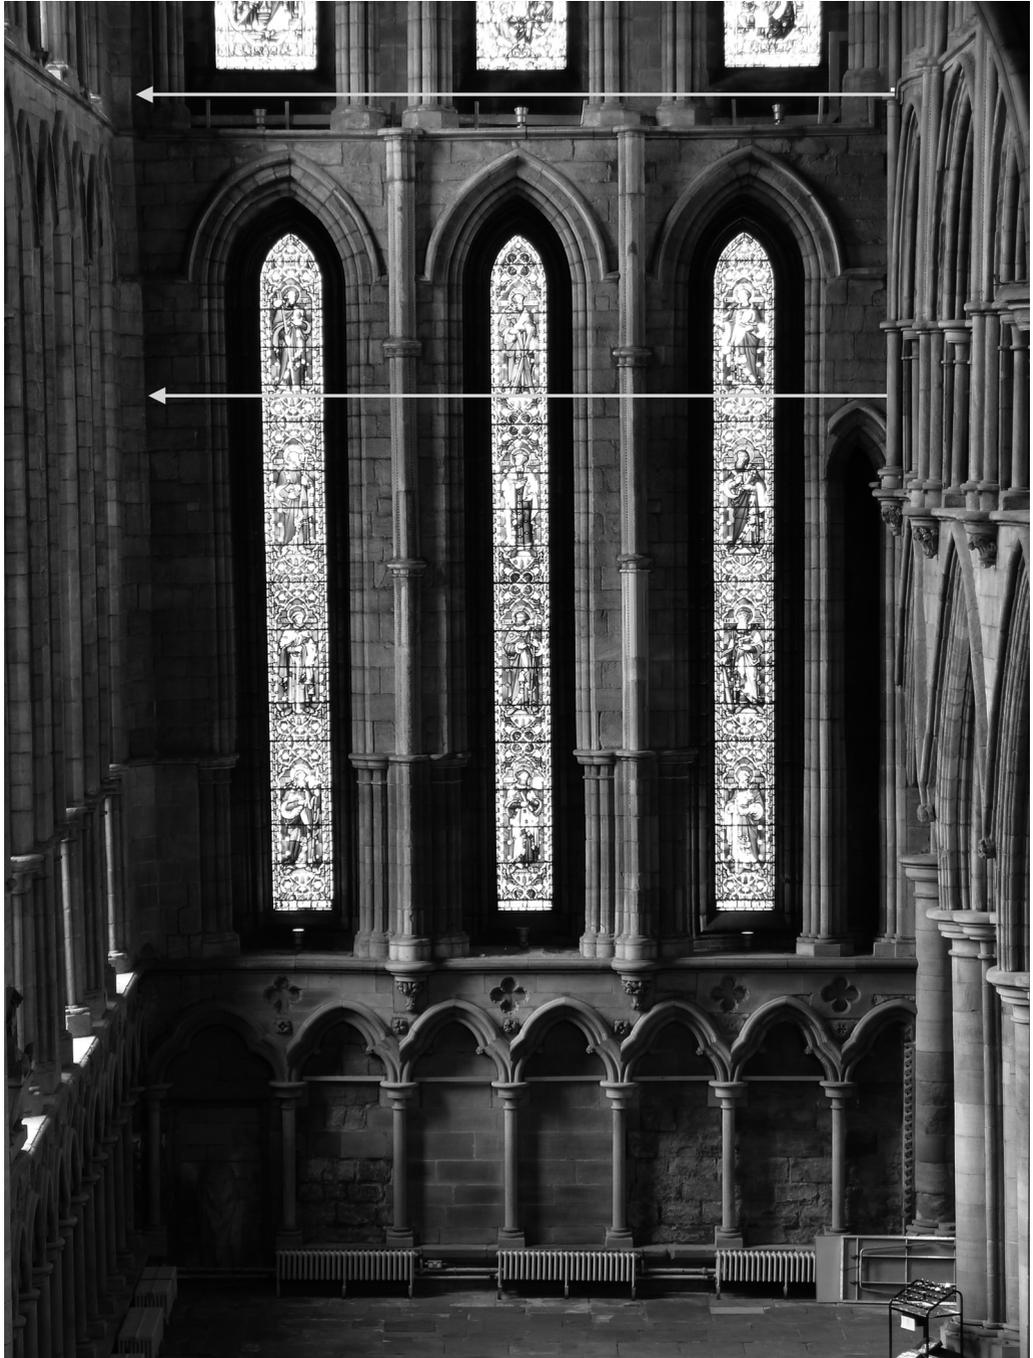
FIG. 24. Site of the intended fourth storey of the north transept north wall

The most profound change, however, was to the number of storeys. The original design was meant to include a narrow fourth storey to the north wall, sited between the two levels of lancets and would, most probably, have consisted of a row of arches fronting a wall passage, or perhaps a row of windows as at Salisbury cathedral. The height of the storey would have been less than that of the triforium of the east wall (Fig. 24), so it is unlikely to have continued its design across on to the north wall, but a row of narrow lancets, as used for the north wall of Lincoln's west transept, is possible (Fig. 25). The blocked entry to the wall passage running westwards above the original low arch survives in the north-east corner, and the masons' marks on it demonstrate that the change of design happened at the same time as the north bay of the east triforium was built. The same masons went on to cut the stone for the second phase of the north wall. The west wall continues the second design of the north wall, with its triforium based on the new north clerestory design in which tall, narrow arches that are open to the rear wall flank the windows (Fig. 26).

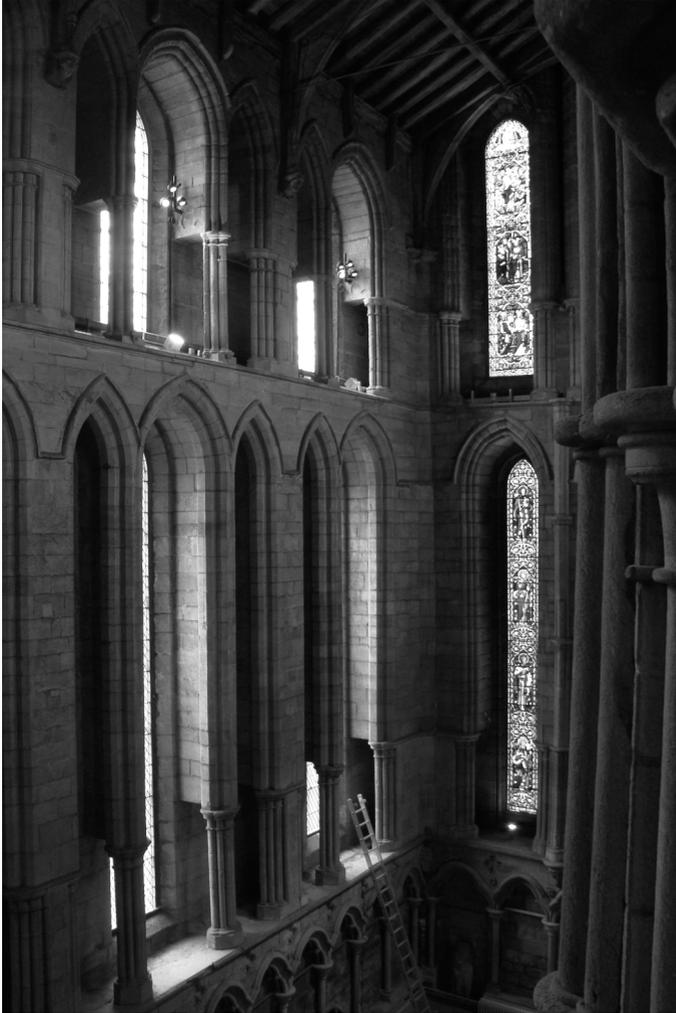
FIG. 26. Hexham north transept west wall from the south east
