### **Three-dimensional Modelling of the Interaction Between Buildings and Tunnelling Operations**

Keywords: Tunnels, Masonry Structures, Finite Elements, Settlements

Conference theme: Effects of building stiffness, different configurations and time

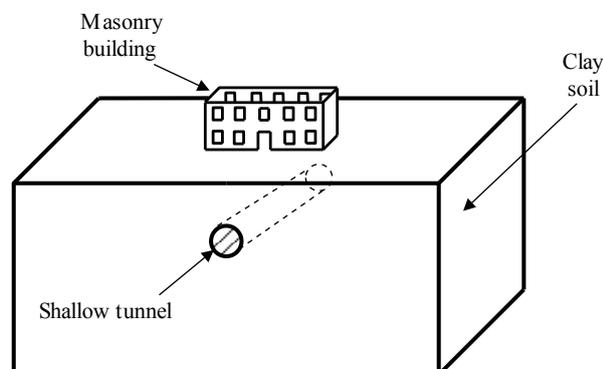
Figure 1: Idealisation of tunnelling under a building in three dimensions

The principle of the model adopted is illustrated in Figure 1. The building, the ground and the tunnelling processes are combined in a single three-dimensional numerical model. The analyses are carried out using the finite element program OXFEM, developed at Oxford University. Details of the relevant finite element formulations are given by Burd *et al* (1994), Augarde *et al* (1995), Augarde (1997), Liu (1997) and Augarde *et al* (1998).

The facades of the structure are modelled by plane stress elements. The roof, floors and internal partitions are not included, although internal load-bearing structural walls are included when necessary. The facades are connected together and to the ground using tie elements (Liu, 1997; Houlsby *et al*, 2000). Foundation details may be modelled if necessary, but are often neglected if the building is on strip footings.

Ten-noded tetrahedral solid elements model the ground, with a free mesh that enables the density to be increased near the tunnel and building. The ground contains a zone of elements defining the tunnel, and these are removed during the analysis to simulate excavation. This may be carried out incrementally to model the response as tunnel construction progresses: this cannot be done in two-dimensional analysis. The tunnel may be unlined, or lined with shell elements, which enable the ground loss due to tunnelling to be controlled and modelled.

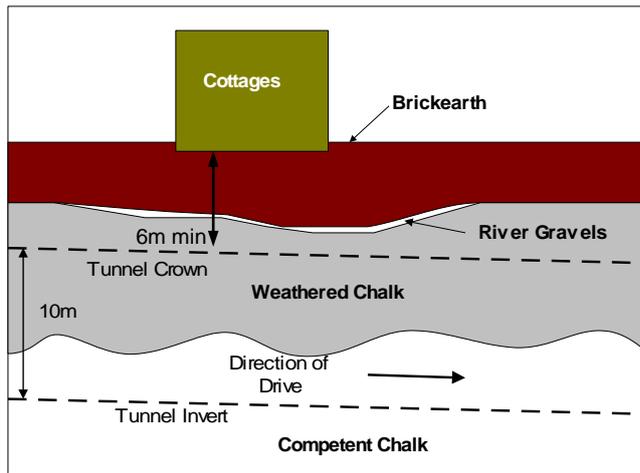
Figure 2: Section through cottages on axis of tunnel

however, the Chalk is weathered to grade Dm in places and the thickness of the overlying surface layers become significant (Fig. 2). The tunnel invert remains within chalk that is structured and relatively unweathered, but still rather weak. The upper part of the bore is in weathered to highly weathered chalk. Overlying this is a layer of 2m - 3m of red brickearth, a firm to stiff silty clay. At the location of the cottages, a buried valley crosses the alignment, decreasing the chalk cover over the crown, and increasing the penetration of weathering.

observed settlements in Figure 10. Agreement is good, particularly at the rear. The model over-predicts the settlements at the front, which were less than at the rear probably because of the less depth of brickearth at the front (Fig. 2).

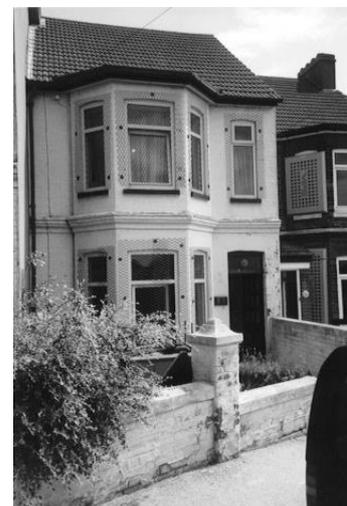
The cottages consist of a terrace of eight similar properties, dating from the early 1900's (Fig. 3). The tunnel passes under the cottages with about 6m cover, on a skew, with the angle between the tunnel axis and front of the cottages being 40° (Fig. 4). The houses are of two storeys, 6m high and without basements. They are of load-bearing brick, on shallow strip foundations, with wooden suspended floors and ceilings. The most important load-bearing walls for each cottage are the party walls each side and the front

Figure 3: Typical cottage

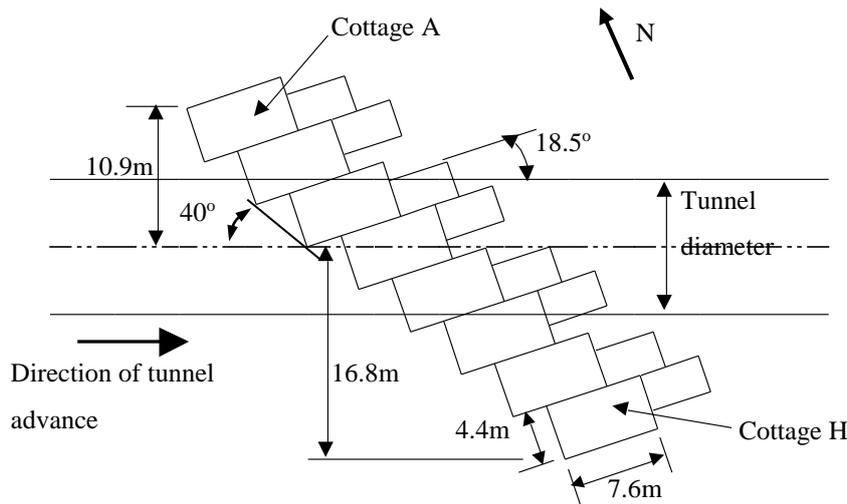
Figure 4: Plan layout on tunnel and cottages

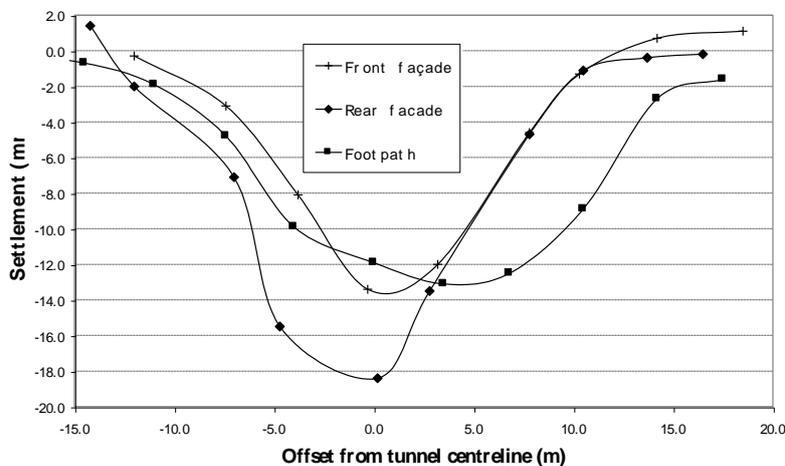
Figure 5: Observed settlement profiles

from the cottages and a section on the footpath in front of them. The settlements finally stabilised after two weeks, although the majority of settlement occurred in the first four days after the tunnel face passed. The maximum settlements observed were 13.4mm at the front, 18.4mm at the rear and 12.8mm on the footpath (Fig. 5).

The final settlement troughs approximated reasonably well to Gaussian shapes, with a trough width parameter ( $i$ ) estimated as 4.5m at the front, and a calculated volume loss of 0.15% - 0.20%.

When the building was included in the model, the surface settlements were as shown in Figure 9. They did not differ significantly from the greenfield case, indicating that in the model the building responded flexibly, as observed in the field (Fig. 5). Profiles of the façade settlements predicted by the model are compared with the

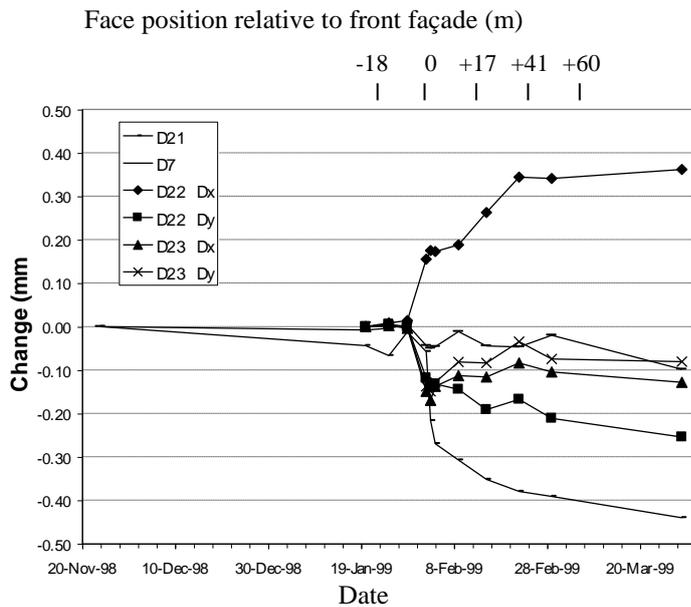
Figure 6: Movement of pre-existing cracks

The Demec studs on the front of the cottages within the settlement trough recorded some slight movements (Fig. 6). Some cracks were observed to open, some to close, and some did not move significantly. The magnitudes of the typical movements, at 0.4mm – 0.5mm, represent a damage category of Very Slight in the Burland *et al* (1977) classification. The readings at the rear were similar. The damaged cottage at the southern end was outside the observed settlement trough, and although movements of cracks of up to 2mm were observed over the duration of the project, they were not strongly correlated in time with the passage of the tunnel heading.

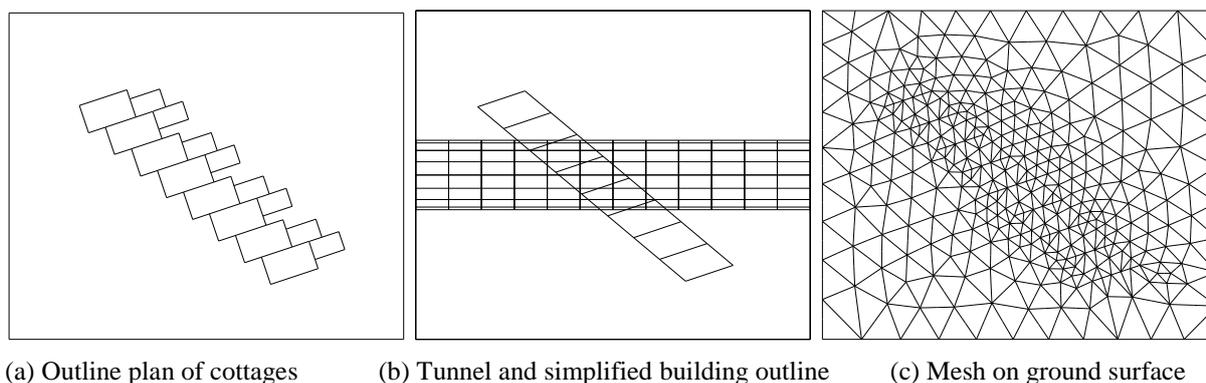
The development of the geometry of the facades of the terrace was simplified as shown in Figures 7(a) and (b), with the front and rear facades modelled as straight and the party walls between cottages included in the model. The tunnel passes beneath the terrace as shown in Figure 7(b). The finite element mesh for the ground is shown in Figure 7(c) and Figure 8.

(a) Outline plan of cottages      (b) Tunnel and simplified building outline      (c) Mesh on ground surface  
Figure 7: Development stages for the finite element model

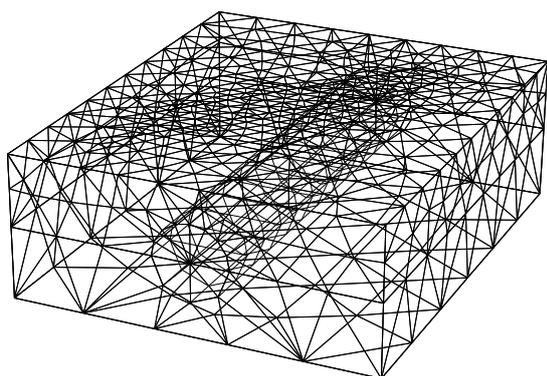
Figure 8: Finite element mesh for ground

The ground above the axis of the tunnel, weathered chalk and brickearth, was modelled with the multi-surface plasticity model with an undrained strength profile with depth  $z$  in metres below ground level  $s_u = 60 + 28z$  (kPa) and a ratio  $G/s_u$  of 1500. The competent chalk below axis level was modelled as an elastic material. The mesh density in the ground beneath the building was increased until the greenfield settlement pattern was no longer sensitive to it. The complete model of the ground and building combined contained about 8000 elements and 30,000 degrees of freedom.

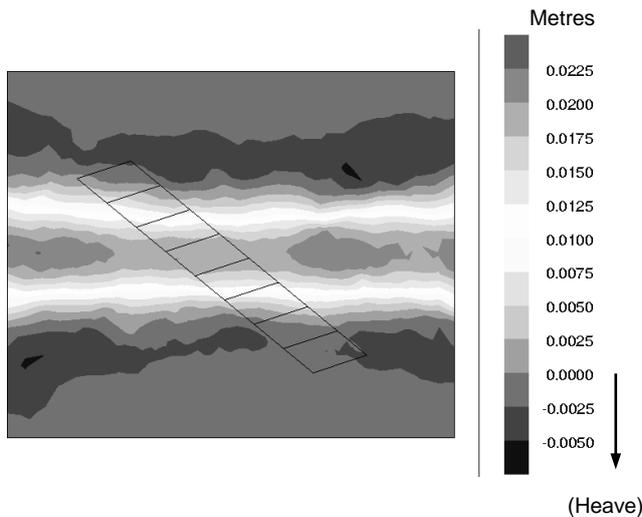
Figure 9: Surface settlements from fully-coupled model

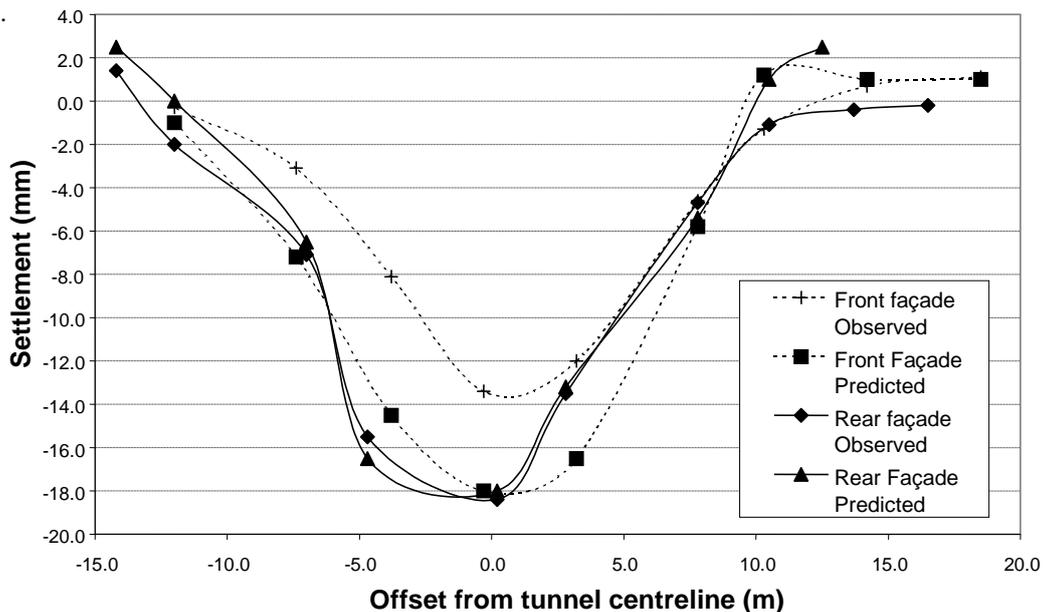
Figure 10: Predicted settlements along building façades and comparison with observations

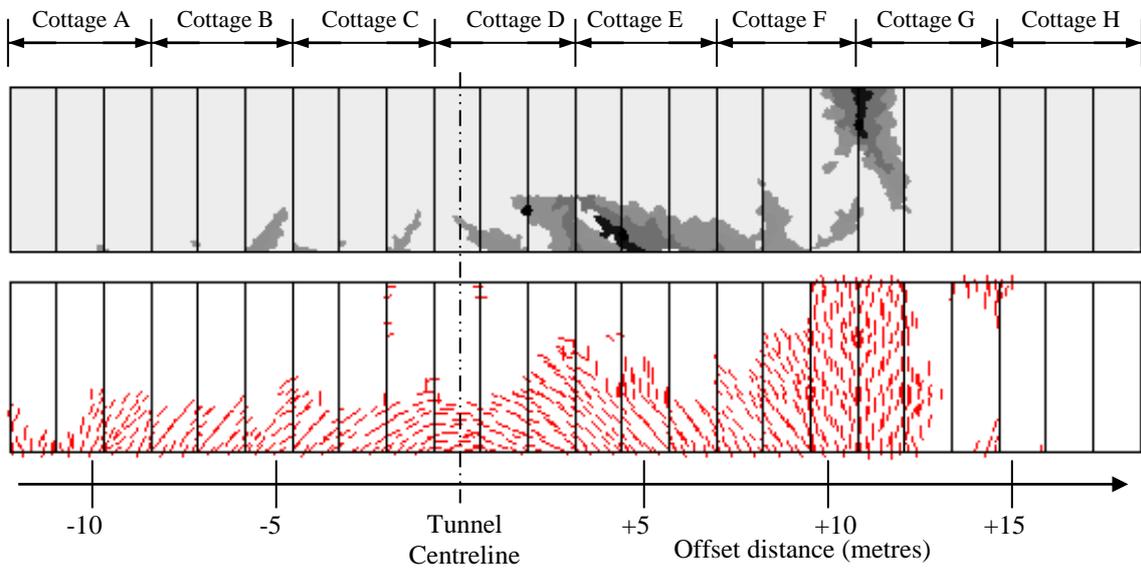
The effects of the tunnelling settlements upon the model of the building are shown in Figures 11 to 13 for the front façade, rear façade and a party wall above the tunnel respectively. The party walls suffered progressively less damage with distance from the tunnel axis. For each façade, the crack strain is contoured according to the categories in Table 1. In addition the crack

pattern is illustrated by a method in which a single line is drawn at each stress point for which the crack strain exceeds  $500\mu\epsilon$ . The direction of the line indicates the expected crack direction and its thickness the severity of cracking.

It may be seen that the façades are mainly undamaged, but where damage occurs it is mainly of Very Slight category, with isolated areas of greater damage. The average damage category for the façades is Very Slight.

Figure 11: Front façade damage category (key on Figure 13) and crack pattern, viewed from front of cottages

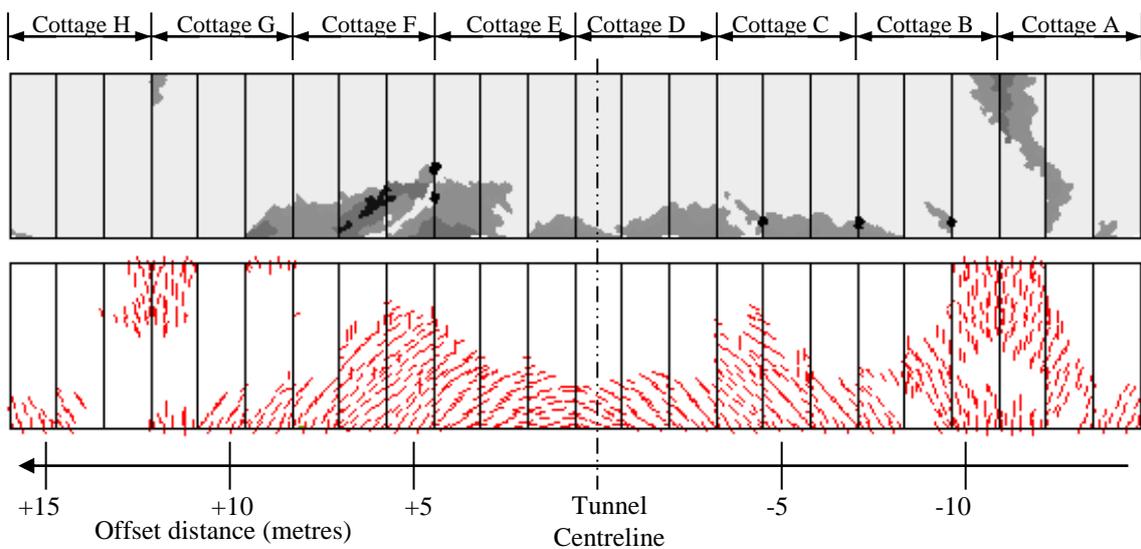
Figure 12: Rear façade 3 damage category (key on Figure 13) and crack pattern, viewed from rear of cottages

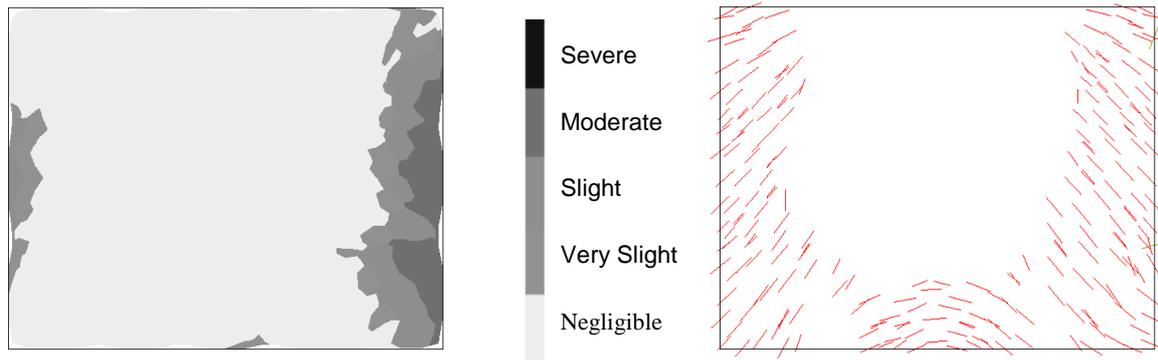
Figure 13: Damage category and crack pattern for party wall above tunnel centreline

A three-dimensional finite element model of the site including the building was analysed. It was possible to reproduce the observed settlement trough. The response of the building modelled as planar facades was globally flexible, thus for this shallow tunnel and rather flexible buildings the necessity for a coupled analysis is not as strong as in other cases. The level of damage predicted agreed with observations. The damage predicted included some cracking starting from the top of the façade in the hogging region, which was not observed on site.
