Bloodworth, Alan G. and Houlby, Guy T.. (2016) Analysis of pre-vault tunnelling interaction with buildings. Proceedings of the Institution of Civil Engineers - Geotechnical Engineering.

Analysis of pre-vault tunnelling interaction with buildings

This paper presents data from a case history of tunnelling using the pre-vaulting method, at low cover and without compensation grouting, beneath a terrace of masonry buildings at Ramsgate, Kent. Surface and building settlements were measured and movements on existing cracks monitored throughout construction. Volume loss was low and the settlement trough quite narrow. Buildings responded flexibly with lower damage level than predicted by assessment using a deep beam analogy. Damage was concentrated in opening of existing cracks, with the only significant new cracks likely to have their origin in three-dimensional effects as the tunnel heading approached the buildings.

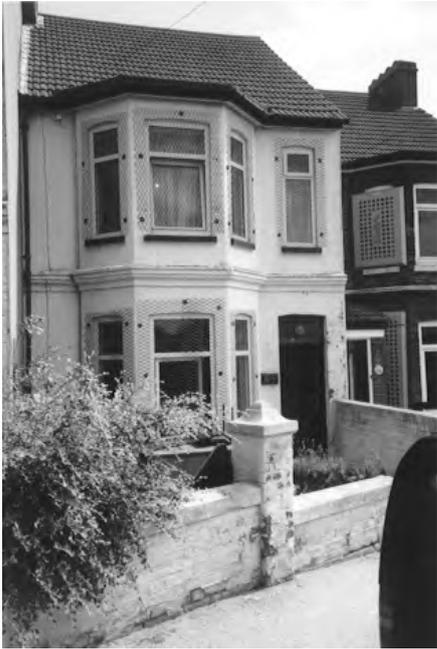
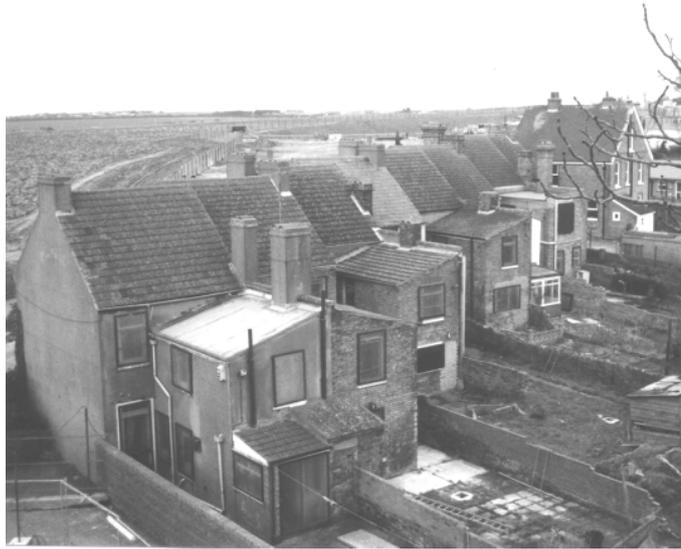
Figure 3: Views to the (a) front and (b) rear of terrace of cottages

The tunnel passed at 40° skew beneath a terrace of eight cottages (Fig. 2) with a cover of only 6m (approximately half a diameter). The cottages date from the early 1900's and are two-storey with no basements (Fig. 3). Each cottage has an extension wing at the back, and is staggered relative to the next by 2m. The structural form is load-bearing brick masonry (solid 220mm thick) on shallow strip foundations, with timber suspended floors and ceilings. Although some alterations have taken place, the main load bearing walls – front, rear and party walls – have been retained, along with the important openings to the front and rear.
