## **ACOUSTIC EMISSION TESTING OF FIBRE REINFORCED CONCRETE TUNNEL LINING SAMPLES**

The aim of the research described in this paper was to trial the use of acoustic emission testing to measure the location of cracks and the degree of damage during loading of sprayed concrete lining (SCL) specimens. AE testing has potential application in research on SCL where there is a need to meet strict crack-width criteria at the serviceability limit state (and therefore to understand the evolution of cracking at low loads), particularly if SCL is to be used for secondary as well as primary tunnel linings.

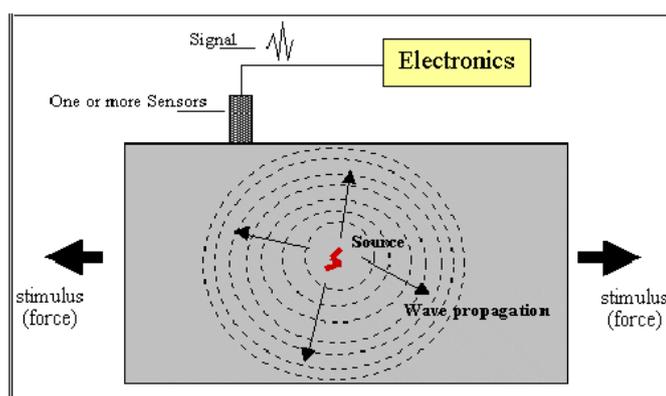
Figure 1 Theory of acoustic emission [4]

The principle of AE detection is that sensors placed on the surface of testing sample detect the transient elastic waves (Fig. 1), record them and send signals to electronic systems for further analysis. In systems with multiple sensors, differences in wave arrival times may be used to calculate the position of the origin of the acoustic energy (normally interpreted as the tip of the advanced crack or defect) in one, two or three dimensions depending on the number of sensors.

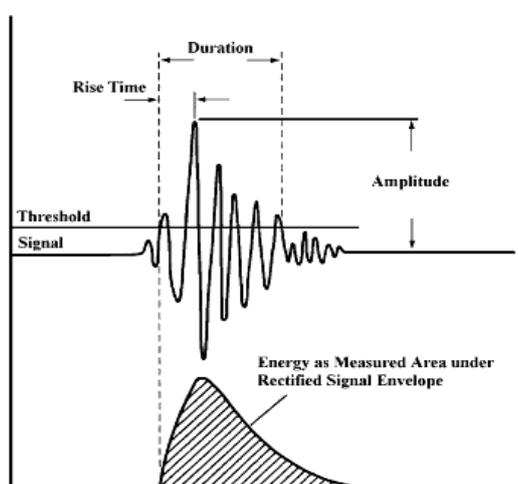
Figure 2 Parameters of a typical AE signal [7]

In parameter-based analysis (also known as *qualitative analysis*), parameters are extracted from the AE signals and the signals themselves are not saved. Figure 2 shows a typical AE signal along with the commonly utilised parameters, descriptions of which are given below:

- **Signal energy** – the area under the rectified signal envelope [6], as shown in Figure 2. This is a measure of the overall magnitude of the source event over the entire duration from the time the Threshold is first exceeded.

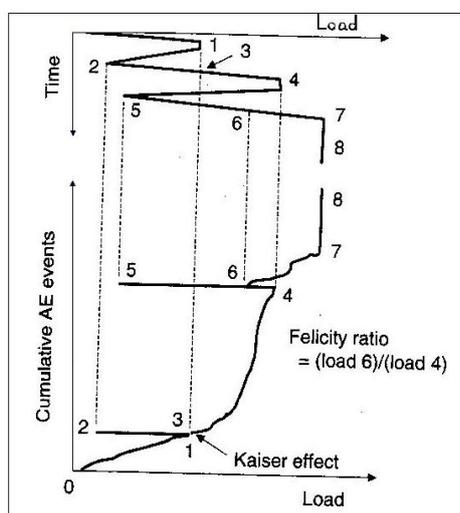
Figure 3 Kaiser and Felicity effects [9]

In Figure 3, cumulative AE Count is plotted directly against applied load for an imaginary sample. Hits are generated during the first load rise (0-1), but as the load is reduced (1-2) and increased again (2-3), there is no more emission generated until the previous stress level (3) is reached. The behaviour observed at (3) is an example of the Kaiser effect.

When significant damage is present in materials, be they metals, fiber-reinforced polymers or reinforced concrete, the Kaiser effect breaks down [10]. AE emission is sometimes observed at load levels lower than the previous maximum, and this is termed the *Felicity effect*, as may be observed at point (6) in Figure 3. The *Felicity ratio* is defined [11] as:

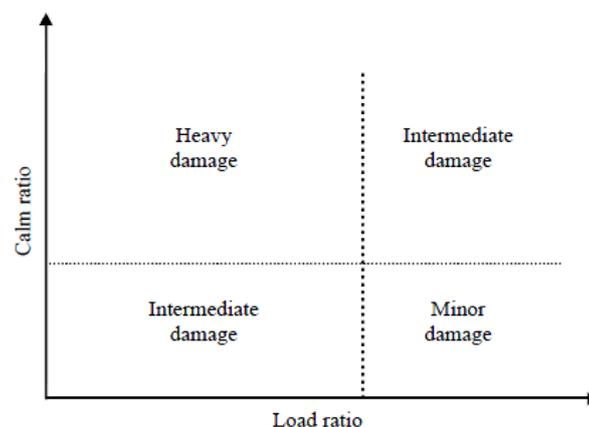
Figure 4 NDIS-2421 damage classification chart [15]

Laboratory experiments were conducted [15] on five different types of RC beam under incrementally increasing loading with AE measurement. Crack-mouth opening displacement (CMOD) values were measured and used to determine the limit values for Load Ratio and Calm Ratio (0.9 and 0.05 respectively) at the boundaries between damage classifications (Heavy, Intermediate, Minor), as shown in Figure 4. For any type of concrete or type of beam other than that used by Ohtsu et al [15], these boundary levels would need to be verified by experiment. For example, for beams shorter than 1 m, 0.4–0.5 and 1.0 have been proposed as limit values for the Load Ratio and Calm Ratio respectively [16].

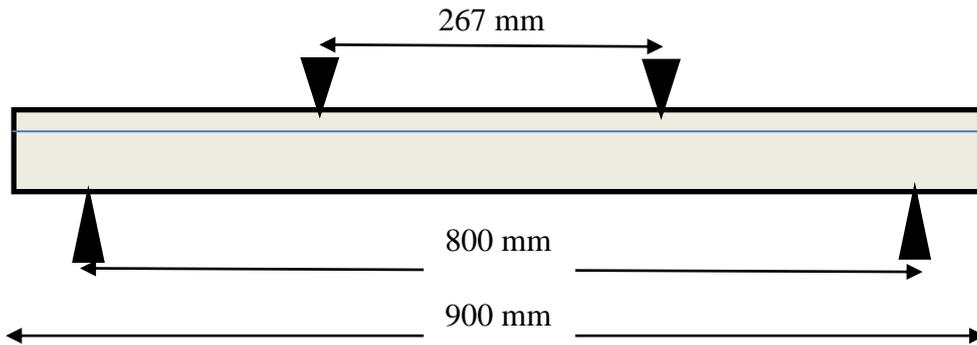
Figure 5 Four-point bending of FRC beam

Three fibre-reinforced sprayed concrete beams of cross-section depth 150 mm, width 150 mm and span 900 mm were tested in four point bending as shown in Figure 5. The beams were cut by diamond saw from test panels produced for the study described in [17] and [18] and included an intermediate layer of spray-applied waterproofing membrane (Fig. 6). 28-day compressive strength of the concrete was 38 MPa and tensile strength 1.7 MPa, obtained as the average of three 100 mm cylinder samples. Practice tests showed the failure load of the beams to be around 14 kN, with a maximum deflection of 6 mm.

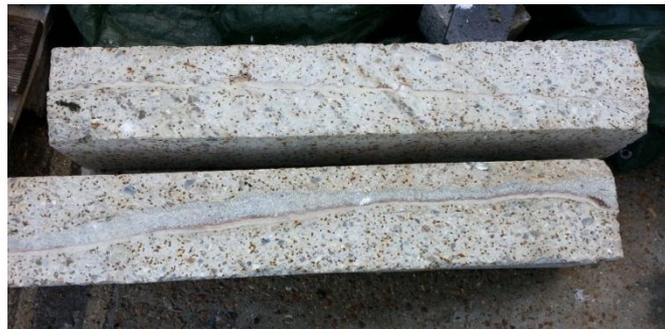
Figure 6 FRC beam specimens with membrane

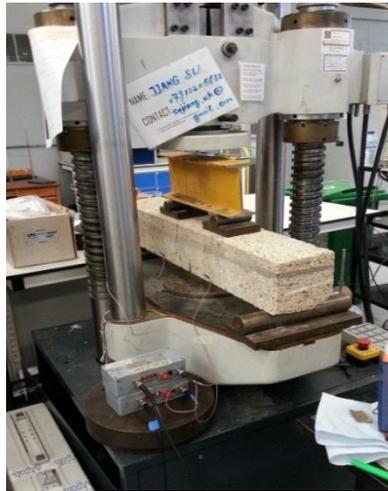
Figure 7 Photograph of experimental setup

The experimental setup is shown in Figure 7. The sample was loaded by a Denison Mayes 7159 servo-hydraulic testing machine operated under displacement control. A steel spreader beam between the actuator and the specimen transferred the machine load as the two point loads. Mid-span deflection was measured using a digital gauge on the underside of the beam on its centreline.

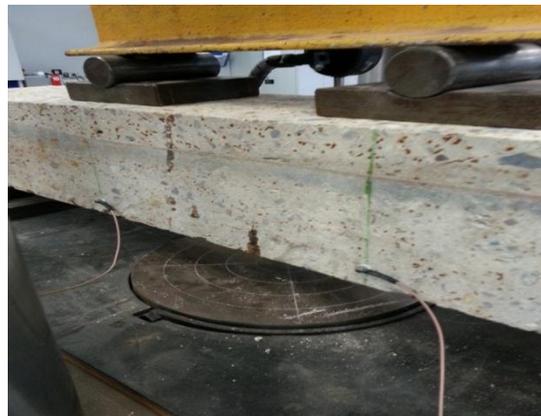
Figure 8 Location of AE sensors

Two acoustic sensors were attached on one side of the beam below the line of the membrane, one under each loading point (Fig. 8). Since all the specimens were designed to fail in the bending mode, a major crack was expected to form from the bottom of the beam in the middle one-third of the beam span, between these sensor positions. To apply the sensors, the surface of the concrete was first cleaned and sanded. High-silicone vacuum grease was used as the coupling medium, applied first to the sensor which was then pressed against the concrete surface.

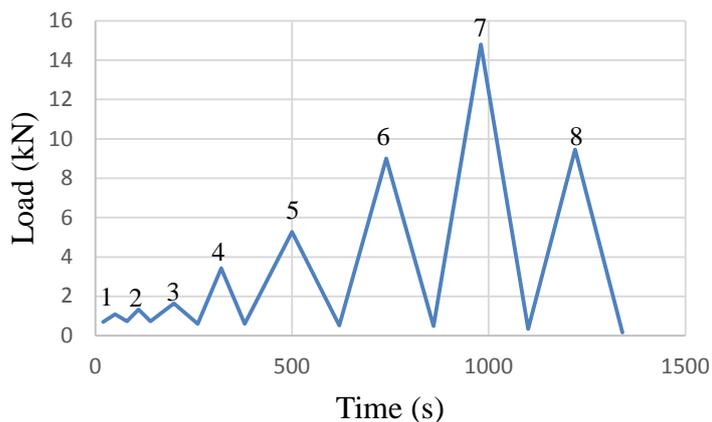
Figure 9 Load-time plot for Beam 1 (with cycle numbers shown)

Cyclic loading profiles are the norm in an AE evaluation as the derived Load and Calm Ratios are calculated between two consecutive cycles. Before any cycles, a 1 kN pre-load was applied to encourage the beam to bed down on the supports. Then a first cycle displacement of 0.05 mm was applied and held for 20s, before unloading. Progressively increasing displacements and hold times were then applied until the ultimate failure load was reached. Figure 9 shows a typical

load-time plot (for Beam 1), where the peak load was reached during cycle 7. Plots are similar for Beams 2 and 3, except that the peak load was reached slightly later, during cycle 8.

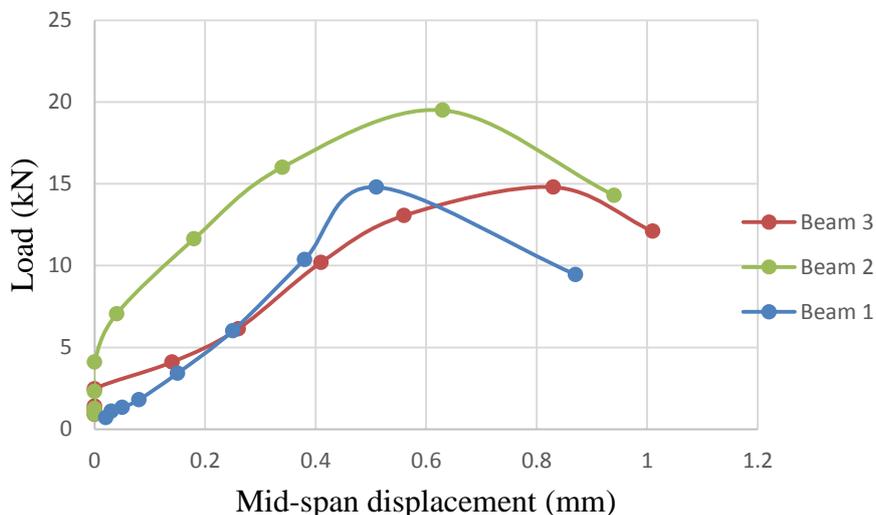
Figure 10 Load-deflection plots for tested beams

Figure 10 shows load-deflection graphs for the three tested beams, plotted at the peak loads for each cycle. Beam 2 has the highest peak load (19.5 kN), with Beams 1 and 3 showing peaks of about 14.8kN. Displacements at peak load for Beams 1 and 2 are similar, 0.51 mm and 0.63 mm respectively, but for Beam 3 it is larger, 0.83 mm. However, all load-deflection plots have similar form, starting linearly and then gradually becoming nonlinear as peak load is approached. Cracks were easy to identify visually during the nonlinear region.

Comparing the load-deflection plots (Fig. 10) with the AE Hits-time plots for the three beams, it is found that AE activity was recorded prior to the load-deflection plots becoming nonlinear. For example, for Beam 1 and Beam 2, AE Hits started to be recorded during load cycle 3 whilst nonlinear behaviour starts in cycles 7 and 8. For Beam 3, AE Hits were recorded during load cycle 5 which is later than the other two beams but still before the load-deflection plot became nonlinear. The indication is that microcracking is occurring within the material at a stage when the release of energy is still mainly elastic.

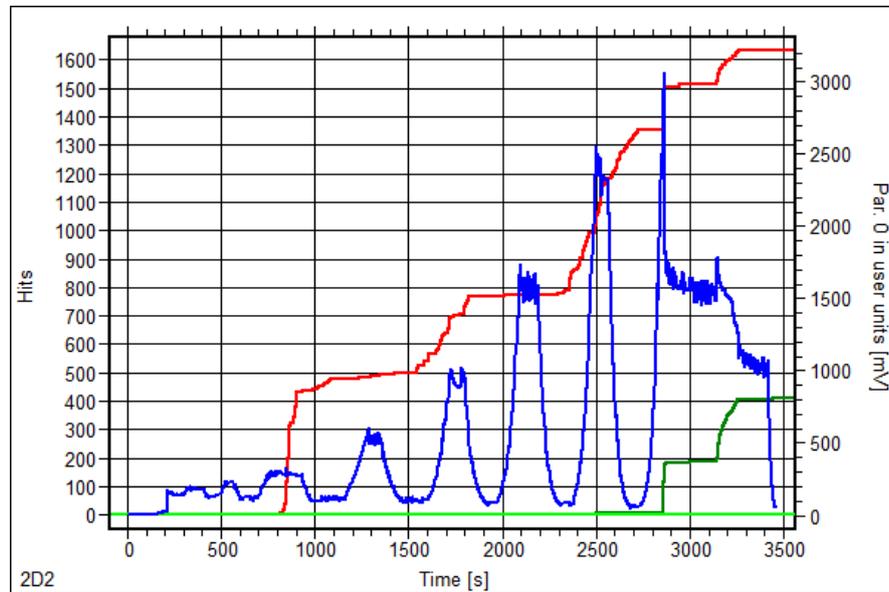
Figure 11 Load, AE Hits and time plot for Beam 1

Figures 11 to 13 give load and cumulative AE hits against time for Beams 1 to 3 respectively. Load is the blue line measured against the axis on the right, reported in mV as recorded by the datalogger. AE Hits for the two sensors are shown in red and green.

For Beam 1, it can be seen that initially no AE activity was recorded until cycle 3, but then AE Hits increased rapidly in this cycle, gradually in cycle 4 and then rapidly again in cycle 5. This

pattern was repeated in general until the failure load was reached. The pause in activity during cycle 6 can possibly be explained by the flexural crack reaching the membrane in the test specimen.

The indication from the AE Hits is that cracking started to form during load cycle 3, however the crack was not visibly evident until cycle 8, where there was again an increase in AE Hits. This shows that AE in the early stages can give evidence of damage occurring that would otherwise not be visible.

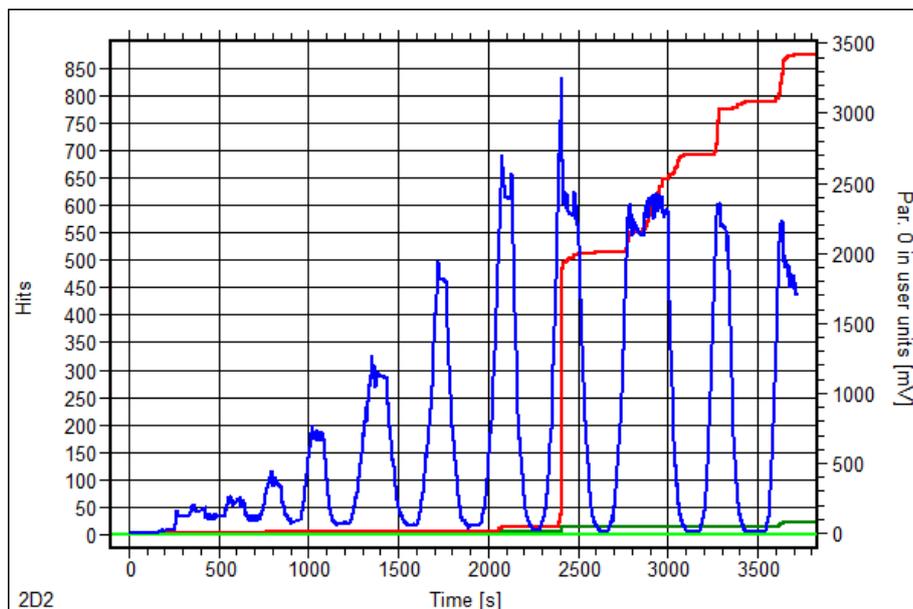
Figure 12 Load, AE Hits and time plot for Beam 2

Figures 12 and 13 show the results for Beams 2 and 3. These beams have a similar behaviour in which little AE activity was detected until the load reached 80% of peak, during load cycle 7. After that, intensive AE Hits were recorded, along with observation of the beam cracking. The sensors used for Beams 2 and 3 were less sensitive than those used for Beam 1, and so it appears they were less able to give advance warning of cracking occurring.

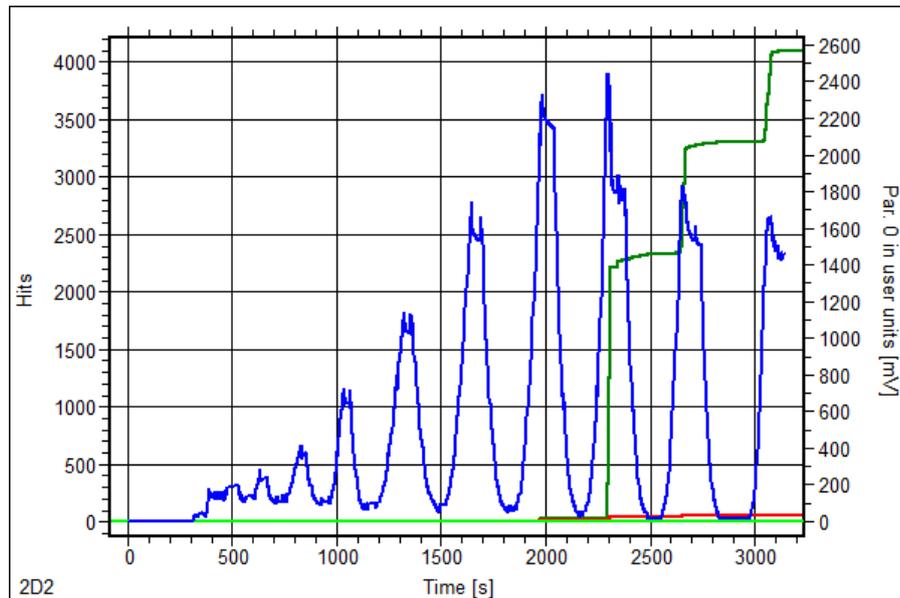
Figure 13 Load, AE Hits and time plot for Beam 3

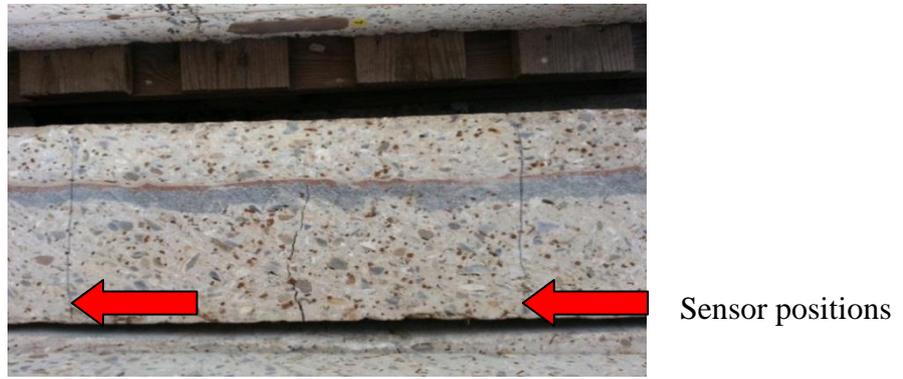
Figure 14 Crack position observed visually for Beam 1

When there are two or more sensors, AE instrumentation may be used to determine the location of cracking within a structure. For Beam 1, the first visually detected crack was almost at midspan (actually 151 mm to the right of the left-hand sensor), as shown in Figure 14. The cumulative Count of AE Hits by location is shown in Figure 15. This shows good consistency with the visual observation, and shows again a large number of cracking events that were not visible at the surface. Similar results were obtained for the other two beams.

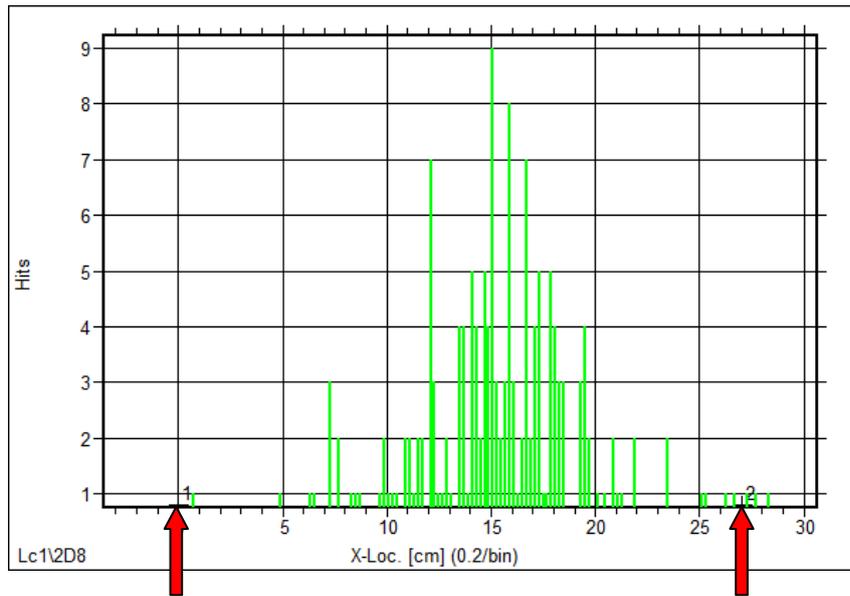
Figure 15 Crack positions detected by AE system for Beam 1  
(sensor positions indicated by red arrows)

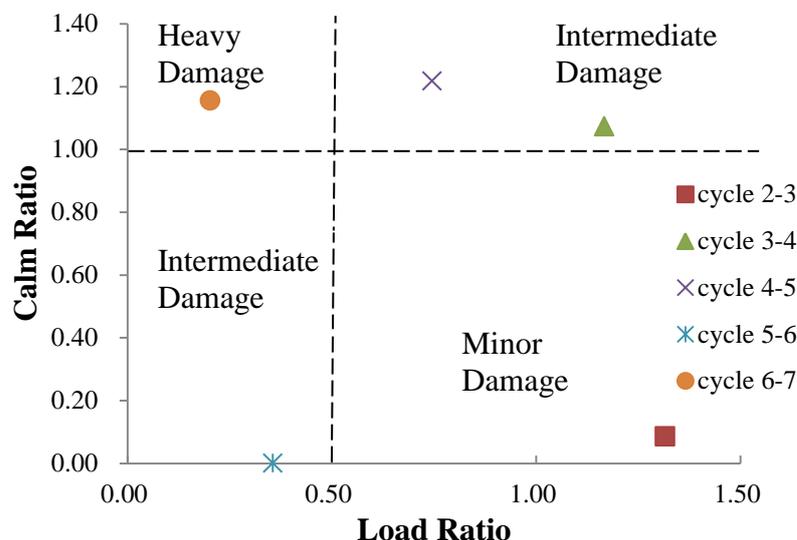
Figure 16 NDIS-2421 classification for Beam 1

The results for AE Hits per cycle on loading and unloading for Beam 1 can be used to undertake a quantitative damage level assessment to JSNDI method NDIS-2421, as described earlier (Fig. 4). Table 1 shows the data extracted from the AE output on a cycle by cycle basis, and Figure 16 shows the resulting assessment. The data shows the evolution of the damage from Minor in cycle 3 (well before any cracks were visible on the surface) through Intermediate to Heavy, which is in accordance with the experimental observation of one large crack close to failure in cycle 8.
