# Smart and repeatable easy-repairing and self-sensing composites with enhanced mechanical performance for extended components life

## ABSTRACT

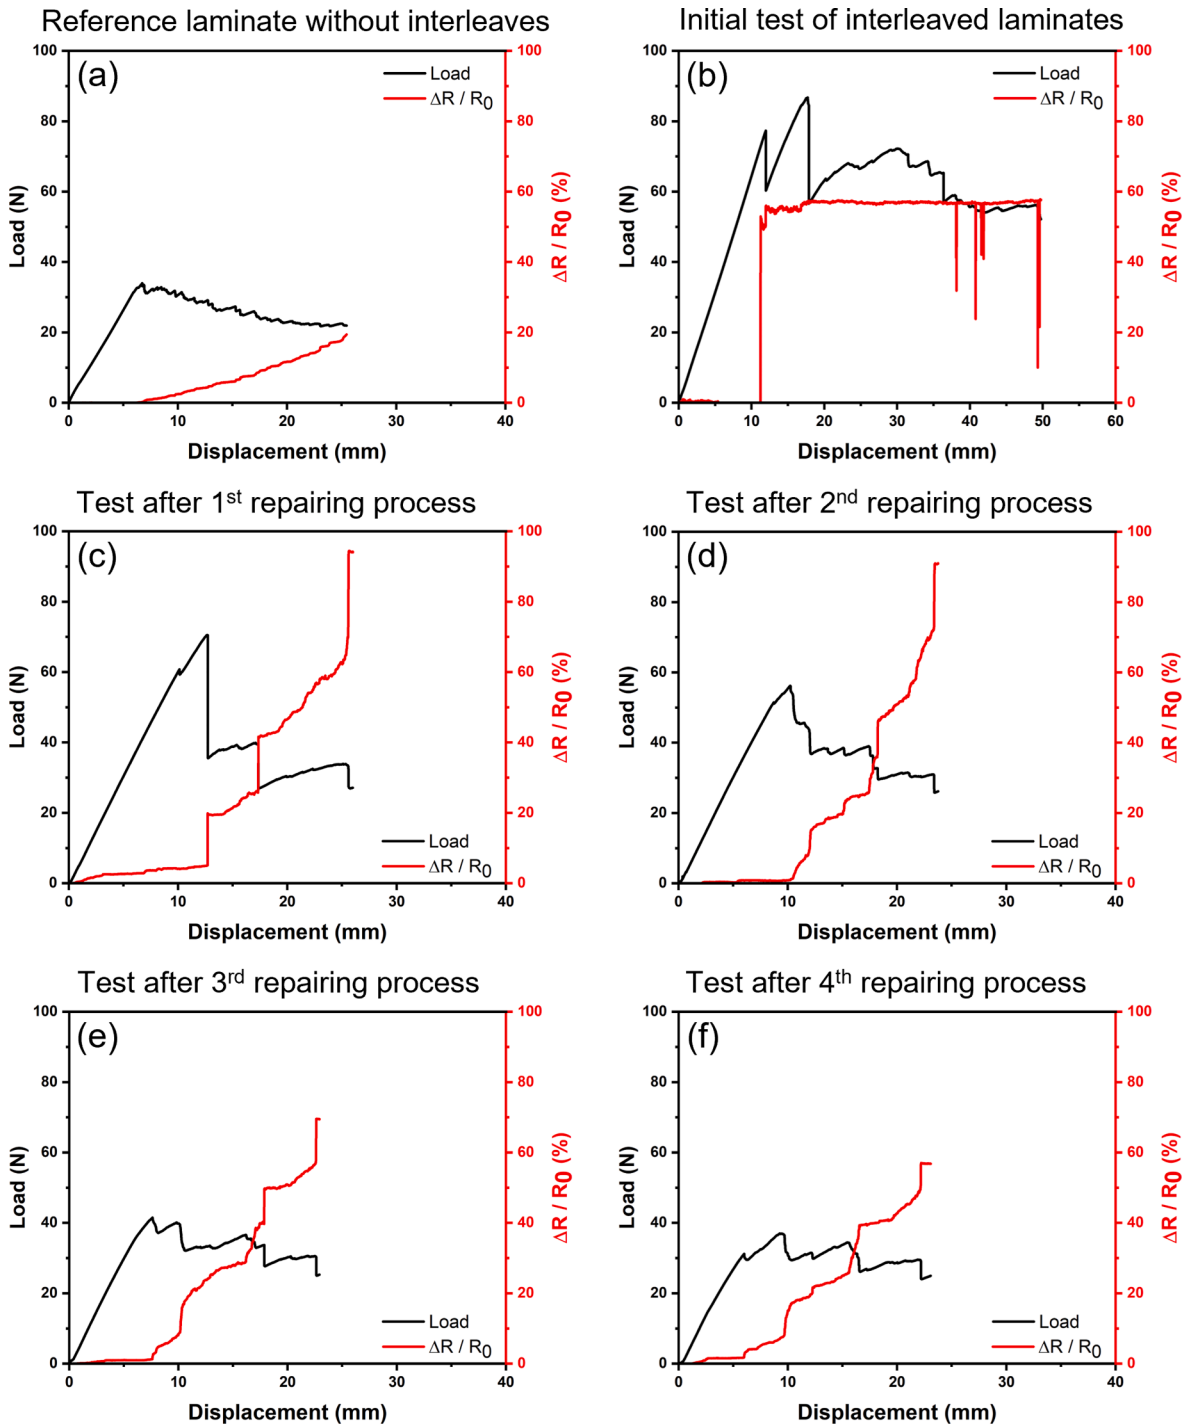
Fig. 4. The in-situ electrical damage sensing of interleaved specimen, showing (a) neat carbon/epoxy laminate without interleaf; (b) initial test of interleaved laminates with no correlation on sensing signals due to the insulating nature of the interleaf; (c) restored electrical sensing signals with good correlation after first repairing process due to improved contact between plies; (d-f) repeatable electrical sensing signals after 4 consecutive damage and repairing cycles, confirming reliable sensing signals to monitor the delamination damages. (For interpretation of the references to colour in this figure legend, the reader is referred to the web version of this article.)

As shown in Fig. 4c, the electrical sensing signals remained at a stable level at the beginning of the test, with a clear step increment when the load suddenly dropped at a crack length of around 12 mm. This jump in sensing signal was due to the internal crack propagation of the specimen. As the test progressed, for each internal crack propagation and load drop in the force curve, a corresponding signal jump is observed for the electrical sensing signal, confirming a good correlation between sensing signals and internal health status. A similar trend was obtained after the second healing process of the composite laminates (Fig. 4d) with clear sensing signals in correlation to load curve and a high sensitivity. Up to the fourth consecutive damage and healing process (Fig. 4e and 4f), the sensing signals remain clear with a good correlation with the load drop, confirming its effectiveness in detecting and monitoring the delamination damage inside the laminates. It is worth noting that the sensitivity of the specimens is slightly reduced with increasing number of damage and repair cycles. For real-world engineering applications, replacement and/or other non-destructive testing should be considered rather than further repairing, should the sensitivity be reduced or unstable sensing signals obtained, although the mechanical performance of the laminates still outperforms the reference carbon/epoxy systems.

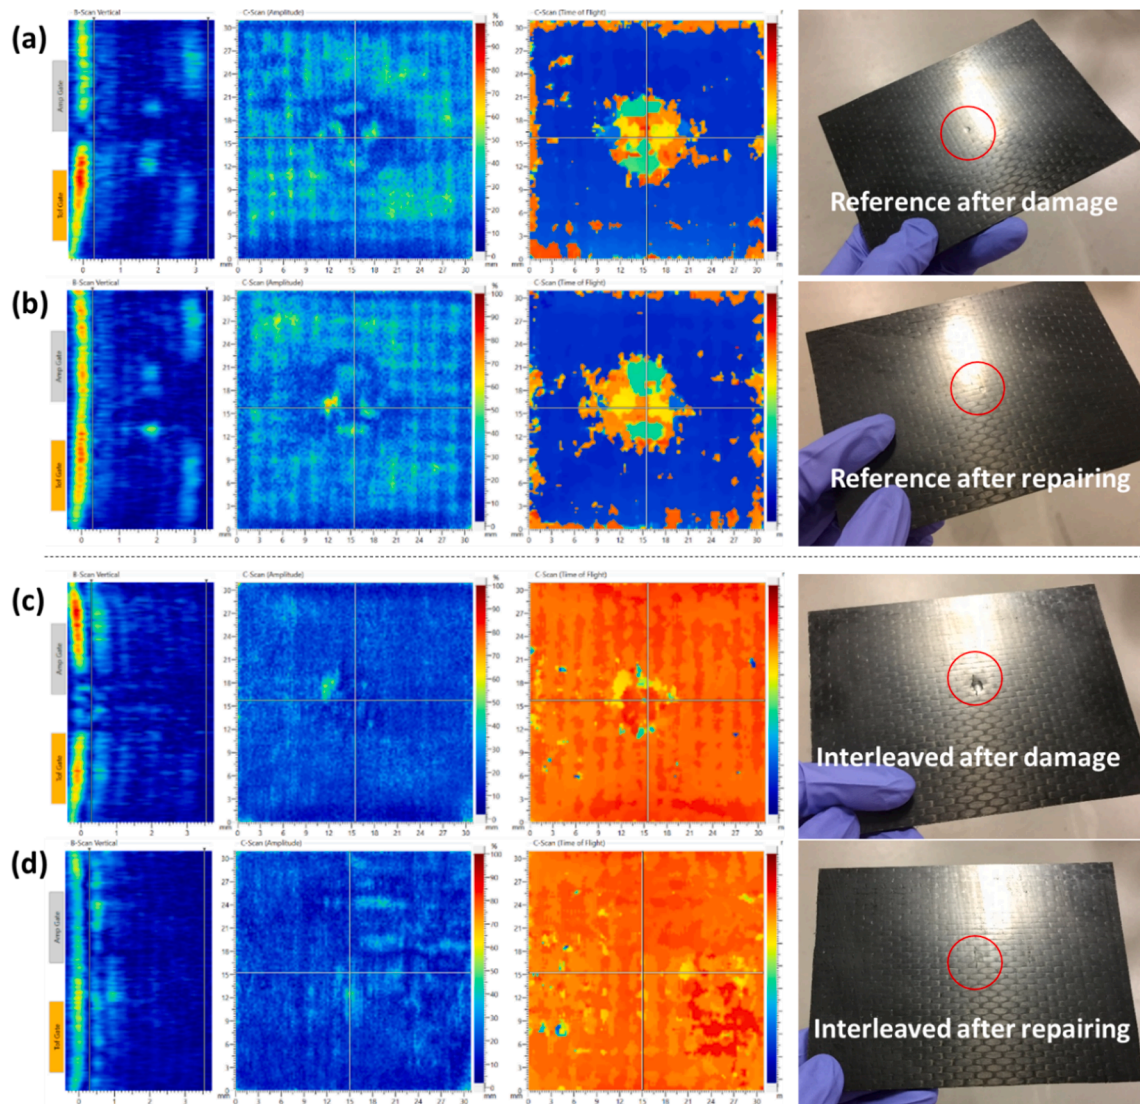
**Fig. 5.** Demonstration of repairing capabilities by comparing indentation damaged laminates before and after the easy-repair process: (a) and (b) carbon/epoxy reference laminate with the same damage areas without any noticeable changes; (c) and (d) phenoxy interleaved laminate with a clear recovery of damage area after repairing process. (For interpretation of the references to colour in this figure legend, the reader is referred to the web version of this article.)

To demonstrate the repairing capability for impact induced delamination, laminates with interleaves placed in between each carbon fibre ply were subject to a static indentation test followed by ultrasonic C-scanning to evaluate the damage areas and repairing performance. After inducing a clear indentation damage into the neat reference panel at a load up to around 1.8 kN, the panel was removed from the test frame and scanned, with ultrasonic scanning results shown in Fig. 5a. B-scan images through the thickness of the panel show a clear discontinuity at the front surface, while a delamination area with a diameter of around 6 mm can be seen in the C-scan images (Fig. 5a). After performing the repair process, the same delamination area was observed without any obvious changes (Fig. 5b).

Compared to the reference laminate, a much earlier time-of-flight was obtained from the interleaved laminate (Fig. 5c) due to the presence of continuous phenoxy interleaves between the surface and second carbon fibre plies, reflecting the signals back to the ultrasonic receiver. Clear damage was generated at the surface, with clear fibre breakages observed in the picture in Fig. 5c. A slightly smaller damage area can be found from the C-scan time-of-flight result, with a less pronounced observation in the C-scan amplitude image, although a much higher load (3 kN) was applied for the interleaved laminate to obtain an obvious load drop during the test. After the repairing process, the internal damage area disappeared from the C-scan time-of-flight image in Fig. 5d, with a continuous reflection of signals from the interleaved areas, confirming the feasibility of using the current method to repair composites. It is worth noting that surface damages and fibre breakages (circled area in Fig. 5d) remained unrepaired after the repairing process due to the nature of current interleaving repair concept.
