Jiang, R., Bull, D. J., Proppentner, D., Shollock, B. A. and Reed, P. A. S. (2017) Effects of oxygen-related damage on dwell-fatigue crack propagation in a P/M Ni-based superalloy : from 2D to 3D assessment. International Journal of Fatigue.

Effects of oxygen-related damage on dwell-fatigue crack propagation in a P/M Ni-based superalloy: from 2D to 3D assessment

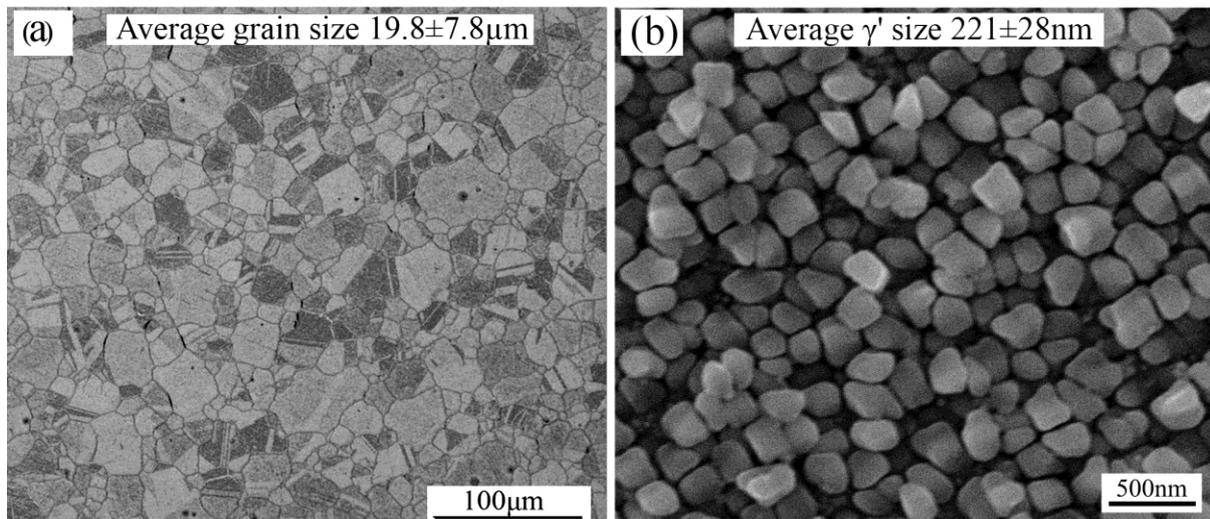
Fig. 1 Microstructures of the LSHR alloy: (a) grain morphology and (b) secondary γ' morphology.

optical microscope and a JSM 6500F field emission gun (FEG) scanning electron microscope (SEM). The obtained microstructures of the LSHR alloy are shown in Fig. 1.

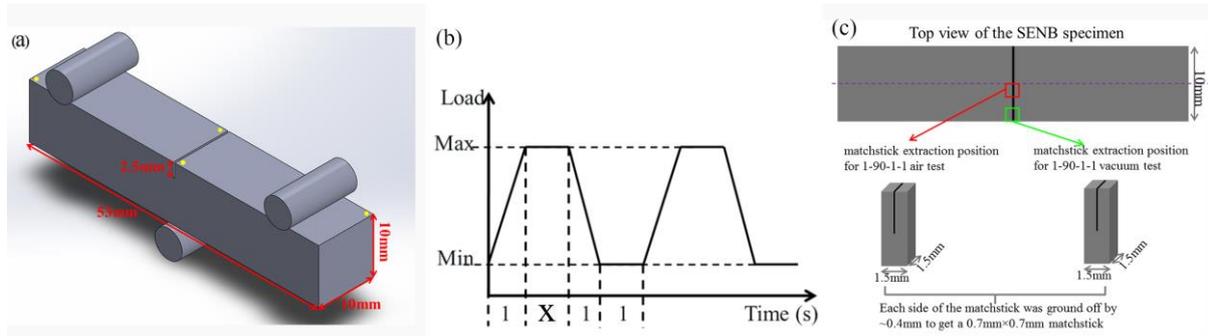
Fig. 2 (a) Schematic diagram of three-point bending test. The small yellow circles on the top surface indicate the location of electrical potential wires. (b) Schematic diagram of the loading waveform. And (c) Schematic illustration of extraction position of the “matchstick” for CT scanning from the specimens tested under 1-90-1-1 loading waveform in air and vacuum respectively.

X-ray CT was employed to evaluate the 3D morphology of the cracks. Due to the high X-ray attenuation of Nickel, regions of interest (“matchstick” specimens) were extracted to minimise the cross-sectional area to $0.7 \times 0.7 \text{ mm}^2$ as schematically shown in Fig. 2 (c). Matchsticks were cut from the tested coupons under a 1-90-1-1 loading waveform which were stopped at a similar ΔK level (*i.e.* $\Delta K \sim 40 \text{ MPa}\sqrt{\text{m}}$) at the crack tip for both air and vacuum conditions. It should be noted that the high ΔK levels evaluated ($\sim 40 \text{ MPa}\sqrt{\text{m}}$) are not necessarily representative of FCP behavior at lower ΔK levels. To generate the matchstick, a section approximately $1.5 \times 1.5 \text{ mm}^2$ was first cut off before being carefully ground down to the desired dimensions $0.7 \times 0.7 \text{ mm}^2$. It should be noted that the matchstick was extracted from a central region in the specimen tested in air, whereas the matchstick was extracted from a region closer to side surface in the specimen tested in vacuum as schematically shown in Fig. 2 (c). However, it is believed that this slight variation of matchstick extraction site will not introduce significant differences when evaluating the

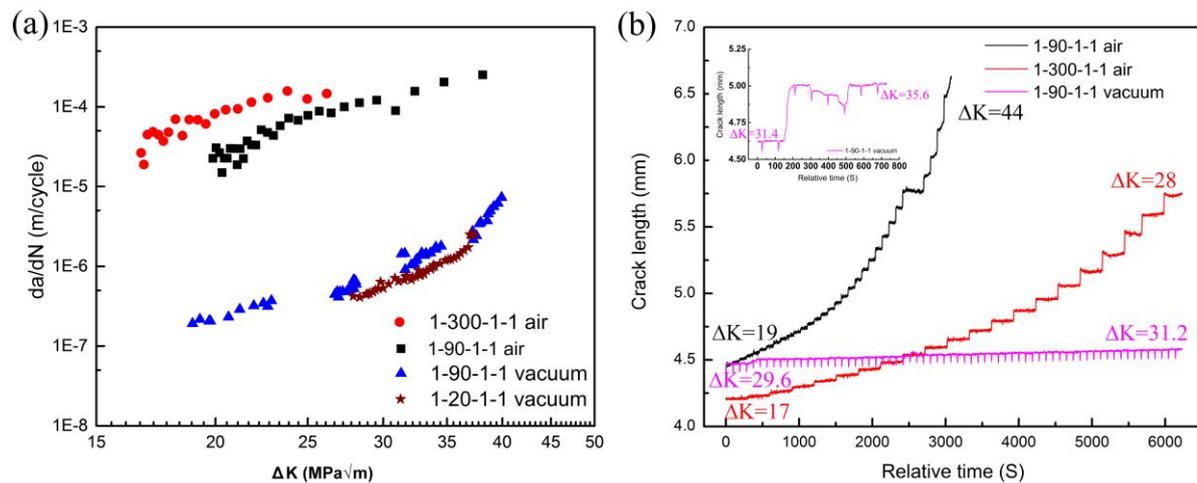
Fig. 3 (a) Fatigue crack propagation rate and (b) the crack length evolution with the loading time in the LSHR alloy.

Fig. 3 presents the FCP rate and the crack length evolution with the loading time in the LSHR alloy. Similar to our previous findings in this alloy, albeit in different microstructural variants, oxygen-related damage has a significant influence on FCP. As shown in Fig. 3 (a), the influence of dwell time at the peak load on FCP is not significant in vacuum. The FCP rate in vacuum under the 1-90-1-1 loading waveform is only marginally higher than that under the 1-20-1-1 loading waveform. But by changing the testing environment from vacuum to air, the FCP rate is enhanced by about two orders of magnitude as shown in the 1-90-1-1 air and vacuum tests. In air, the dwell time at the peak load exerts a more evident influence on FCP than in vacuum as indicated by the 1-90-1-1 test and the 1-300-1-1 test.

Fig. 3 (b) shows the crack length evolution with the *relative* time under load cycling. The corresponding ΔK at the beginning and end of the selected load cycling time is indicated on the graph. As shown in Fig. 3 (b), two different patterns of crack length evolution with time under load cycling in air and vacuum can be identified. In the air tests either under the 1-90-1-1 or the 1-300-1-1 loading waveform, the crack length increment mainly occurs at the end of the dwell period (*i.e.* the unloading and re-loading stage) at the low ΔK level, and no

evident dwell stage can be discerned due to the small crack length increment in a loading cycle. As crack length (ΔK) increases, the crack length increment during the unloading and reloading stage after a dwell period becomes more evident, this makes the dwell stage more apparent. In an individual loading cycle in the mid-range of the ΔK level, no apparent crack length increase during the dwell period is spotted. As crack length (ΔK) further increases, a continuous crack length increase can be seen during the dwell period at the peak load as shown in the 1-90-1-1 air test. Conversely, the vacuum test under the 1-90-1-1 loading waveform shows a completely different pattern during most stages of fatigue crack propagation. A quite significant crack length reduction (which is associated with crack closure during the unloading stage) is observed during the unloading and reloading stage after a dwell period, and then the crack is kept open during the dwell period at the peak load, showing the pattern of crack response to the loading in an individual cycle. However, it is interesting to notice that intermittently there is a significant increase in crack length after a particular dwell period in vacuum as shown in the inset graph at the top-left corner in Fig. 3 (b). After this dramatic crack length increase, the crack shows some evidence of closure behavior and then a similar crack length evolution pattern can be seen again. The different responses of the cracks to the loading in an individual loading cycle in air and vacuum indicate the different cracking mechanisms operating at the crack tip.

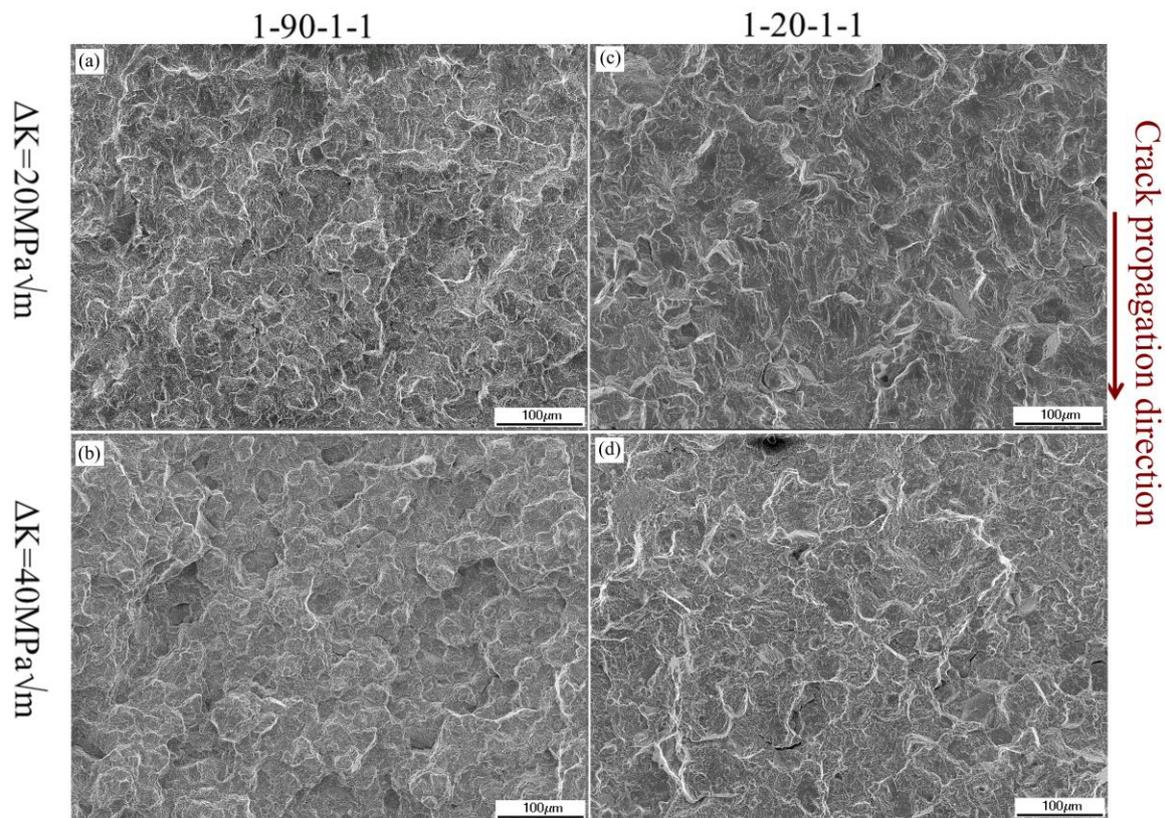
Fig. 4 Fractography of vacuum tests: (a) 1-90-1-1, $\Delta K=20$ MPa \sqrt{m} ; (b) 1-90-1-1, $\Delta K=40$ MPa \sqrt{m} ; (c) 1-20-1-1, $\Delta K=20$ MPa \sqrt{m} [6]; and (d) 1-20-1-1, $\Delta K=40$ MPa \sqrt{m} [6].

The fractography of the 1-90-1-1 vacuum test is shown in Figs. 4 (a) and (b). The fractography of the 1-20-1-1 vacuum test from our previous study [6] on the LSHR alloy variant (which has a coarser grain size) is also presented in Figs. 4 (c) and (d) for comparison.

As shown in Fig. 4, the fracture surfaces in both cases show mixed inter-transgranular fracture. The presence of partially intergranular failure in the vacuum tests is probably due to the relatively poor vacuum (i.e. 5×10^{-4} mbar) and high test temperature (i.e. 725 °C) in these tests which allow some environmental degradation to still take place. It appears that the fracture surface of the 1-90-1-1 vacuum test in this study appears to be more intergranular and rougher than that in 1-20-1-1 vacuum test. This might be associated with the longer dwell time at the peak load and the relatively smaller grain size of the LSHR alloy used in this study.

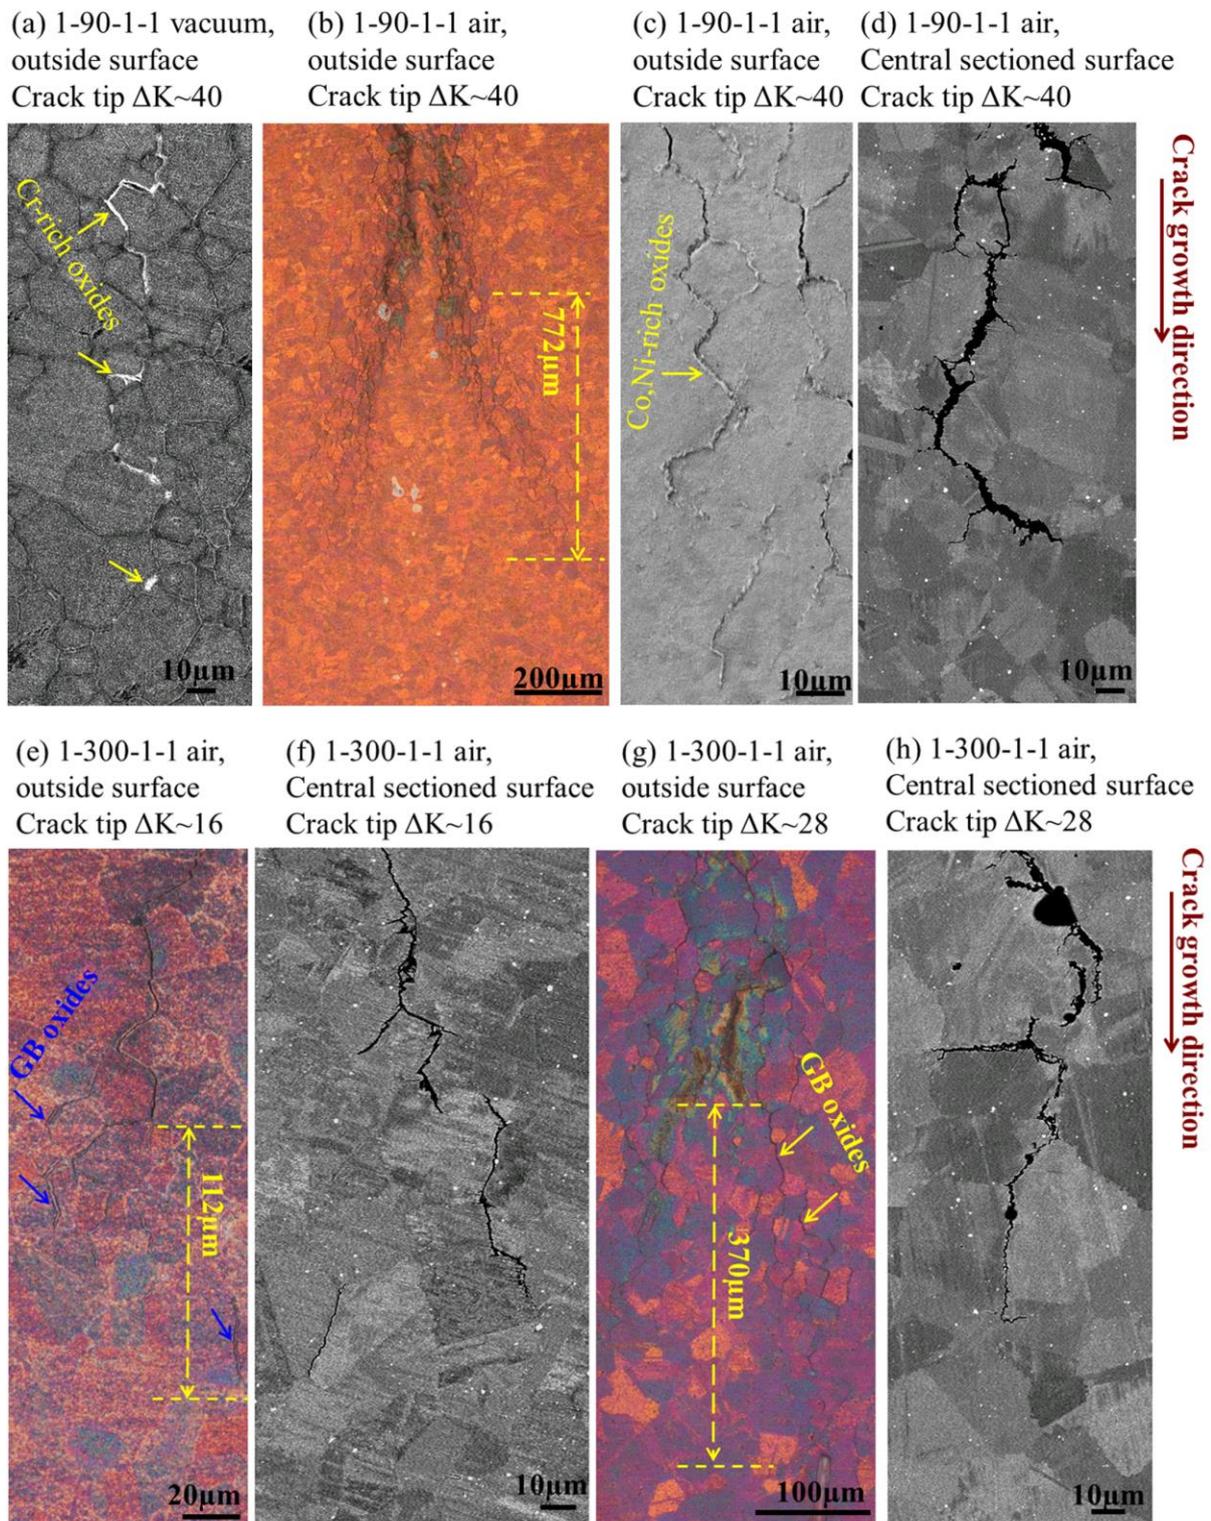
Fig. 5 Crack tip at side surface and central sectioned surface: (a) 1-90-1-1, vacuum, outside surface, $\Delta K \sim 40 \text{ MPa}\sqrt{\text{m}}$; (b) and (c) 1-90-1-1, air, outside surface, $\Delta K \sim 44 \text{ MPa}\sqrt{\text{m}}$; (d) 1-90-

1-1, air, central sectioned surface, $\Delta K \sim 44 \text{ MPa}\sqrt{\text{m}}$; (e) 1-300-1-1, air, outside surface, $\Delta K \sim 16 \text{ MPa}\sqrt{\text{m}}$; (f) 1-300-1-1, air, central sectioned surface, $\Delta K \sim 16 \text{ MPa}\sqrt{\text{m}}$; (g) 1-300-1-1, air, outside surface, $\Delta K \sim 28 \text{ MPa}\sqrt{\text{m}}$; (h) 1-300-1-1, air, central sectioned surface, $\Delta K \sim 28 \text{ MPa}\sqrt{\text{m}}$.

Oxidation processes at the crack tip on the side surface and in the center of the bulk material in both vacuum and air tests has been examined by OM and SEM. As shown in Fig. 5 (a), even in vacuum under a loading waveform of 1-90-1-1, oxidation can still be discerned on the side surface at the crack tip and in the crack wake. Grain boundaries are visible on the side surface due to a thermal etching effect. The EDX analysis indicates that the oxides formed at the crack tip and crack wake at the side surface are Cr-rich oxides. Figs. 5 (b) and (c) present the morphology at the crack tip on the side surface in the 1-90-1-1 air test, from

which we can see a branched crack tip. Unlike the vacuum test, oxidation at the crack tip on the side surface in the air testing condition is much more significant. Bulged grain boundary oxides are seen at the crack tip (as indicated in Fig. 5 (c)). These bulged grain boundary oxides are Co and Ni-rich oxides as shown in our previous studies where FIB extraction of TEM lamellar containing bulged grain boundary oxides characterised the oxides in the TEM using EDX [12, 18]. Due to the oxidation, an inverted “V” shape oxidation damage zone is discerned at the crack tip on the side surface which appears to be associated with the expected plastic zone at the crack tip. This characteristic inverted “V” shape showing possible plastic lobes at the crack tip form a distinct oxidation damage zone on the side surface. Fig. 5 (d) shows the crack tip in the bulk material seen in the center, obtained after sectioning the specimen tested in air. The crack tip in the bulk material appears to be a much simpler geometry than seen on the side surface, but an intergranular crack path is still found in the bulk material. However, it should be borne in mind that the difference in crack tip geometry observed between the side surface and center may also depend on which plane was sectioned, and does not reflect the true 3D crack geometry. EDX examination of the crack tip in the center shows little enrichment of O at the grain boundary at the crack tip.

Figs. 5 (e) - (h) present the crack tip morphology in the 1-300-1-1 air tests. Similarly to the 1-90-1-1 air test, bulged grain boundary oxides can be found on the side surface at the crack tip either at ΔK of $\sim 16 \text{ MPa}\sqrt{\text{m}}$ or $\sim 28 \text{ MPa}\sqrt{\text{m}}$ as shown in Figs. 5 (e) and (g) respectively, and the intergranular crack tip morphology seen in the bulk material is also simpler than that observed on the side surface as shown in Figs. 5 (f) and (h). An inverted “V” shape oxidation damage zone is also found at the crack tip at a ΔK of $\sim 28 \text{ MPa}\sqrt{\text{m}}$ (Fig. 5 (g)), even though it is not as evident as seen in the 1-90-1-1 air test (Fig. 5 (b)) due to the lower ΔK level at the crack tip (and hence the smaller plastic zone size). Examination of oxidation at the crack tip in the bulk material using EDX shows that an apparent enrichment of O is found at the crack tip at a ΔK of $\sim 16 \text{ MPa}\sqrt{\text{m}}$, but no O enrichment is found at the crack tip at a ΔK of $\sim 28 \text{ MPa}\sqrt{\text{m}}$. This difference indicates that FCP rate (which affects the available oxygen diffusion time at/ahead of the crack tip before the crack advances through the embrittled region) also has an influence on the observed oxidation damage process at/ahead of the crack tip. However it should be noted that the absence of O detection at the crack tip at relatively high ΔK levels may be related to insufficient resolution of EDX and/or the relatively fast crack propagation rate which results in less apparent oxide forming. Detailed examination and

The measured oxidation damage zone size at the crack tips on the side surfaces in the air tests is shown in Table 2 and is indicated in Fig. 5. The monotonic ($r_{p,monotonic}$) and cyclic ($r_{p,cyclic}$) plastic zone sizes (PZS) at the crack tip were calculated using Irwin's approximation based on a plane stress assumption with Equations (1) and (2) [42], and are also presented in Table 2 to make a comparison with the measured oxidation damage zone at the side surface .

close to that observed in vacuum/low oxidation conditions. This can be further supported by the extensive GB oxidation observed at the outside surface in the air test but limited GB oxidation observed in the mid-section plane as shown in Fig. 5. Based on the metallographic 2D observations and X-ray CT 3D observations of crack morphology, a schematic diagram (Fig. 11) has been drawn to illustrate the main crack advance process and secondary crack development in the air test. As schematically shown in Fig. 11 (a), for a crack with a length of a , within the discontinuous cracking zone ahead of the crack tip, there is insufficient oxygen arriving in this region due to the existence of the uncracked ligaments acting as barriers to the oxygen flow path, even though the discontinuous cracks are partially connected to the main crack plane in 3D as shown in Fig. 7. As a result, the discontinuous cracking zone ahead of the crack tip is under a quasi-vacuum/low oxygen partial pressure condition. Consequently, the secondary cracking within the discontinuous cracking zone ahead of the crack tip is similar to that which occurs in vacuum and mainly occurs only in the plastic zone around the crack tip. As the crack advances via breaking the uncracked ligaments (due to eventual oxygen-related damage in the uncracked ligaments) and connecting of the discontinuous crack segments, as shown in Fig. 11 (b), oxygen can relatively easily access the fully opened crack wake where the crack has just advanced and is still encompassed by the plastic zone (due to the complex surrounding 3D nature of the crack tip). With the assistance of the relatively high stress/strain of the plastic zone and the increased oxygen partial pressure, oxygen-related damage along grain boundaries occurs by SAGBO or dynamic embrittlement. As a consequence, secondary cracking starts to develop in this freshly formed crack wake as schematically shown in Fig. 11 (c). Hence, more secondary cracks are observed in the air test. As the crack tip continues to advance, the stress at this position in the crack wake diminishes and the ongoing oxygen-related damage becomes less significant until the stress becomes insufficient to continue to assist oxygen-related damage along grain boundaries and the secondary cracking process then stops at that part of the crack wake (which is now too far from the active crack tip stress state).

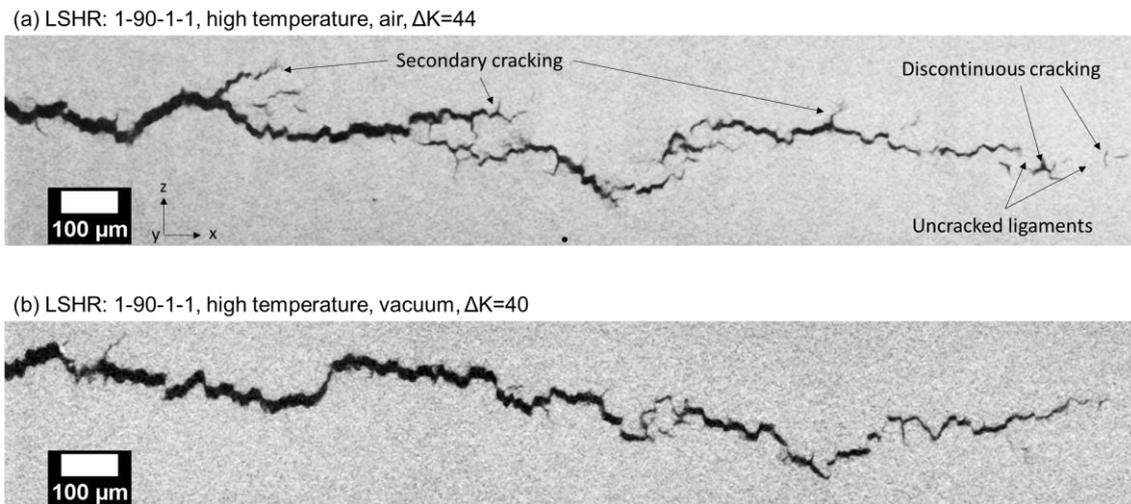
Fig. 6 CT cross-sections of LSHR 1-90-1-1 test in (a) air and (b) vacuum at 725 °C.

Figs. 6 (a) and (b) show an X-ray CT cross-section of the main crack in air and vacuum conditions respectively. Two key features can be identified from the cross-sections: secondary cracking in the crack wake and bridging ligament formation (uncracked ligaments) caused by discontinuous cracks within the discontinuous cracking zone ahead of the crack tip. These two features were present in both specimens and are quantified further later to understand the extent of these features.

forming off the main crack body) was observed in the specimen tested in air (Fig. 6 (a)). In the discontinuous cracking zone ahead of the crack tip, islands of crack segments appear completely unconnected to the main body of the crack (as can be observed in an individual CT slice shown in Fig. 6) but these regions can be discerned to be partially connected to the main crack in 3D in specimens tested in both air and vacuum.

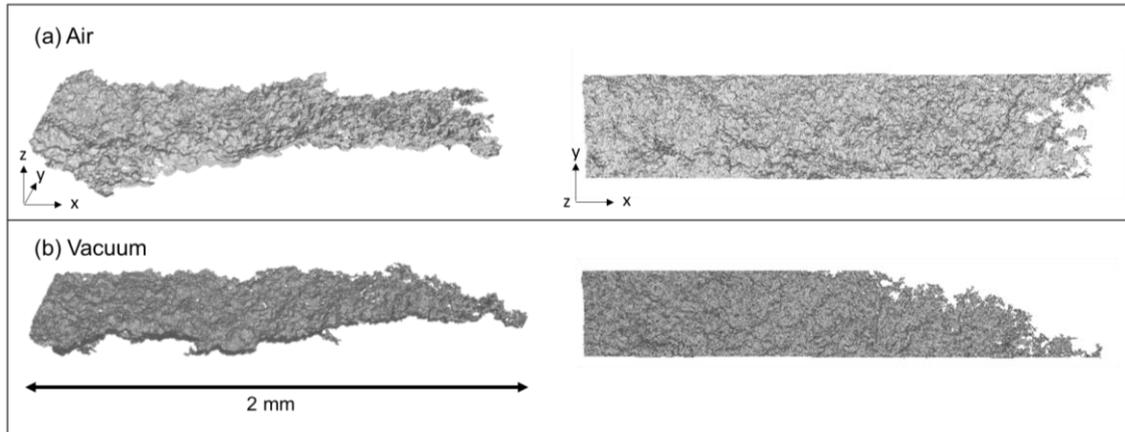
Fig. 7 CT 3D renderings of crack profile for 1-90-1-1 (a) air and (b) vacuum environment. Contained in the rendering is a 45° slanted view of the crack profile (left) and a topological view of the crack profile (right).

3D renderings of the cracks are shown in Fig. 7 for (a) air and (b) vacuum conditions. From this image, the overall geometry of the cracks can be observed including the overall roughness present in both cracks. It appears that the crack front in air is more symmetrical than that in the vacuum condition. It should be noted that this difference is probably related to the sampling as schematically shown in Fig. 2 (c). Although the matchstick extraction position has certain influence on the overall crack geometry, it is believed that this slight variation of matchstick extraction site should not bring significant bias when evaluating the effects of environmental damage on fatigue crack propagation mechanisms. The discontinuity ahead of the crack tip and the interlinked uncracked ligaments in the discontinuous cracking zone ahead of the crack tip can be seen in both cases. Two distinct zones are observed consisting of (a) a continuous cracking zone at the crack wake, and (b) a discontinuous cracking zone ahead of the crack tip where uncracked ligaments forming between cracks are observed. In the continuous cracking zone, a large extent of secondary cracking (cracks

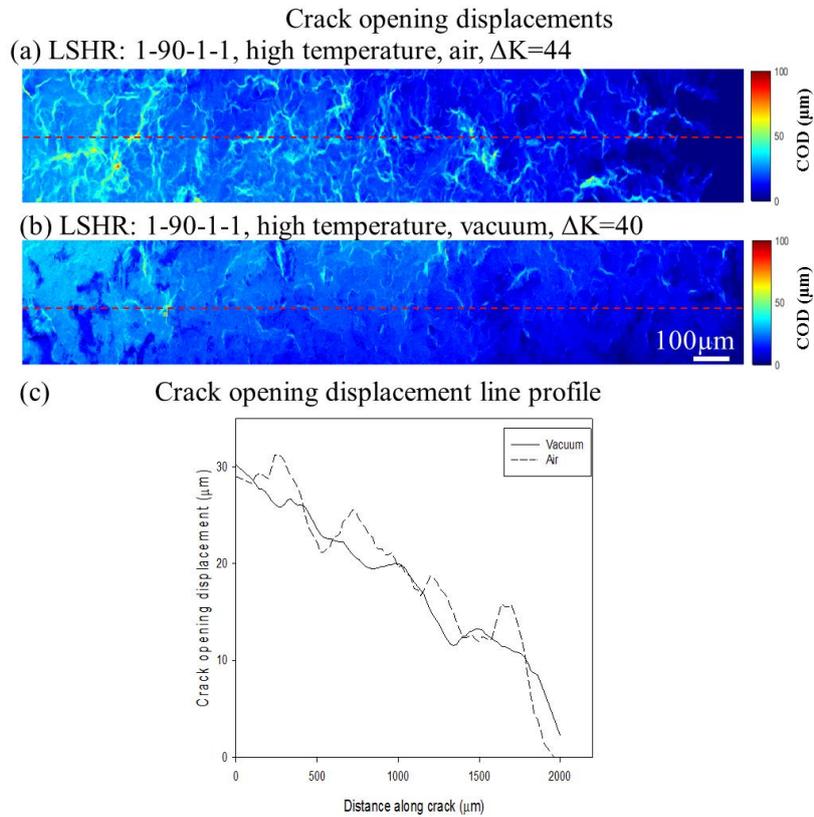
Fig. 8 Crack opening displacement plots across the crack face (crack tip on right) for LSHR alloy in (a) air and (b) vacuum under 1-90-1-1 loading waveform at 725 °C. (c) COD line profile plots as measured across the red dotted lines in (a) & (b). Line profile has been smoothed to make clearer the overall COD profile.

Fig. 8 shows the CODs measured perpendicular to the crack plane. Figs. 8 (a) and (b) show a full field COD map across the specimens tested in air and vacuum respectively. Line plots across the dotted lines in Figs. 8 (a) and (b) are shown in Fig. 8 (c). One key difference is more extensive “fringed peaks” representing locally higher COD measurements. These are believed to be caused by secondary cracks which when summed together with the main crack give locally larger readings. Qualitatively, this phenomenon appears to be more extensive in the air specimen than vacuum and has been exploited later to quantify the extent of secondary cracks between these two specimens. It should be mentioned that the line plots shown in Fig. 8 (c) have been smoothed to remove the high frequency measurements and to give the general profile of the opening. In both air and vacuum cases, the general shape and magnitude of the COD are similar.

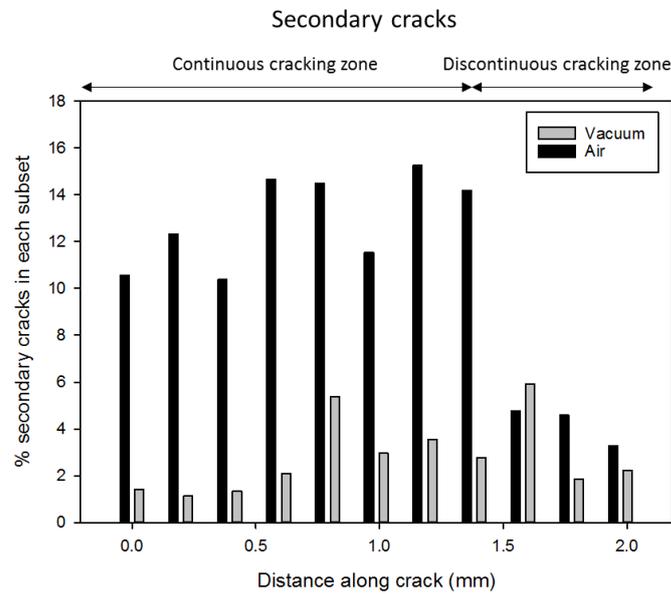
Fig. 9 Bar plot comparing the extent of secondary cracking from crack wake (left) to crack tip and to the discontinuous cracking zone (right) between the 1-90-1-1 air and vacuum tests. Two cracking zones are indicated consisting of a continuous cracking zone 0-1.5 mm and discontinuous cracking zone 1.5-2.0 mm. Subset size is 0.2 mm.

Fig. 9 presents the quantified secondary crack measurements for the specimens tested in air and vacuum. These were measured as a percentage of secondary cracks occupying an area of the projected crack in 0.2 mm subsets from the crack wake to the crack tip. It is clear that towards the crack wake, 0.5 mm behind the crack tip (i.e. the continuous cracking zone in the

crack wake), there is an extensive increase in secondary crack formation in the air test. In this continuous cracking zone, it appears that the amount of secondary cracks is about two to five times more in the specimen tested in air than that in vacuum. Within the discontinuous cracking zone ahead of the crack tip, similar extents of secondary cracking are observed.

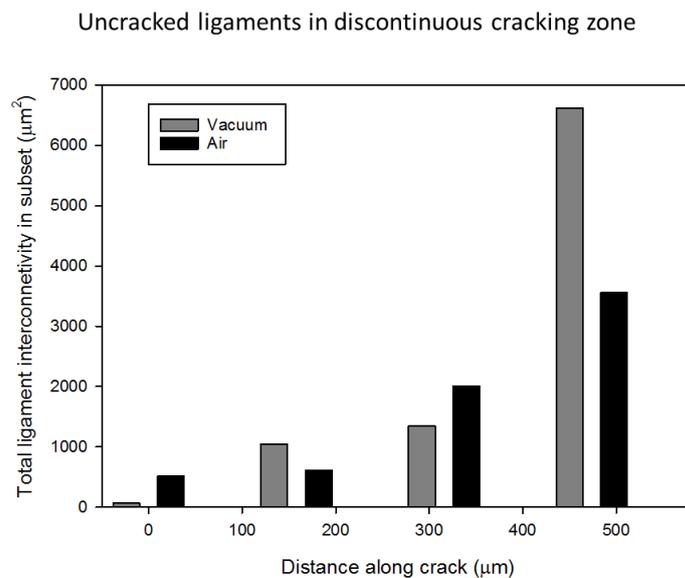
Fig. 10: Uncracked ligament quantification in the discontinuous cracking zone along the direction from crack wake (left) to crack tip (right). Subset size 158 microns.

Fig. 10 quantifies the discontinuous crack formation ahead of the crack tip (*i.e.* uncracked bridging ligaments). The total interconnectivity area between each discontinuous crack was calculated using 158 μm subsets along the direction from the crack wake towards the crack tip. The general trend of the plots shows the diminishing extent of ligaments towards the crack wake as the crack becomes more developed and transitions into a continuous cracking zone. This occurs over a 500-micron region. Comparing the uncracked ligaments between the specimens tested in vacuum and air, it appears that the specimen tested in vacuum has $\sim 75\%$ more ligaments within the subset farthest away from the crack wake. However the results here are quite sensitive to the binning size and local variations within the material, so in this

respect may not be a fair comparison to make. Summing together the total ligaments across the whole 500 μm range results in similar extents of ligaments observed in both specimens (~35% difference).

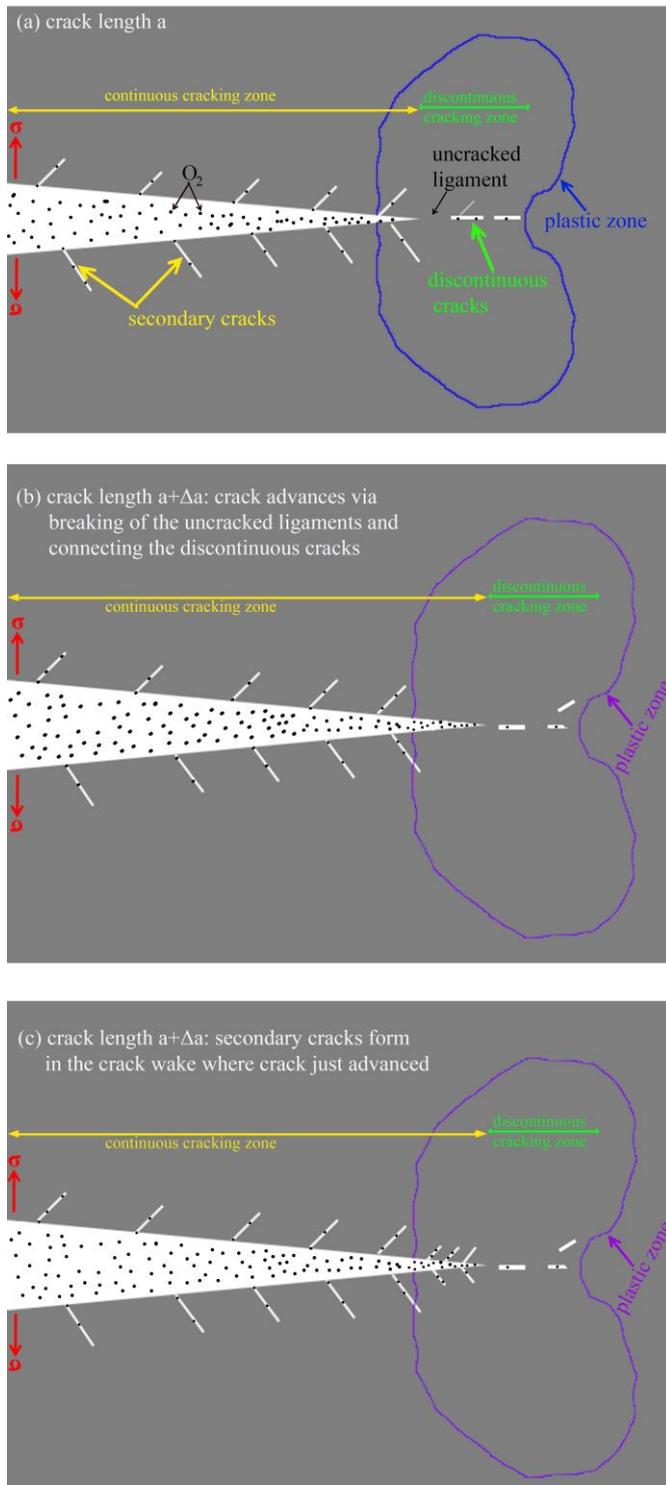
Fig. 11 Schematic diagram of crack advancement and secondary cracking formation. The plastic zone profile is sketched at the crack tip based on a simulation presented in our previous study [44]. (a) Crack tip at a crack length of a ; (b) crack advances via breaking of the uncracked ligaments and connecting to the discontinuous cracks; and (c) secondary cracking formation in the crack wake where the crack has just advanced.
