# Metrological study of CFRP drilled holes with x-ray computed tomography

Nadia Kourra · Jason M. Warnett · Alex Attridge ·  
Ercihan Kiraci · Aniruddha Gupta · Stuart Barnes ·  
Mark A. Williams

**Abstract** The popularity of composite materials is continuously growing with new varieties being developed and tested with different machining processes to establish their suitability. Destructive as well as non-destructive methods, such as ultrasonics, X-ray radiography and eddy-current, have previously been used to ensure that the combination of particular machining methods and composites provide the required quality that can allow the required lifespan of the final product. X-ray computed tomography (CT) is applied as a novel method in this paper to obtain quantitative data about the inner and outer structures of carbon fibre reinforced polymer (CFRP) drilled holes providing more information than any other non-contact and non-destructive evaluation. This is combined with precise measurements from optical CMM and image processing for a full analysis for the entire part. This method can provide accurate measurements for all the layers of the CFRP and very little interaction from the

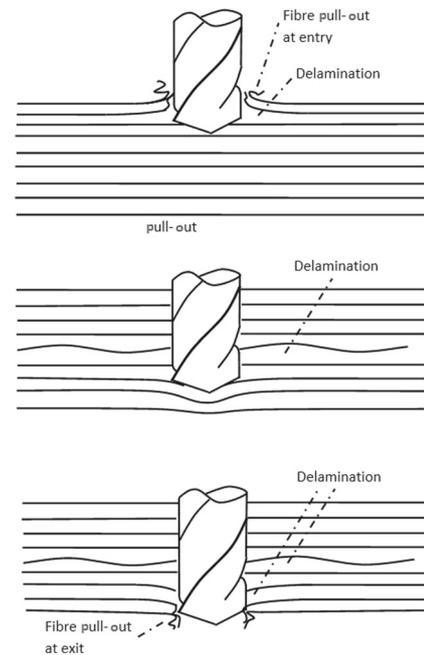
**Fig. 1** Machining may cause de-bonding, fibre pull out and delamination

Due to the difficulties faced when composites materials are machined, near-net shape processes are often applied to avoid any damage that would adversely affect their strength [8, 9]. However, some machining processes are unavoidable since mechanical fasteners are often required. The most common secondary machining applied in CFRPs is drilling, which may cause fragmentation, burrs, interlaminar cracks, interfacial de-bonding, thermal damages and fibre pull-out, all of which can lead to delamination, as indicated in Fig. 1 [2, 4, 8, 10, 11].

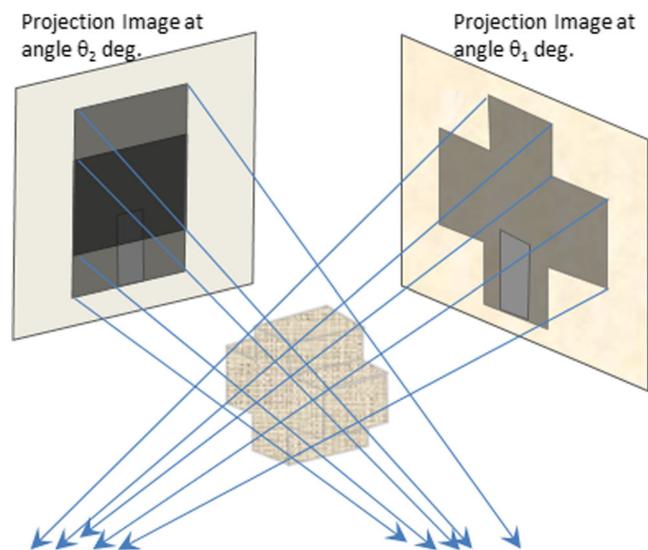
**Fig. 2** FBP rebuilds a 3D model of the scanned parts with voxels

In an X-ray radiograph each pixel has a grey value that represents the attenuation of the X-ray after it penetrates the scanned object. Numerous 2D radiographic projections are collected during a CT scan through 360° rotation of the object and they are then reconstructed with Filtered Back Project (FBP). These algorithms digitally rebuild the part. When the radiographs are reconstructed the grey values of each pixel are converted to represent the grey values of a corresponding volume called voxel, as shown in Fig. 2. This 3D volume can then be exported for analysis [30–33].

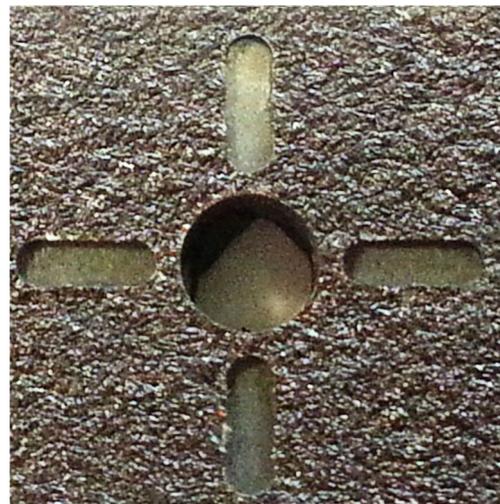
**Fig. 3** The slots are perpendicular to one another, with their bisectors meeting at the intended centre,  $c_{\text{ideal}}$

The location of each hole was marked prior to the drilling by four slots as shown in Fig. 3 to identify the indented centre of the hole,  $c_{\text{ideal}}$ , with the positioning accuracy of the holes and slots < 8  $\mu\text{m}$ . Both UAD and CD used the same cutting speed of 0.0157 m/s. All of the slots were produced by a 2-mm diameter, Q-coat tungsten carbide slot drill with 2-flute twist, with cutting speed of 18,833 m/s, cross feed 0.042 m/s and depth feed 0.0017 m/s. They have thickness of 2 mm, depth of 0.7 mm and length 8 mm.

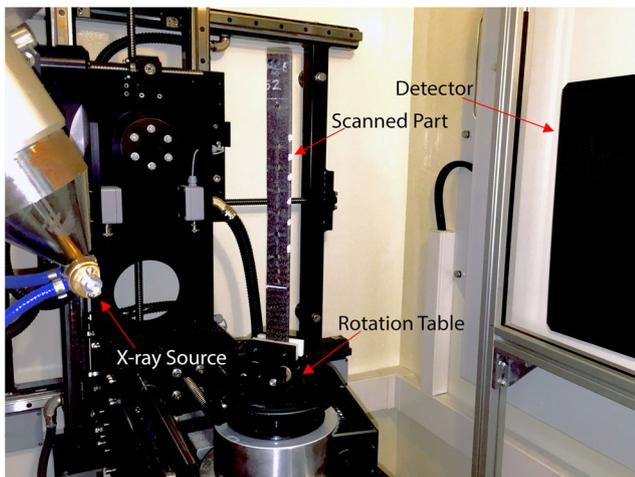
**Fig. 4** Experimental set-up inside X-ray CT scanner

as shown in Table 2 and positioning the part for maximum magnification and reduction of potential artefacts. Each part was CT scanned, Fig. 4, the acquired data reconstructed, reviewed in inspection software and then analysed with image processing. In addition, the parts were measured on a CMM to later be used for voxel scaling. The scanners and software used can be found in Table 3.

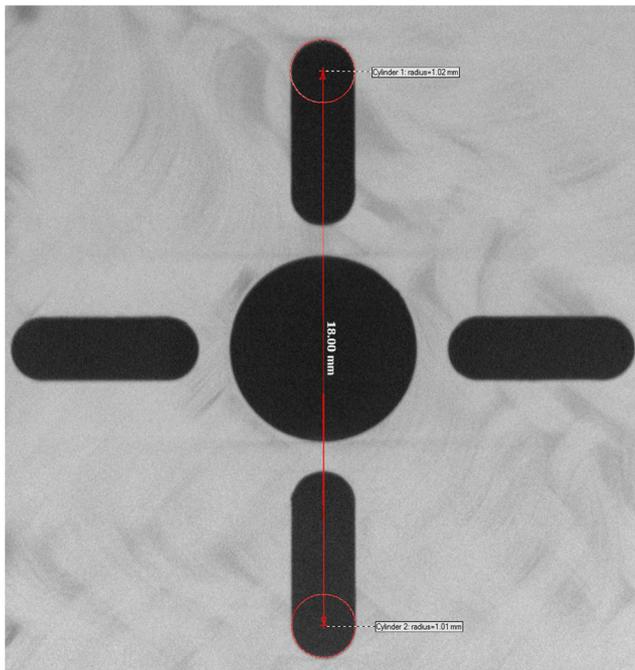
**Fig. 5** Voxel rescaling according to CMM measurements. This centre to centre distance is scaled to the actual centre to centre distance measured by optical CMM

The threshold independent measurements obtained for this analysis were the distances between the top and the lower cylindrical centres of the slots as shown in Fig. 5. The procedure followed for the voxel rescaling corresponds

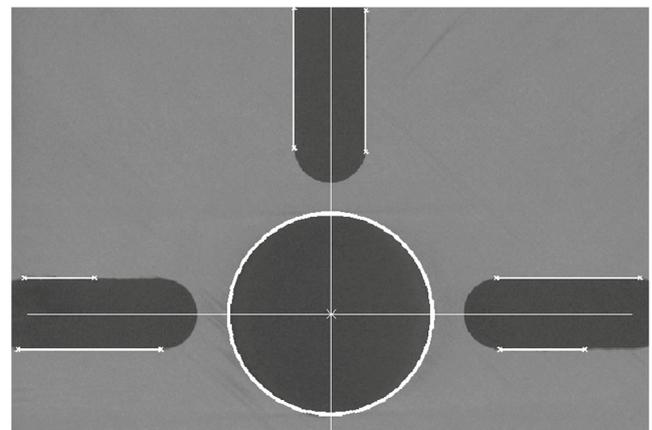
**Fig. 6** Identification of the  $c_{\text{ideal}}$  based on the slots. Lines of slots found by the Hough transform, and the circle periphery is found by the Cunny method

The image processing was performed in MATLAB with DICOM images exported from VG Studio Max 2.2. Initially, a slice is selected manually close to the entrance surface of the hole that includes the representation of the slots. The image is transformed to a binary image with the threshold selected by the Otsu method [43]. The slots are used to identify the centre of the circle, where the intersection of their bisectors represent the ideal centre,  $c_{ideal}$ . Imaging processing then utilises Hough transform to identify lines with slope of  $0^\circ$  and  $90^\circ$  with two lines identified for each slot. The mid-point between the two edges of a horizontal slot ( $0^\circ$ ) gives the  $y$ -coordinates of the centre of the circle while the mid-point of a vertical slot ( $90^\circ$ ) gives the  $x$ -coordinates as shown in Fig. 6.

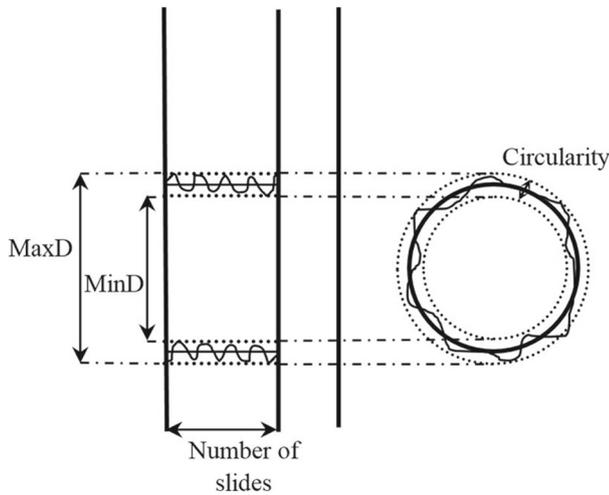
**Fig. 7** Identifying the maximum and minimum diameter and calculating the circularity for each slide

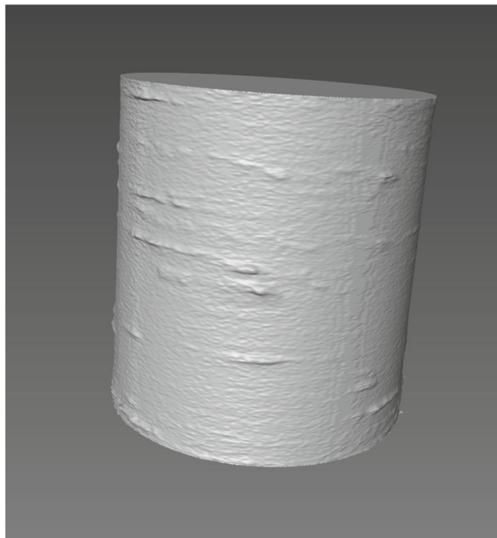
**Fig. 8** The reverse surface of the hole demonstrates the inclusions as protrusions

Initially, the morphology of the hole was considered to gain a general understanding of the defects. Figure 8 provides the reverse surface of the hole negating entry and exit layers with all the defects clearly shown. Protrusions in this view represent the defects, making it easier to qualitatively assess the surface of the hole.

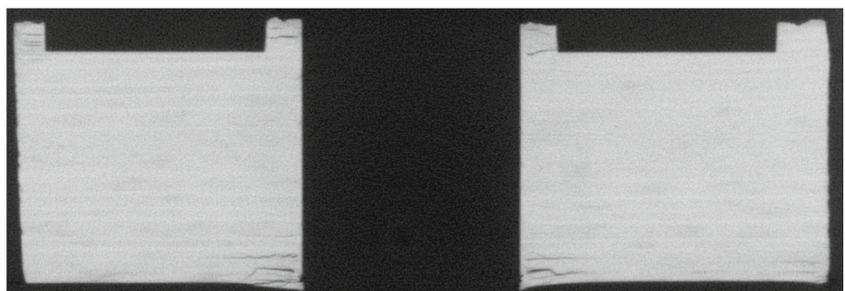
**Fig. 9** Delamination can be detected that is not connected to the wall but can still affect the quality of the part

The CT data were then examined as 2D images to identify the problematic areas, as shown in Fig. 9. Here, a 2D image of the cross section of the hole demonstrates that drilling can cause delamination that is not connected to the walls of the hole in any plane. This issue has not been considered in this study and further analysis can be performed to quantify this delaminated area.

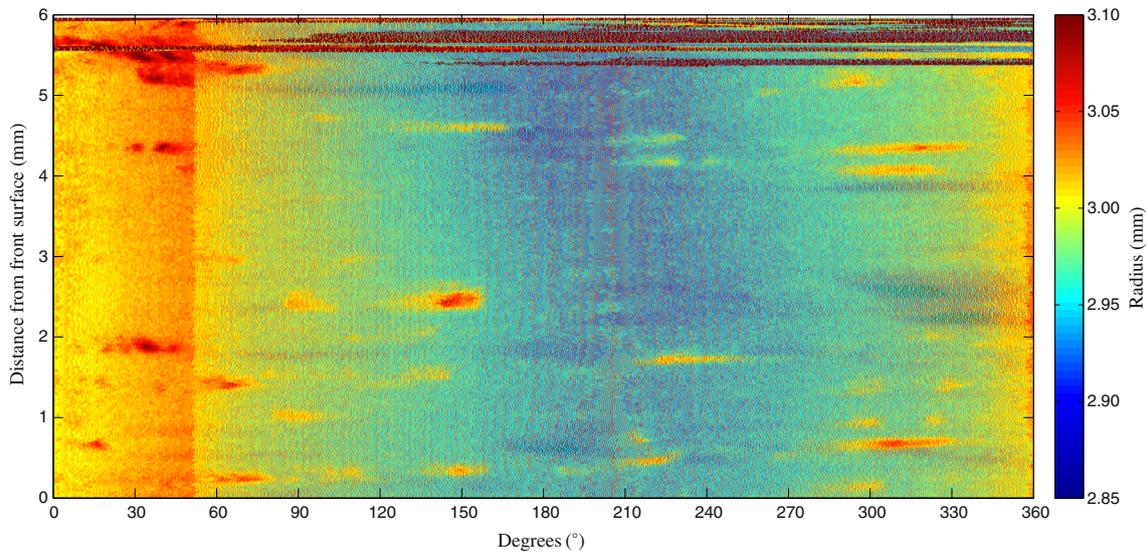
**Fig. 10** The hole was unravelled from a cylinder to plane. Each point represents a radius for a specific position on the periphery of the hole

A CD hole was digitally unravelled in Fig. 10 from a cylinder to a plane, providing a non-planar view. Here, the radius from  $c_{ideal}$  is shown through 1440 discrete angular values throughout the length of the hole. The variation is immediately evident, with problematic areas readily identifiable. This figure indicates a positioning misalignment with the radii close to  $150^\circ$  to be less than 2.95 mm and the radii close to  $330^\circ$  to exceed 3.05 mm. Another remarkable observation is the perpendicular to the drilling areas that are affected by delamination. They are approximately 20 problematic areas that exceed 3.05 mm. This indicates that particular areas of the material are weaker than others. Values that are represented in dark red indicate delamination. The degree of delamination is worse at the exit and interestingly varies through  $360^\circ$ . The magnitude of delamination at the exit of the hole can be examined further in Fig. 11.

- Acceptable positioning: The positioning for UAD passes the tolerance inspection and indicates that the technique is adequate while CD fails the inspection with a crack that reaches 0.1 mm. The positioning results of the CD hole also indicates the misalignment of the drill with radii smaller than 2.95 mm at 150° and larger than 3.05 mm in the horizontally corresponded area, as shown in Fig. 10.

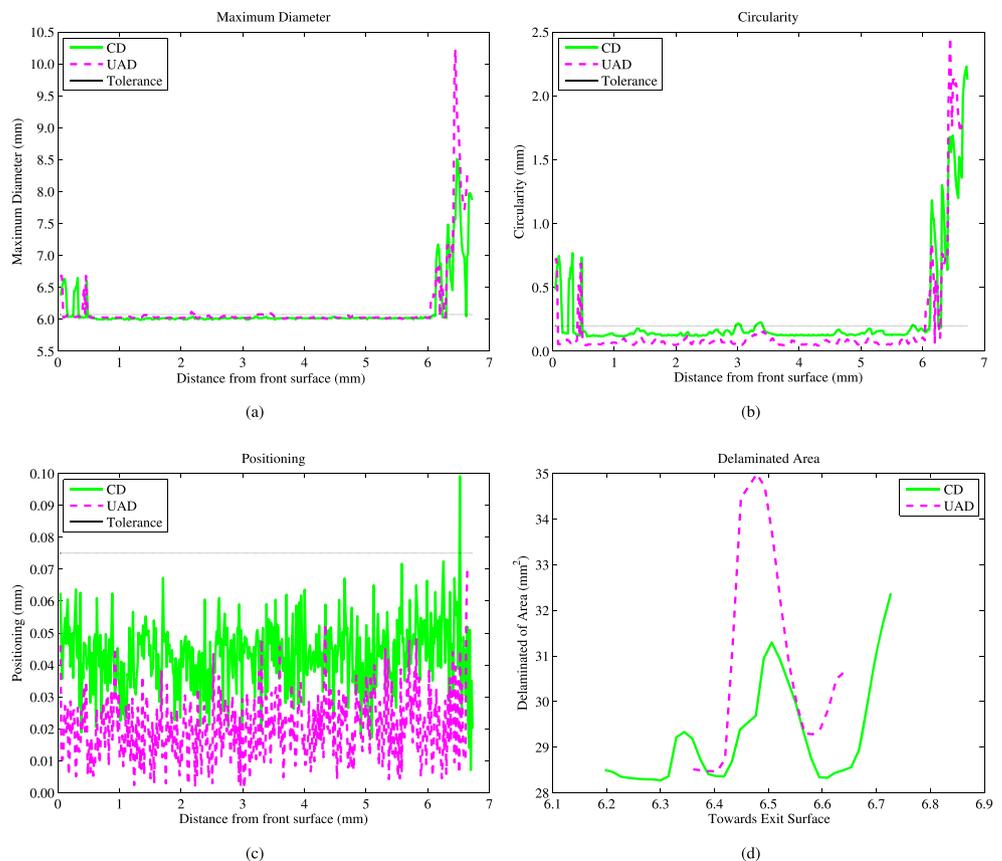
**Fig. 11** Zero millimeter represents the entry plane of the drill and 6.75 mm the exit plane. **a** The maximum diameter of each slice of the hole represented throughout the length of the hole. **b** The circularity of each slice of the hole represented throughout the length of the hole. **c** The positioning of each slice represented throughout the length of the hole. **d** The delaminated area at the exit of the hole represented from 6.2 to 6.75 mm and represents only the delaminated areas connected to the hole

The maximum diameter of each slice was calculated by identifying two edge points that pass from the  $c_{ideal}$ , and the results in Fig. 11a indicate delaminated areas close to the entrance and exit surfaces. The circularity was calculated by the difference between maximum and minimum radii of each slice, with results displayed in Fig. 11b. The

The delaminated area was calculated near the exit by summing up the darker area that exceeds the boundaries of the hole, as shown in Fig. 11d. The results indicate a growth of delaminated area close to the exit surface for both UAD and CT samples.

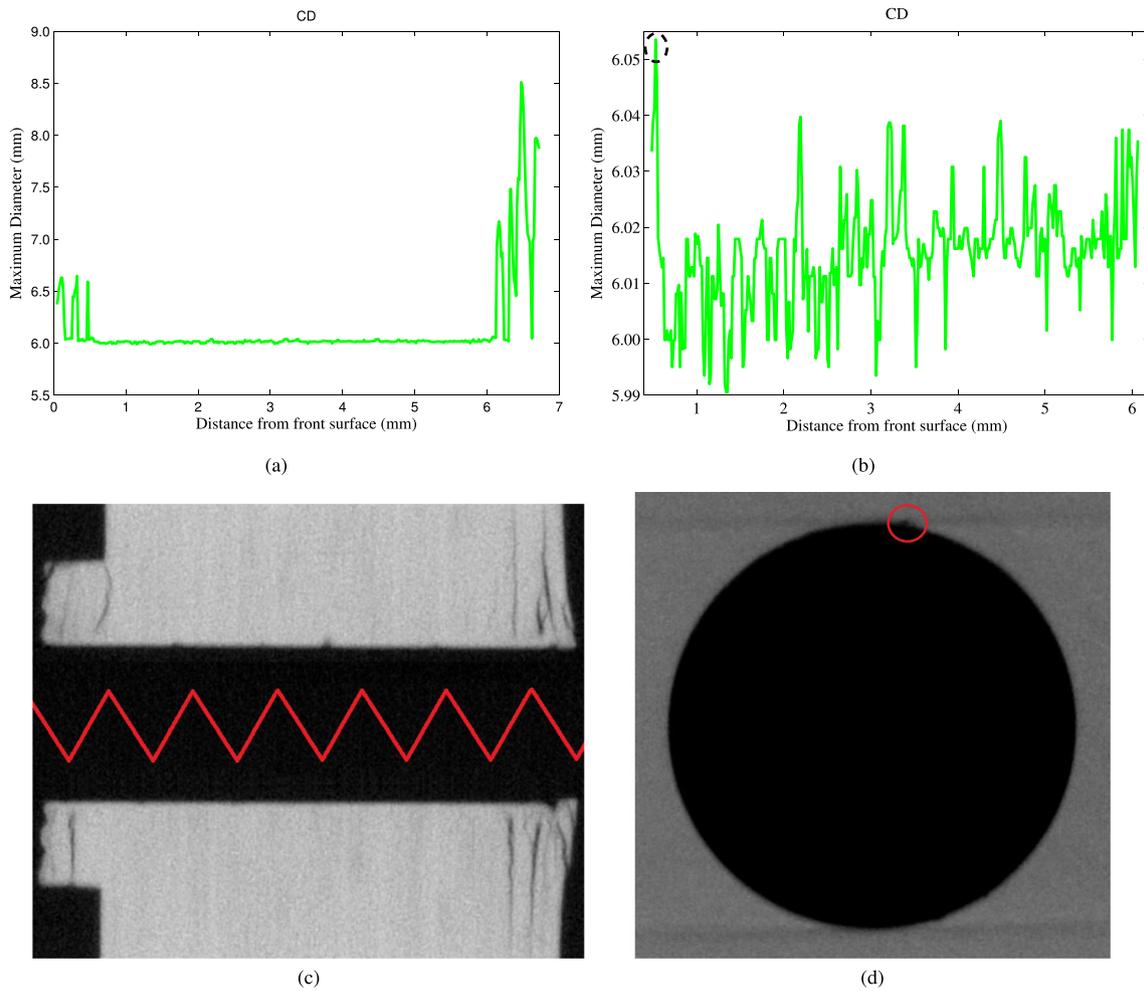
**Fig. 12** The maximum diameter of the hole can assist to identify the delaminated areas, **a** shows the maximum diameter of all of the slices. **b** Shows the maximum diameters of the main body of the hole. **c** Shows the corresponding point of the hole for each maximum diameter from

the graph above. The central hole has been removed in this picture as indicated by the *jagged line*. **d** shows the slice of the selected point from **(b)** and highlights the defect in *red*

A more precise examination of CD hole is provided in Fig. 12. The results representing the maximum diameter are indicating different defects, as well as their size. Figure 12a shows the deviation of maximum diameter from all the slices of the hole, severe exit delamination, seen in Fig. 12c for an example of CD hole, contributes to the sharp peaks observed in this graph. Figure 12b concentrates on the maximum diameter of the main body of the hole to better demonstrate the issues that are not related to entrance and exit delamination. A slice is represented in Fig. 12d that represents the slice of the hole at 0.73 mm from the entrance surface and has a defect marked with red that causes the circled peak in Fig. 12b.
