An Investigation of Misalignment Effects on the Performance of Acetal Gears

Zedong Hu and Ken Mao

School of Engineering, University of Warwick, Coventry CV4 7AL, UK

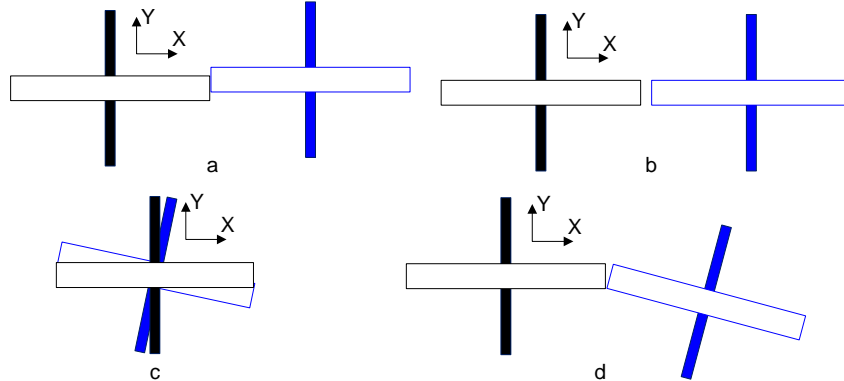
Fig.1 Schematic of a gear pair mesh misalignment [39]:

(a) Axial misalignment, (b) Radial misalignment, (c) Pitch misalignment, (d) Yaw misalignment

A gear pair mesh alignment is the ideal condition. There are four main categories of misalignment for gear engagement in imperfect condition shown in Fig.1 [30]:

- Axial misalignment (AM)- (Fig.1(a))
- Radial misalignment (RM)- (Fig.1(b))
- Pitch misalignment (PM) - (Fig.1(c))
- Yaw misalignment (YM) - (Fig.1(d))

Apart from the AM (reduction in tooth mating length along tooth face width) and RM (variations in centre distance), the PM and YM (angular misalignment on the plane of action) tend to cause an uneven

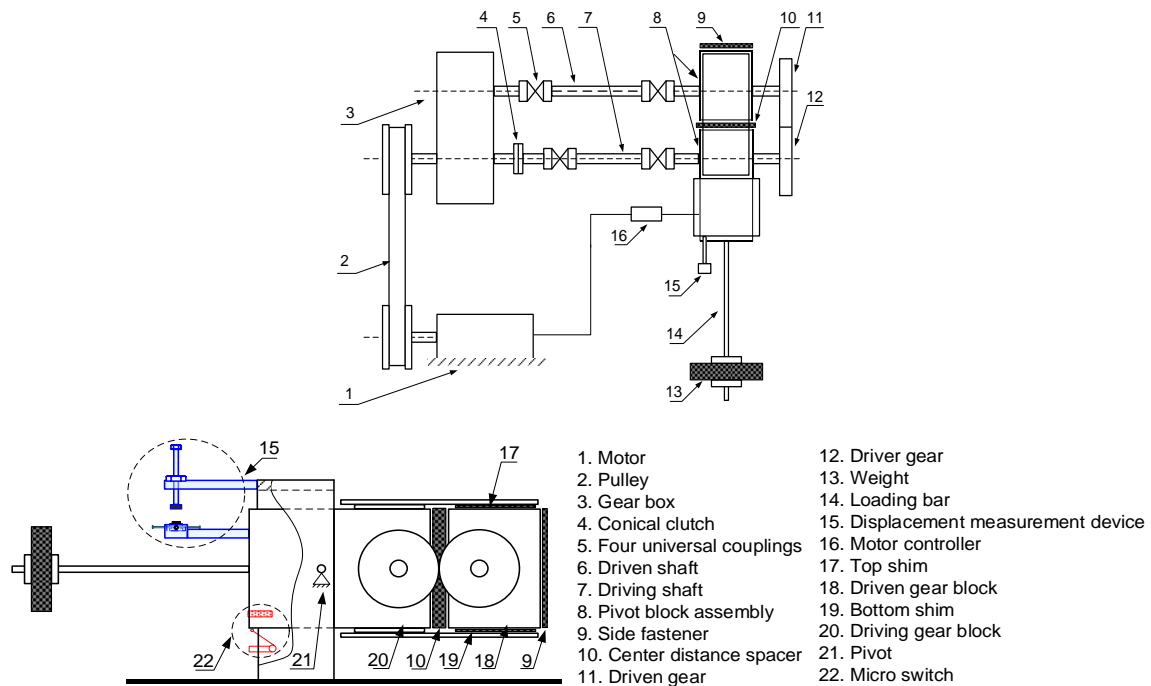
Fig.2 Schematic diagram of polymer gear test rig

A unique gear test rig shown in Fig.2, was designed and manufactured at the University of Warwick with a capacity to continuously measure the gear surface wear, and also conduct the test in both alignment and misalignment modes. The assembly photos of gear test rig and its wear mechanism are presented in detail in [39]. To continuously measure and record the wear in real-time, an exclusive data-logging system was designed and made, consisting of a displacement measurement device and a data-logging software. The non-contact displacement measurement device was designed by applying the principle that output voltage of Hall Effect sensor varies in response to an applied magnetic field. The transducer is able to move in three dimensions according to the experimental requirement. The gear wear is indirectly measured through the rotation of the pivot block. The details of wear definition and wear measurement method are explained in [8, 39].

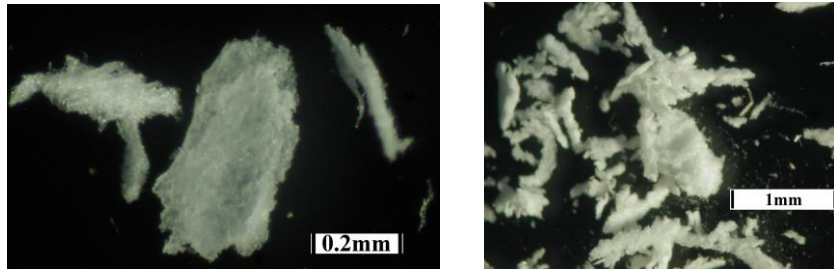
(a) Powdery debris

(b) Granular debris

Fig.3 OM micrographs of debris morphologies from alignment test

In the alignment test, two regimes of debris shown in Fig.3 were observed by using an OM. Powdery debris dominated through all the test and granular-like debris emerged around the transitional wear phase. There were no wood-shavings-like wear debris and large snowflake-like wear debris mentioned in tests of AM and PM, although the load was increased to 12NM. SEM examinations of the driving and driven teeth shown in Fig.4 (a) demonstrate markedly different wear features on the worn surfaces. A 'groove' forms at the pitch line on the driving tooth and a 'ridge' on the driven tooth. Many wear striations-ploughing-are observed on the wear surface of the dedendum area than that of the addendum on the driving tooth, and vice versa for the driven tooth.

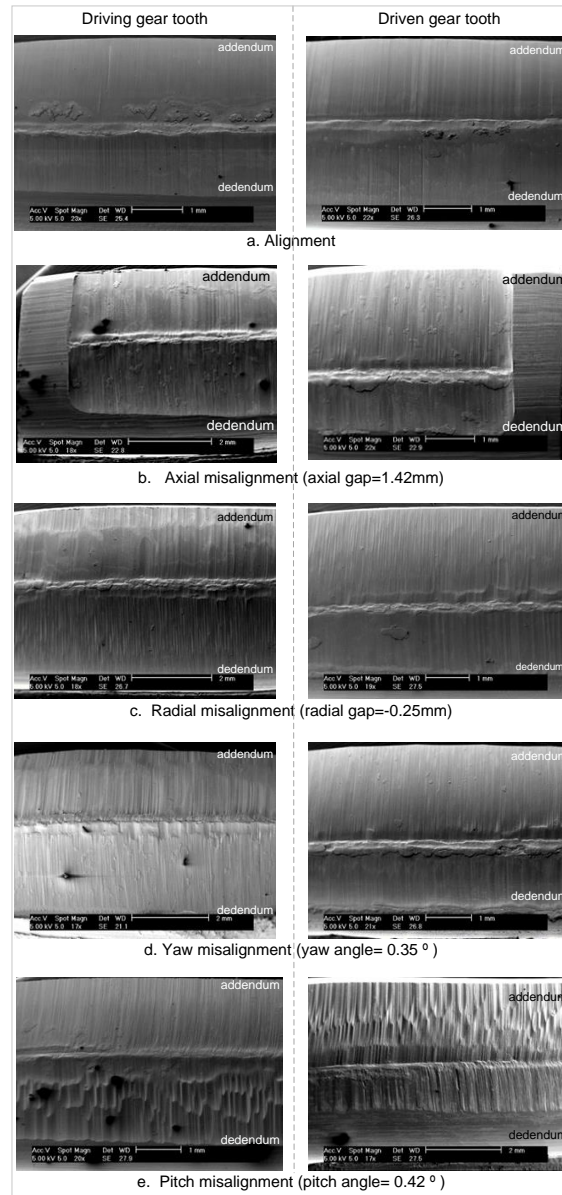
Fig.4 SEM micrographs of gears mesh alignment and misalignment

As with alignment test, almost no visible differences of debris morphology was found when actual CD increases ($d=+0.45\text{ mm}$). However when actual CD diminishes, a strikingly different debris regime was observed. Long strip-like debris shown in Fig.8 (a) dropped instantly once initiated and needle-like debris shown in Fig.8 (b) generated in steady phase. SEM micrographs of worn tooth surfaces are shown in Fig.4(c).

The wear debris of YM tests is similar to that of RM ($d=-0.3$ mm), spindly needle-like wear debris shown in Fig.10 dropped instantly once initiated and powdery debris dominated in steady wear phase. Striking wear characterises can be seen clearly from SEM micrograph in Fig.4 (d). 'Scoops' wear marks formed closely along the bottom of the driver's pitch point and the top of the driven. Coarse wear furrows can be seen and much wear occurs over addendum of driving gear as RM tests (Fig.4 (c)). Copious debris scatters over driving tooth roots and driven tooth tips, however, not much as AM test (Fig.4 (b)).

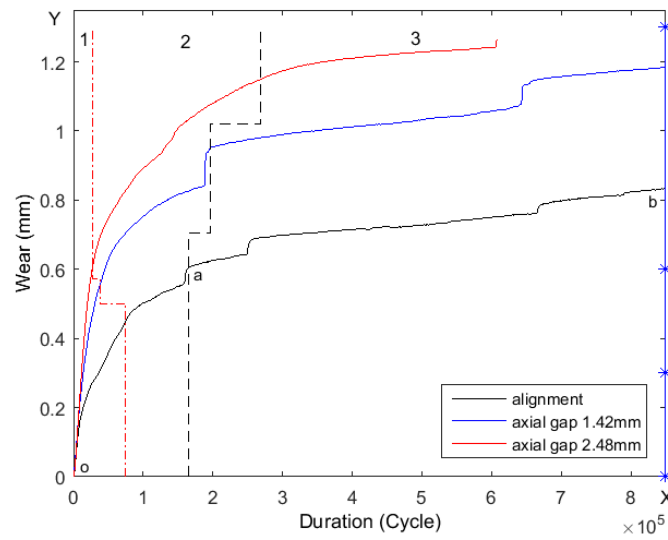
Fig.5 (a) Wear curve of axial misalignment: 1-initial (wear-in) phase, 2-transitioal wear phase, 3-steady wear phase (remove)

AM test results presented in Fig.5 (a) indicate three main wear phases: initial (wear-in), transitional and steady wear phases, having very similar wear curves. Wear rate discussed in the following paragraphs is achieved through averaging the total wear by its corresponding operating revolutions. The wear rate calculated prior to steady wear phase is defined as initial wear rate and the one within steady phase is referred as linear wear rate. Taking the results of alignment (see Fig.5 (a)) as an example, the expression of initial wear rate is $(Y_a - Y_o)/(X_a - X_o)$ and the linear one is $(Y_b - Y_a)/(X_b - X_a)$.

In contrast to alignment test, the initial wear of AM is sharper and wear loss is heavier. The initial wear loss increases as axial gap widens. Fig.5 (b) shows that the wear rate tends to increase as axial gap increases. It is noted that the initial wear rate is directly proportional to the axial gap and the linear wear rate appears slightly less linear to the axial gap.

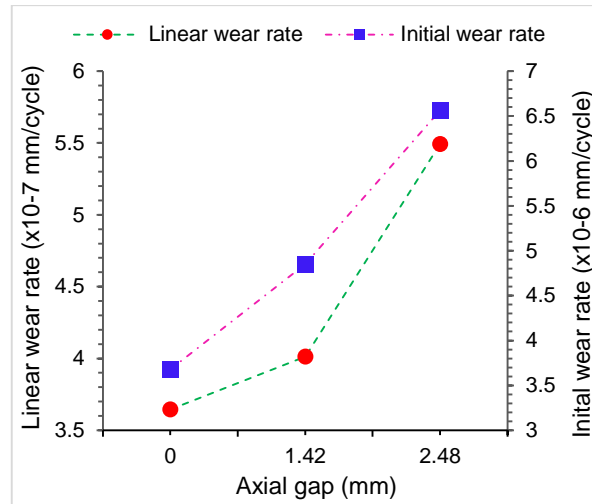
Fig.5 (b) Wear rate against axial gap

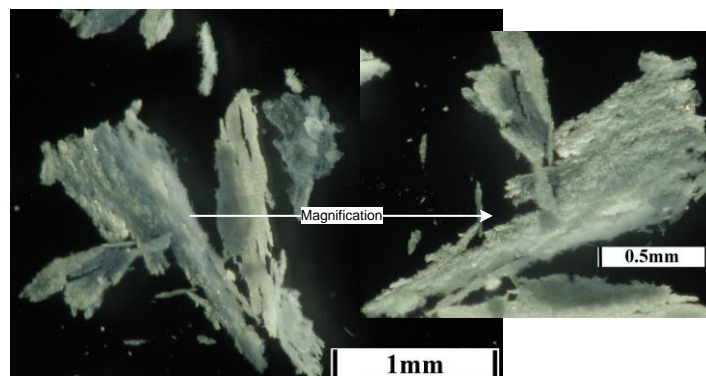
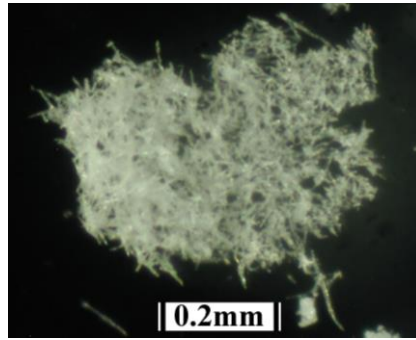
Fig.6 (a) Wood shavings-like wear debris

(b) Small round flake-like wear debris

Fig.6 OM micrographs of wear debris from axial gap =1.42 mm test

In addition to powdery wear debris, handful of long strip-like wear debris shown in Fig.6 appeared in these tests. The strip-like wear debris resembles wood shavings and small flake-like wear debris is like thin slice of snow. Noticeable load distribution shift could be seen from SEM micrographs of worn tooth surfaces shown in Fig.4 (b). Obvious characteristics are that the worn tooth surfaces are much rougher (coarse furrows) and more debris distributes on them. Compared with alignment (Fig.4 (a)) considerably more debris evenly scatters over the dedendum of the driving teeth and over the addendum of the driven.

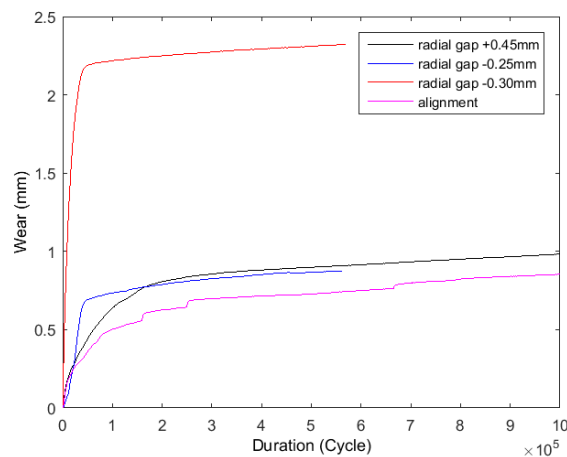
Fig.7 (a) Wear curve of radial misalignment

Note: CD is nominal centre distance 60 mm, CD' is the actual centre distance, d presents radial gap, thus $CD'=CD+d$ alignment $d=0$ mm

RM has two cases that actual centre distance (CD) is less than and greater than the nominal CD. The RM test results are shown in Fig.7. The wear curve ($d=+0.45\text{mm}$) shown in Fig.7(a) is parallel to that of alignment, and its initial wear rate is close to that of alignment but linear wear rate is slightly lower than that of alignment as shown in Fig.7(b). The RM wear curves ($d=-0.25$ and -0.3 mm) shown in Fig.7(a) are steep in initial phase, and their initial wear rates shown in Fig.7(b) are over twelve times that of alignment. However their linear wear rates are not greater than that of alignment.

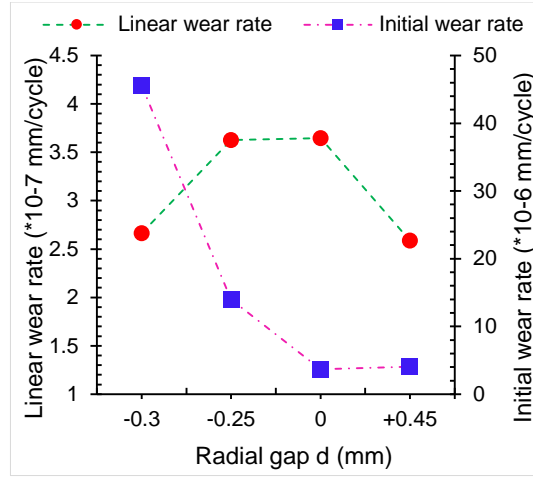
Fig.7 (b) Wear rate against radial gap d

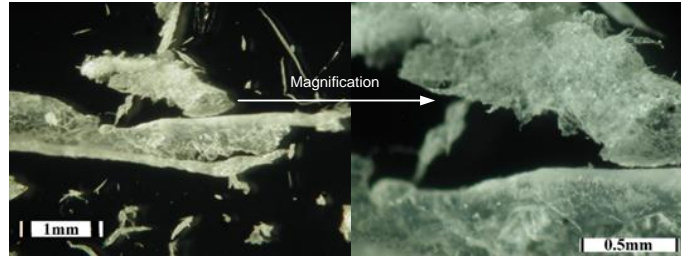
Fig.8 (a) OM micrograph of long strip-like debris - radial gap $d= -0.3$ mm

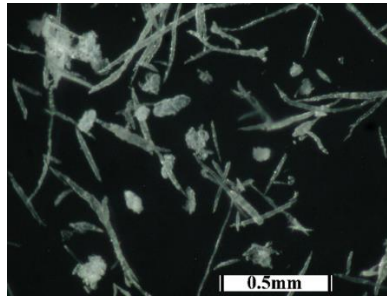
Fig.8 (b) OM micrograph of needle-like debris - radial gap $d= -0.3$ mm

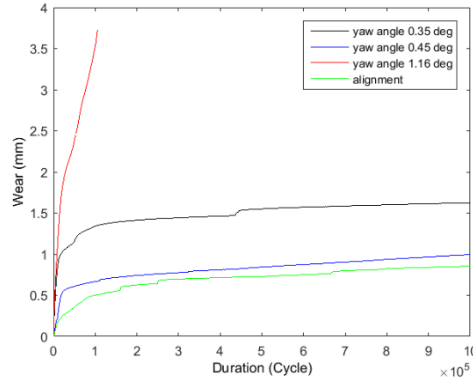
Fig.9 (a) Wear curve of yaw misalignment

Note: the plot of yaw angle $\alpha=0.45^\circ$ does not conform to others due to the testing device and environment variations. However it still shows the wear trend. The wear loss is the sum of driving and driven teeth.

Three different sets of acetal gear tests subjected to YM were conducted, at yaw angles α of 0.35° , 0.45° and 1.16° respectively. The YM wear curves and wear rates are plotted in Fig.9. Fig.9 (a) shows that the wear curves with yaw angles of 0.35° and 0.45° are similar to that of alignment except relatively steep wear gradient and high wear loss in initial wear-in phase. Fig.9 (b) shows that wear rates increase as yaw angle increases. Note that when a yaw angle $\alpha=1.16^\circ$, the wear curve gradient is steep almost no transitional wear phase and linear wear rate is over fifty fold that of the other three.

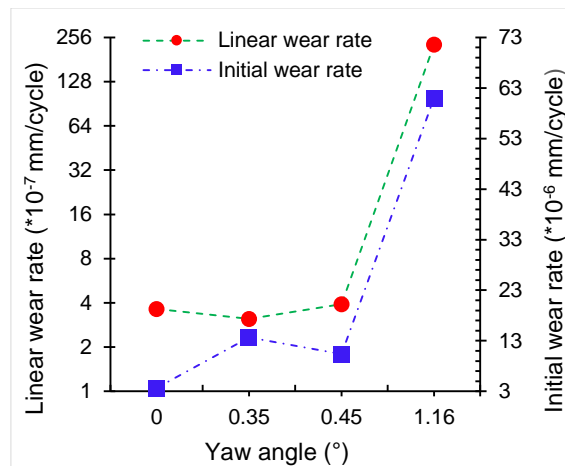
Fig.9 (b) Wear rate against YM angle

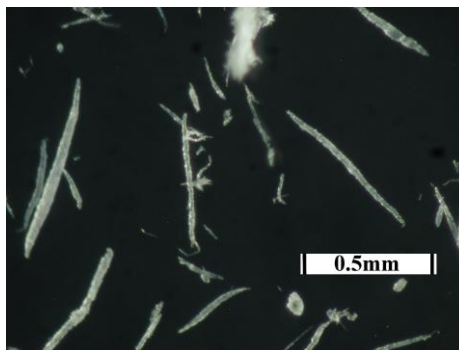
Fig.10 OM micrograph of spindly needle-like debris of 0.35° YM test

to short active line contact. Consequently it leads to wear rate increases as yaw angle increases. The appearance of spindly needle-like debris (Fig.10) is much likely to be caused by cyclic scratches due to imperfect conjugate contact action and short line contact. Perfect gear involute profile does not exist due to YM, which is a possible reason for scoops of material being removed from the surfaces near pitch point.

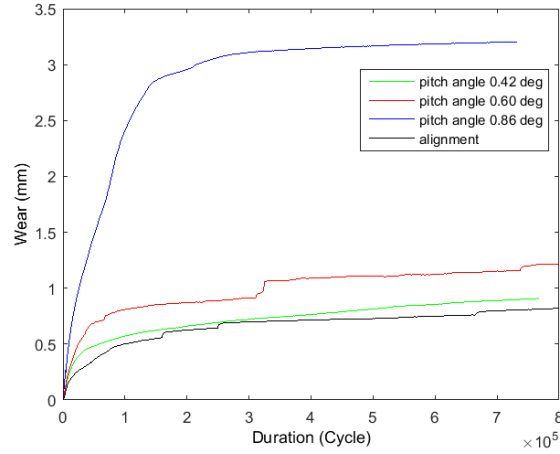
Fig.11 (a) Wear curve of pitch misalignment (pitch angle β)

Three different sets of pitch misalignment (PM) experiment were carried out respectively at pitch angles of $\beta=0.42^\circ$, $\beta=0.60^\circ$ and $\beta=0.86^\circ$. PM test results are presented in Fig.11. Fig11 (a) shows that PM wear curves are similar to that of alignment when pitch angle does not exceed a threshold value. A

steep wear gradient would be initiated once the pitch angle β reaches a threshold value, such as $\beta=0.86^\circ$. Its initial wear loss approaches 1.6 mm per tooth, nearly half of tooth thickness (at pitch point). This will reduce the tooth strength resulting in gears failing prematurely. Wear rates plotted in Fig.11 (b) shows that initial wear rate approaches a linear relationship with PM angle. However, linear wear rate increases as PM angle increases within 0.6° , and possibly decreases as PM angle greater than 0.6° .

in the linear wear phase. In brief, while gear teeth were in mesh, the non-conformal line contact evolved into conformal contact. Fig.11 (a) indicates that when pitch angle is great, such as 0.86° , initial wear loss should be taken into account. Otherwise gear may fail prematurely. The snowflake like debris is found solely in PM tests. From the OM magnification micrograph, it is similar to chunk snow, piling up by copious small flake-like wear debris of AM. The superimposed layers of 'palisade' wear striations tend to trap powdery debris which is recirculated in many revolutions and is squeezed into large snowflake-like wear debris.

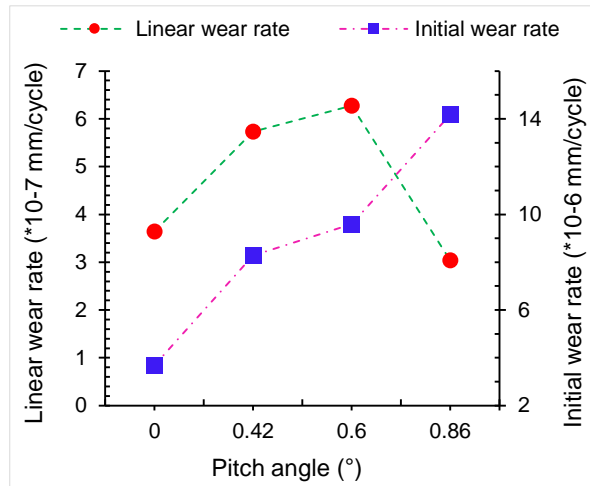
Fig.11 (b) Wear rate against pitch angle

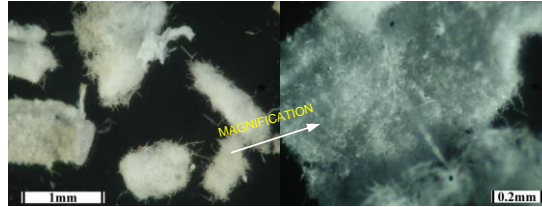
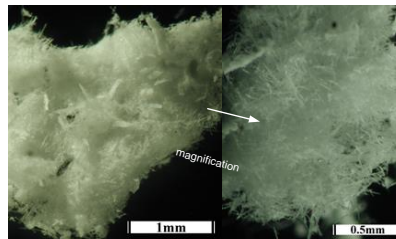
(a) Snowflake like debris (pitch angle 0.42°)

(b) Snowflake like debris (pitch angle 0.86°)

Fig.12 OM micrographs of snowflake like debris from PM tests

High volume of large snowflake-like wear debris was produced prior to steady wear phase. The powdery wear debris took dominant in the steady wear phase as other tests. Fig.12 shows the OM micrographs of snowflake-like wear debris. It reveals that the size of snowflake-like debris increase as PM angle increases. Coarser wear 'ploughing' can be seen from SEM in Fig.4 (e), where a series of 'palisade' wear marks across the dedendum of the driver and addendum of the driven. A visible difference is that 'groove' forms along the pitch line on the driven tooth and a 'ridge' on the driving tooth. Fig.13 shows the pitting over driving root, the intersection of 'superimposed palisade' wear marks and micro cracks on tooth root respectively.

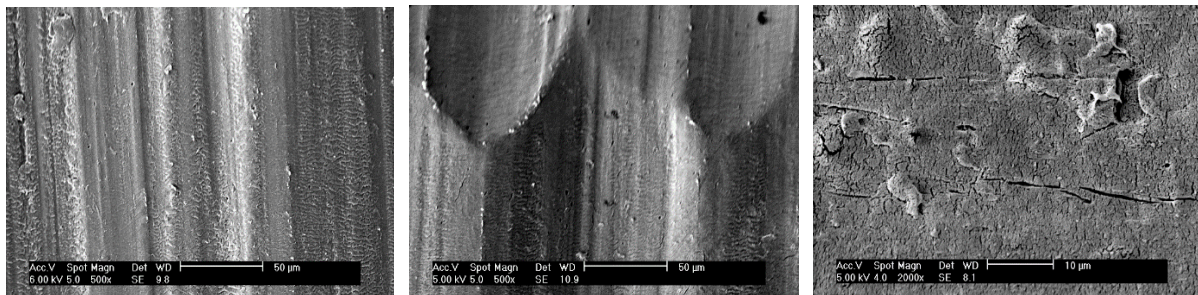
(a) Pitting on root of driving gear

(b) Junction of multi-layers palisade

(c) Micro cracks of driving gear tooth root

Fig.13 SEM micrographs of a gear pair with pitch angle 0.42°

It is concluded that of four types of misalignment, pitch misalignment has significant effect on the wear of acetal gears. pitch misalignment has greatly changed the size, shape and position of contact area [30]. A unique wear mark—a superimposed layer of 'palisade' (Fig.4(e)) was noticed, which resembled the wear striation described in [14]. It may contribute to the generation of snowflake-like wear debris. It is very possibly developed in initial wear phase. Micro cracks (Fig.13 (c)) were observed near tooth roots. Further tests are underway to establish its origin.
